4. **Select:** Campaign number 0635.

Touring, Police Touring and CVO Touring

Trike and CVO Trike

Hydraulic Portion of Trike Brake Switch Rework

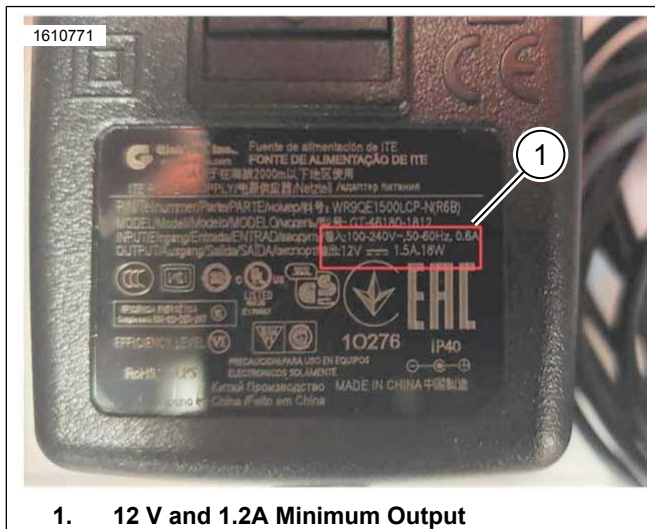
Figure 2. 12 V and 1.2A Output

1. 12 V and 1.2A Minimum Output

- See Figure 2. The external power adapter must have an output of at least 12 V and 1.2 A. This includes the power adapter included with the TL-3 or the adapter for the DT II.
- The vehicle battery should be fully charged prior doing the software update.
- Have a battery tender connected to the battery while performing software update.

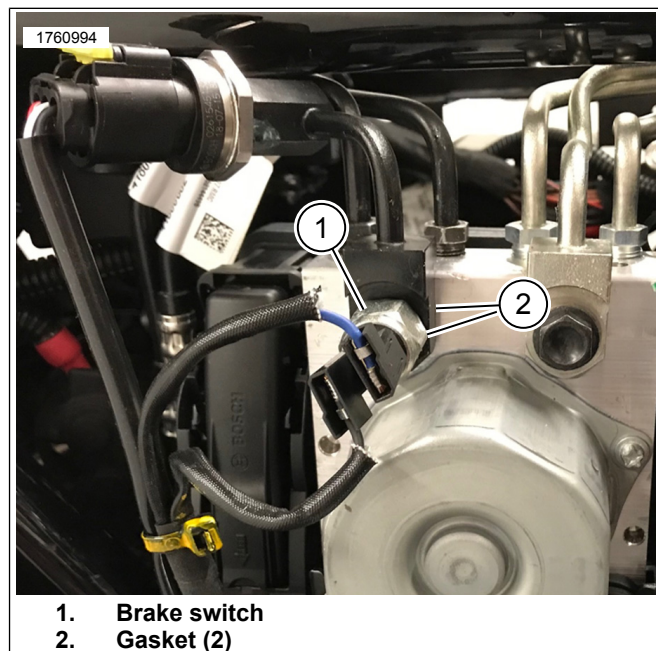
Figure 3. Brake Switch

**1. Brake switch
2. Gasket (2)**

1. Remove left and right side covers. See service manual.
2. Remove rear master cylinder to Electro Hydraulic Control Unit (EHCU) banjo bolt. Discard gaskets.
3. See Figure 3. Install rear brake switch (1) banjo bolt (Part No. 72025-06B).
 - a. Install two **new** gaskets (2) (Part No. 41751-06A).
Torque: 19–21 ft-lbs (25.5–28.5 N·m) *Rear Brake Switch Banjo Bolt*
4. Bleed brake system using special tool.
Special Tool: DIGITAL TECHNICIAN II (HD-48650)

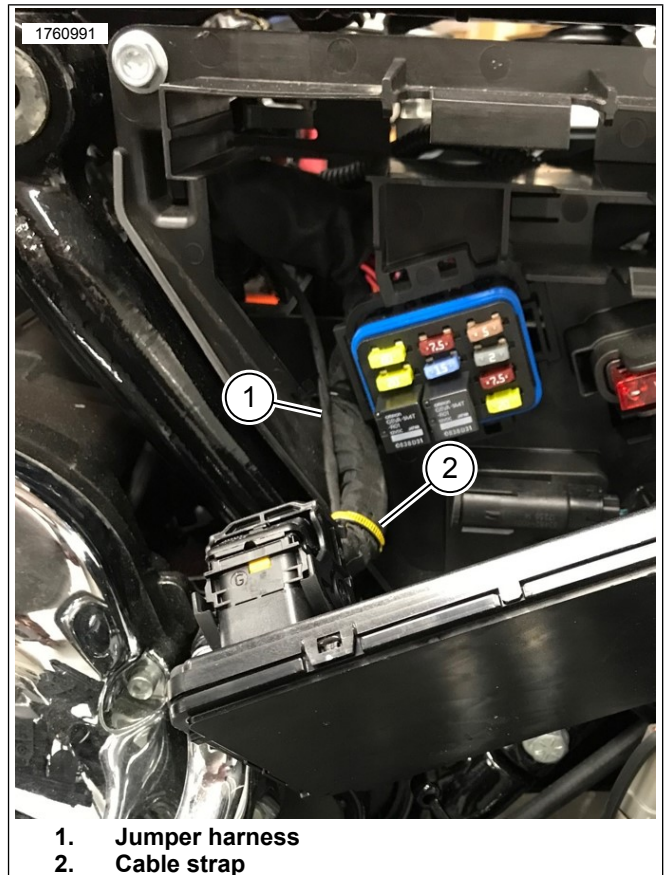
Figure 5. Jumper Harness BCM Connector

1. Jumper harness
2. Cable strap

4. See Figure 4. Install jumper terminal (Part No. 69203239) into cavity (F3) of the BCM connector.
 - a. See Figure 5. Using cable strap (2) secure jumper harness (1) to main harness.
5. See Figure 6. Route and install jumper ring terminal to left side ground stud.
 - a. Using cable strap (2) secure jumper harness (3) to main harness.
6. Route jumper harness (3) behind EHCU assembly and secure using cable straps (2).
7. See Figure 7. Install flag terminals (1) to **new** brake switch.
8. Install battery. See service manual.
9. Install main fuse. See service manual.
10. Install BCM calibration using special tool.

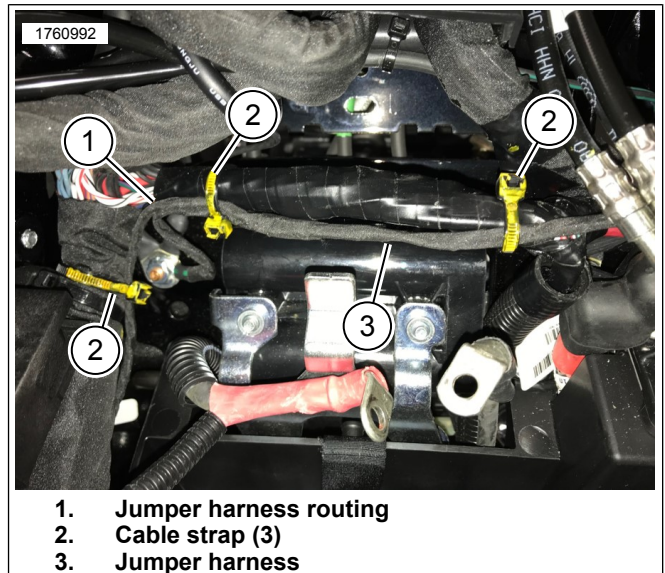
Figure 6. Jumper Harness Routing

1. Jumper harness routing
2. Cable strap (3)
3. Jumper harness
