4. **Select:** Campaign number 0635.

## Touring, Police Touring and CVO Touring

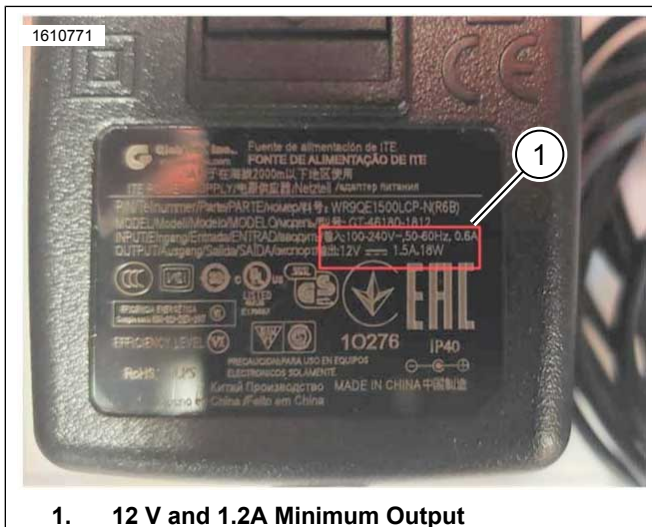
Figure 2. 12 V and 1.2A Output

1. **12 V and 1.2A Minimum Output**

- See Figure 2. The external power adapter must have an output of at least 12 V and 1.2 A. This includes the power adapter included with the TL-3 or the adapter for the DT II.
- The vehicle battery should be fully charged prior doing the software update.
- Have a battery tender connected to the battery while performing software update.

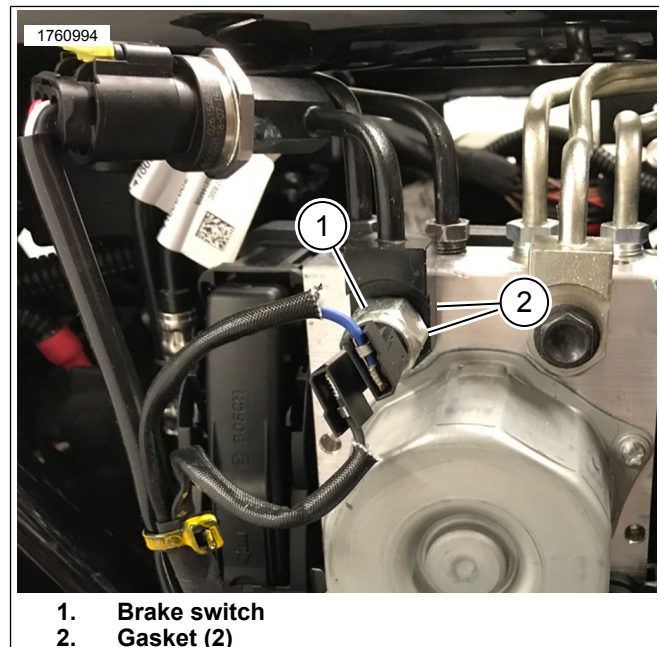
Figure 3. Brake Switch

1. **Brake switch**
2. **Gasket (2)**

1. Remove left and right side covers. See service manual.
2. Remove rear master cylinder to Electro Hydraulic Control Unit (EHCU) banjo bolt. Discard gaskets.
3. See Figure 3. Install rear brake switch (1) banjo bolt (Part No. 72025-06B).
  - a. Install two **new** gaskets (2) (Part No. 41751-06A).  
Torque: 25.5–28.5 N·m (19–21 ft·lbs) *Rear Brake Switch Banjo Bolt*
4. Bleed brake system using special tool.  
Special Tool: DIGITAL TECHNICIAN II (HD-48650)

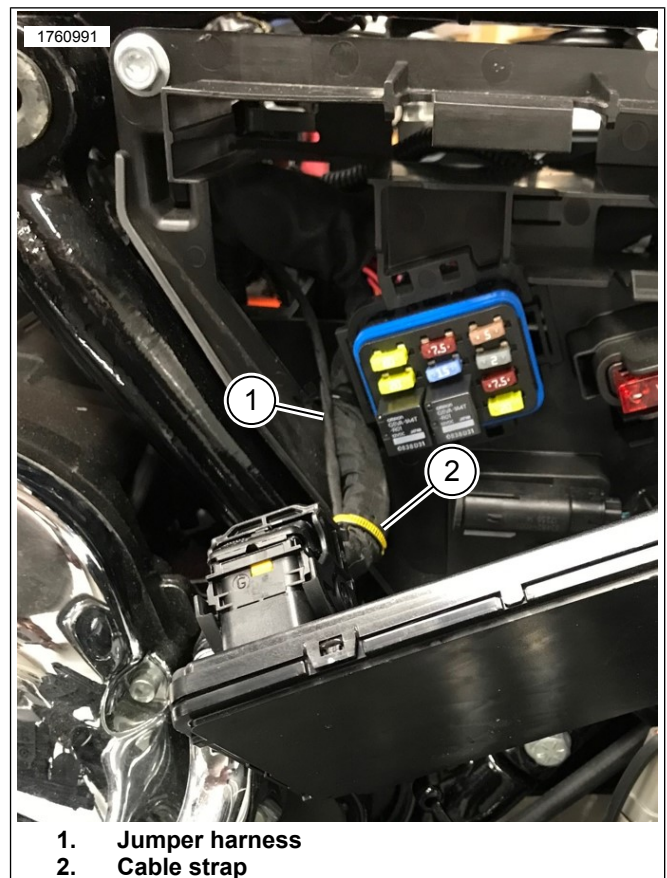
**Figure 5. Jumper Harness BCM Connector**

1. Jumper harness
2. Cable strap

3. Remove battery. See service manual.
  - a. Gain access to left ground stud and main harness.
4. See Figure 4. Install jumper terminal (Part No. 69203239) into cavity (F3) of the BCM connector.
  - a. See Figure 5. Using cable strap (2) secure jumper harness (1) to main harness.
5. See Figure 6. Route and install jumper ring terminal to left side ground stud.
  - a. Using cable strap (2) secure jumper harness (3) to main harness.
6. Route jumper harness (3) behind EHCU assembly and secure using cable straps (2).
7. See Figure 7. Install flag terminals (1) to **new** brake switch.
8. Install battery. See service manual.
9. Install main fuse. See service manual.
10. Install BCM calibration using special tool.

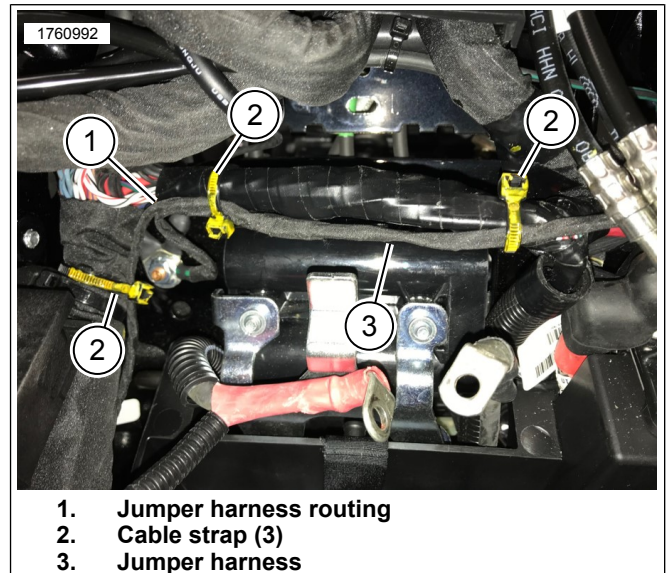
**Figure 6. Jumper Harness Routing**

1. Jumper harness routing
2. Cable strap (3)
3. Jumper harness

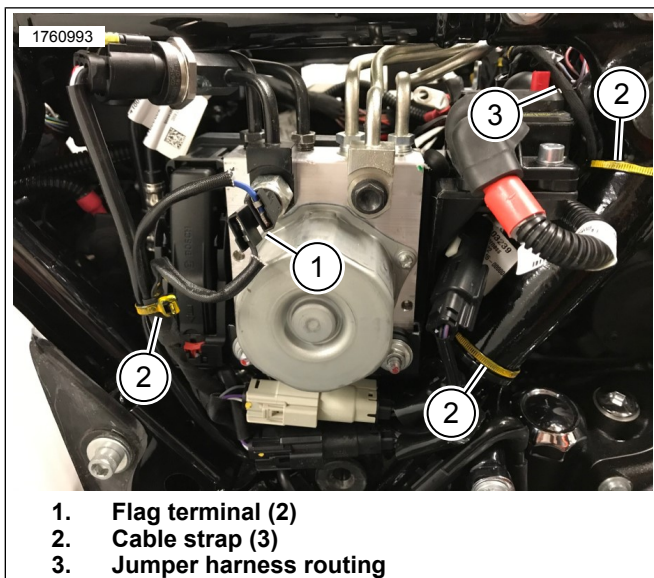
Figure 7. Brake Switch

1. Flag terminal (2)
2. Cable strap (3)
3. Jumper harness routing
