WARRANTY BULLETIN SAFETY CAMPAIGN

October 31, 2022 Subject: **Front Fenders Electrical Harnesses May Be Loose – Potential Loss of Power**

No. **2023-1**

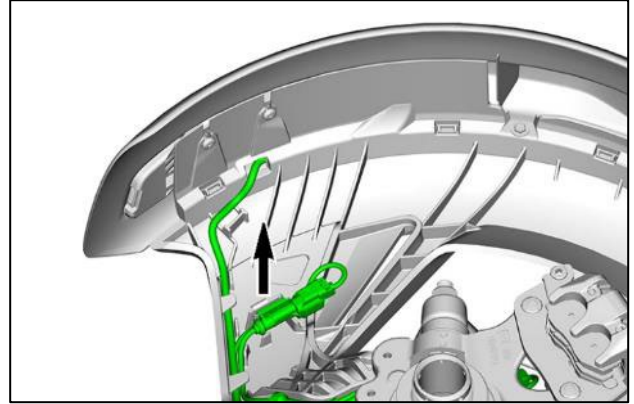
4. Inspect the harness condition. If it was previously damaged, it will need to be repaired.

5. Unclip harness connector and pull harness out of location to provide access for drilling.
