GROUP	MODEL
Safety Recall Campaign	2008-2009MY Sportage (KM)
NUMBER	DATE
SC253	December 2022

SAFETY RECALL CAMPAIGN

HECU INSPECTION/REPLACEMENT AND FUSE REPLACEMENT (SC253)

This bulletin provides information relating to the inspection and, if necessary, replacement of the Hydraulic Electronic Control Unit (HECU) in the 2008-2009MY Sportage (KM) vehicles produced from August 9, 2007 through May 13, 2009 that were previously recalled under Kia's Campaign SC138. In addition, the two (2) '40A' fuses for the HECU circuits will be replaced with new '30A' and '20A' fuses to prevent an over-current condition in the HECU's electrical circuit board to mitigate the risk of a fire. An engine compartment fire originating from the area of the HECU may occur while the subject vehicle is being driven or while parked after replacement of the HECU connector cover under the previously launched SC138 recall. Although the exact cause is unknown, it is believed that an internal electrical short circuit can occur from foreign substances remaining on the printed circuit board. Follow the procedure outlined in this publication to inspect the HECU and its wiring harness and connectors for proper function

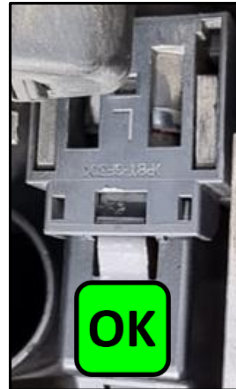
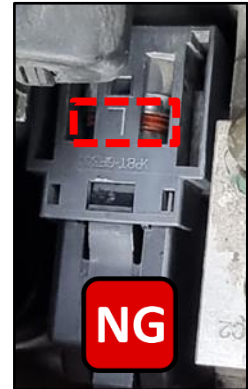
- 6. Confirm that the orange connector seal is NOT visible (NG) from the top. If so, properly reconnect HECU connector and secure (OK).
