Safety Recall

Code: 42M2

Subject	Driver Side (Left Side) Rear Trailing Arm Bolts																									
Release Date	November 15, 2022																									
Affected Vehicles

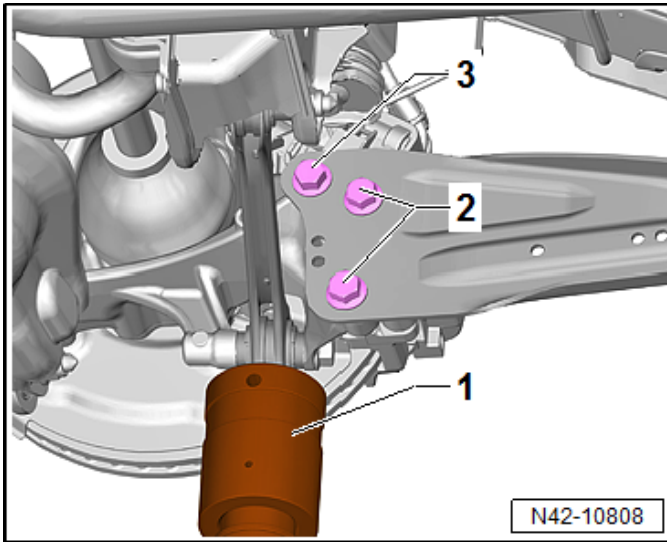
Repair Overview

What is the issue? The driver side (left side) rear trailing arm bolts may loosen over time and fall out, or the trailing arm may fracture due to overload around the remaining bolt(s). This could cause excessive movement of the driver side (left side) rear wheel bearing carrier, which can lead to a change in vehicle handling characteristics. If this were to occur there could be a sudden loss of vehicle control. This may increase the risk of a crash.

- Tighten, then replace bolts for left rear trailing arm.
