SIB 51 18 22

2022-11-15

RECALL 22V-820: WINDSHIELD NOT PROPERLY BONDED

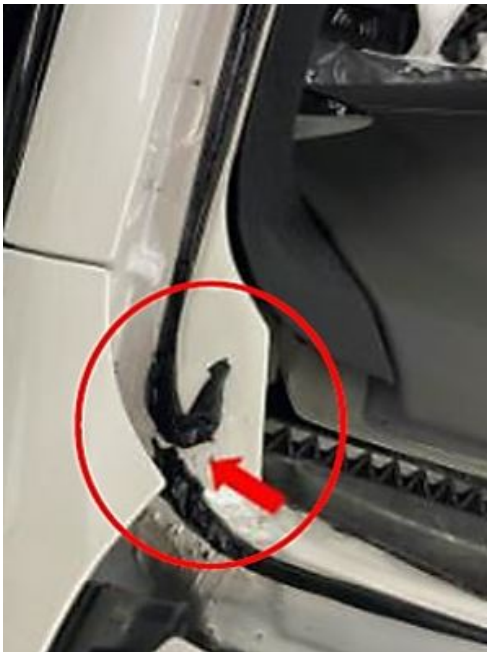
During vehicle assembly, the windshield on the passenger side of the bottom A-pillar may not have been properly sealed to the vehicle.

Note: If the windshield was not properly bonded, the glove compartment and passenger footwell area may become wet. As a result, the control units that are located in that area may get damaged and potentially create a short circuit, and consequently, a thermal event cannot be ruled out.

Inspect the front windshield adhesive on the passenger side bottom A-pillar and rework if necessary.
