IMPORTANT SAFETY RECALL

2022 QUALITY TRAILER

Safety Recall Notice/NHTSA Recall 22V824

Product Bulletin CA-5400-O/B/Z 14K RAM A-Frame Couplers with QC#GTR202107XX Placard Date

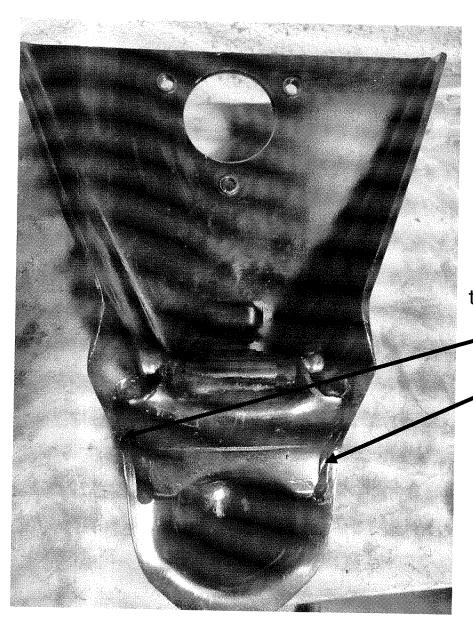
Check for coupler welds on bottom side of coupler.

Normal Welds On Coupler up the entire length of the bottom ball clamp

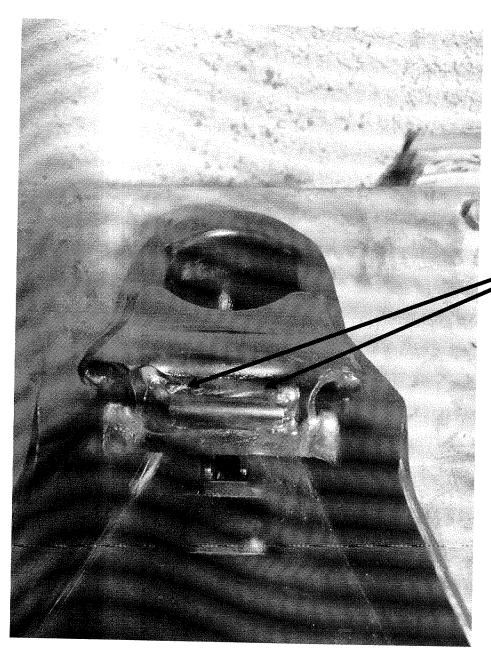
Check for coupler welds on bottom side of coupler.

Normal Welds On Coupler the entire length of the back side of bottom ball clamp

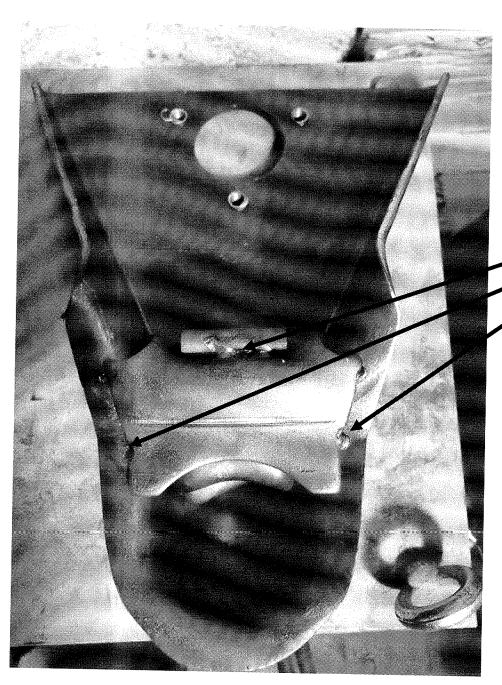
What is the issue? On your trailer, it may be possible that the 2(5/16)" A-Frame Coupler was not fully

welded by the manufacturer of the coupler. There are 3 welds on the underside of the

coupler that may have been tack welded instead of solid welded.

What is the risk? The welds on the underside of the coupler could break causing possible disconnect with

tow vehicle increasing the risk of a crash.

Check for coupler welds on bottom side of coupler.

If any spot welds like on this coupler, these need to be pulled out of inventory and not used.

What should you do? Inspect the underside of your coupler without delay. Please see enclosed pictures of

both correct and incorrect welds from the manufacturer for reference. <u>Please contact</u> <u>Quality Trailers at (330) 332-9630</u> with the results of the inspection. Quality Trailers will instruct you as to how to proceed with your repair should any defects be found.
