December 12, 2022

**SUBJECT: NEW VEHICLE DEMONSTRATION / DELIVERY HOLD -
Compliance Recall 22C27**

Certain 2021-2022 Model Year Bronco Vehicles
Accessory Protocol Interface Module Software Update

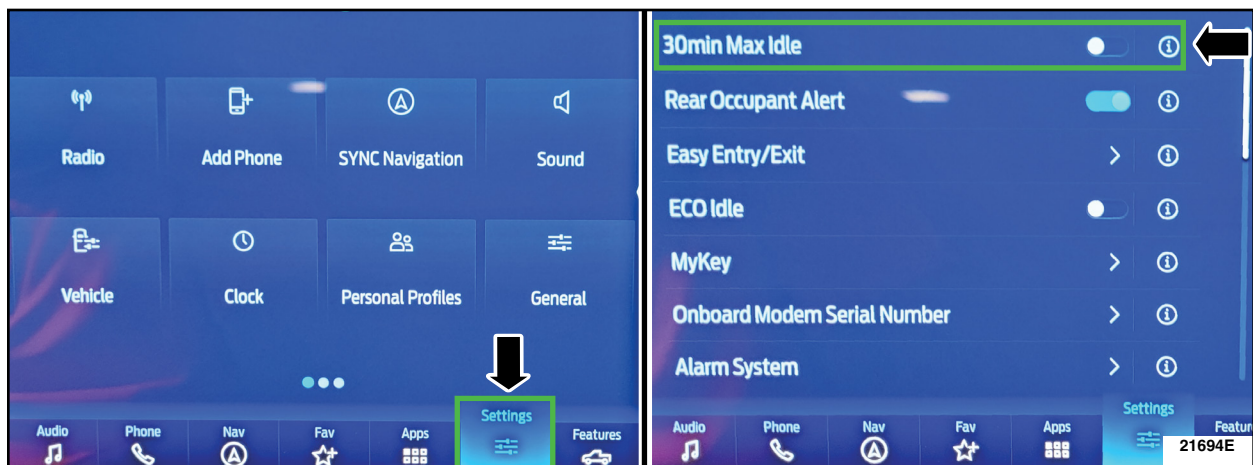
FIGURE 1

1. From the vehicle settings menu disable the 30 minute max idle option. From the center display press the vehicle settings button and turn off the 30 minute max idle setting. See Figure 1.

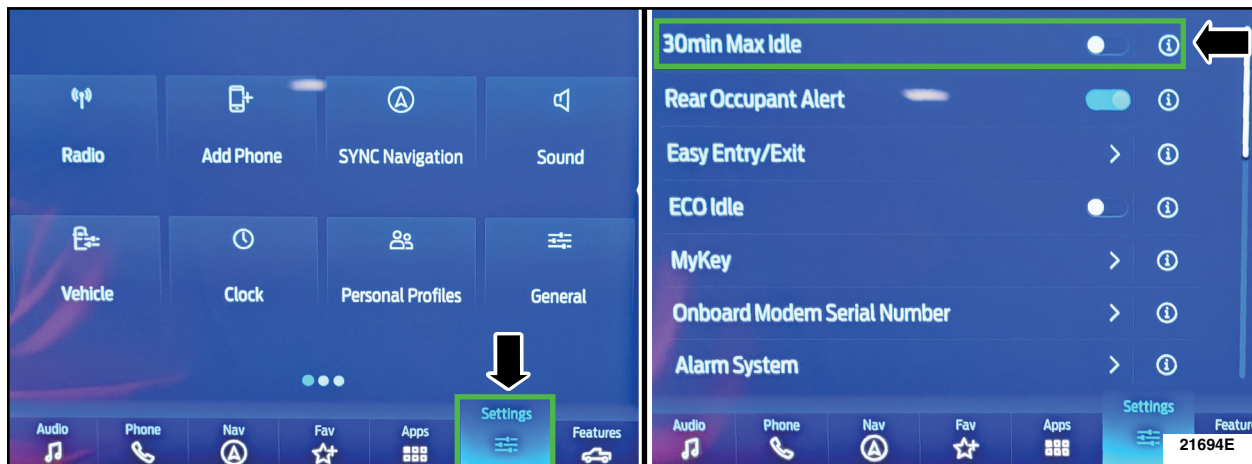
FIGURE 2

1. From the vehicle settings menu disable the 30 minute max idle option. From the center display press the vehicle settings button and turn off the 30 minute max idle setting. See Figure 2.
