Safety Recall

Code: 19Q9

Subject	Electric Motor Coolant Sealing Ring										
Release Date	December 13, 2022										
Affected Vehicles	<table border="1"><thead><tr><th>Country</th><th>Beginning Model Year</th><th>Ending Model Year</th><th>Vehicle</th><th>Vehicle Count</th></tr></thead><tbody><tr><td>USA</td><td>2023</td><td>2023</td><td>ID4</td><td>393</td></tr></tbody></table>	Country	Beginning Model Year	Ending Model Year	Vehicle	Vehicle Count	USA	2023	2023	ID4	393
Country	Beginning Model Year	Ending Model Year	Vehicle	Vehicle Count							
USA	2023	2023	ID4	393							
Problem Description	<p>Check Campaigns/Actions screen in ELSA on the day of repair to verify that a VIN qualifies for repair under this action. ELSA is the <u>only</u> valid campaign inquiry & verification source.</p> <ul style="list-style-type: none">✓ Campaign status must show "open."✓ If ELSA shows other open action(s), inform your customer so that the work can also be completed at the same time the vehicle is in the workshop for this campaign. <p>Due to an incorrectly assembled sealing ring, it may be possible for coolant to enter the high-voltage system, potentially resulting in ground bouncing in the low-

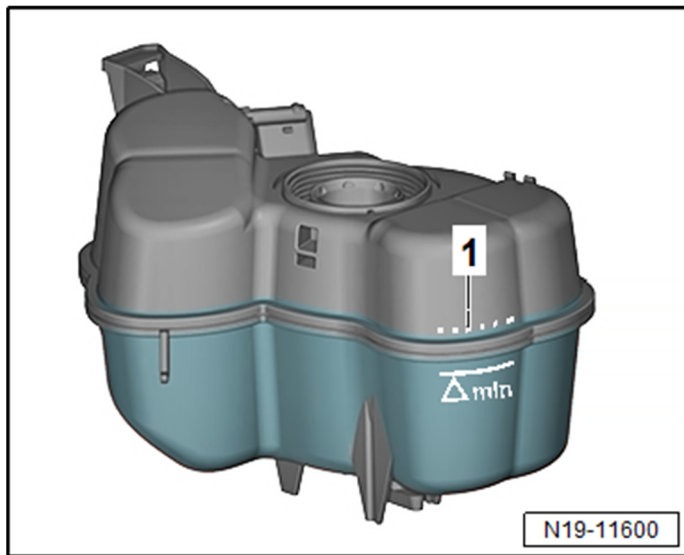
Section C – Inspection Procedure

- Fill coolant ***precisely*** up to the max. mark <1>.
- Activate “Traction” driving mode via the “Mode” button of the touch panel.
- Carry out a dynamic test drive of at least 6 miles (10 km). The test drive should include driving under full load multiple times.
- Check whether coolant level is still precisely at the level of the max. marking <1>.
- If the coolant level is above or still at the height of the max. marking <1>:
 - The front drive motor does not require replacement.
 - Proceed to Section E.
- If the coolant level is below the max. marking <1>:
 - The front electric drive must be replaced.
 - Proceed to Section D.
