GROUP	MODEL
Safety Recall Campaign	2017-2018MY Niro HEV (DE HEV)
NUMBER	DATE
SC256	January 2023

### POWER RELAY ASSEMBLY (PRA) OR HV MAIN RELAYS

### INSPECTION / REPLACEMENT (SC256)

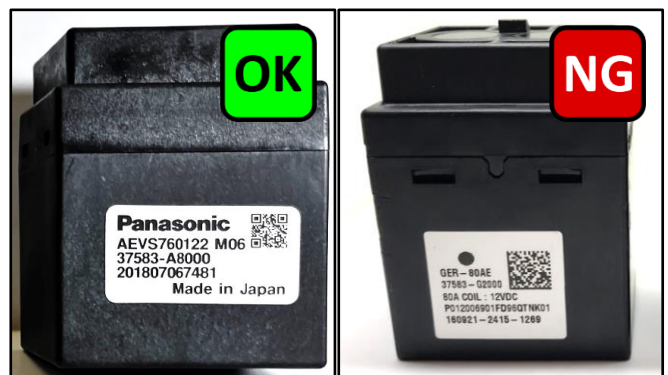
Refer to the removed HV main relay images below for samples of the label.

5. Inspect and verify if the existing HV Main Relays are labeled 'Panasonic' with PN 37583 A8000.

- **OK** - Campaign is complete. Reinstall all removed parts in the reverse order of removal.
- **NG** - Proceed to the 'Replacement Procedure' on page 5.

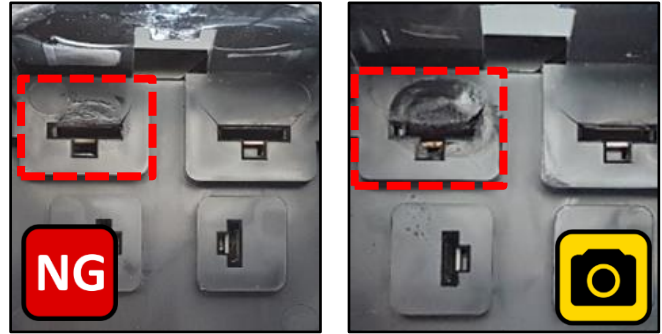
8. Inspect the PRA at the HV main relay large contact areas for thermal damage.

**Note:** Damage should only be present at the large HV main relay terminals.

- If any sign of thermal damage is present, replace the PRA.

- If no sign of thermal damage is present, replace the two (2) HV main relays.

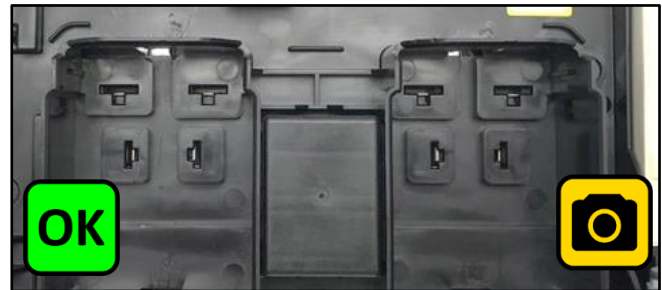
For **NG** conditions, PHOTOS ARE REQUIRED to be attached to the claim when replacing the PRN.

For **OK** conditions, PHOTOS ARE REQUIRED to be attached to the claim when replacing the relays.
