January 2023
FL959AB
NHTSA #22V-840

Subject: TBB Minotour Barrier Configuration

Models Affected: Specific model years 2021-2023 TBB Minotour school buses manufactured June 3, 2020, through July 19, 2022.

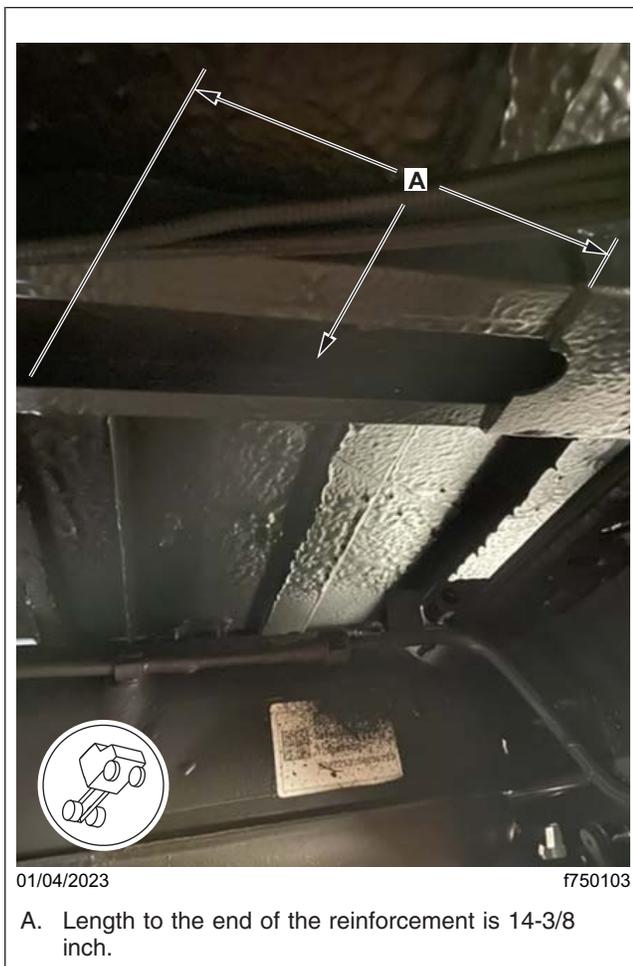
Fig. 1, Installing the Joist Reinforcement

The forward seat barrier installed may not provide sufficient protection to passengers. In the event of a crash, the occupant may experience higher impact forces than intended, which may increase the risk of injury to the occupant.

1. Park the vehicle on a level surface, shut down the engine, and set the parking brake. Chock the tires.
2. Disconnect the negative battery cables at the batteries.
3. Remove the existing barrier. **Do not** discard the fasteners, they will be used during install.
4. Install the joist reinforcement (205873). See [Fig. 1](#).

5. Use a #20 (or 5/32-inch) drill bit to drill four pilot holes in the underside floor joist.

6. Install four self-tapping screws (69003250) in the pilot holes to hold the joist reinforcement in place.
7. Install the new barrier as per the new seat plan. For detailed instructions, see **Drawing 214356** (reference **Drawings 214355** and **151775**).
8. Connect the negative battery cables at the batteries.

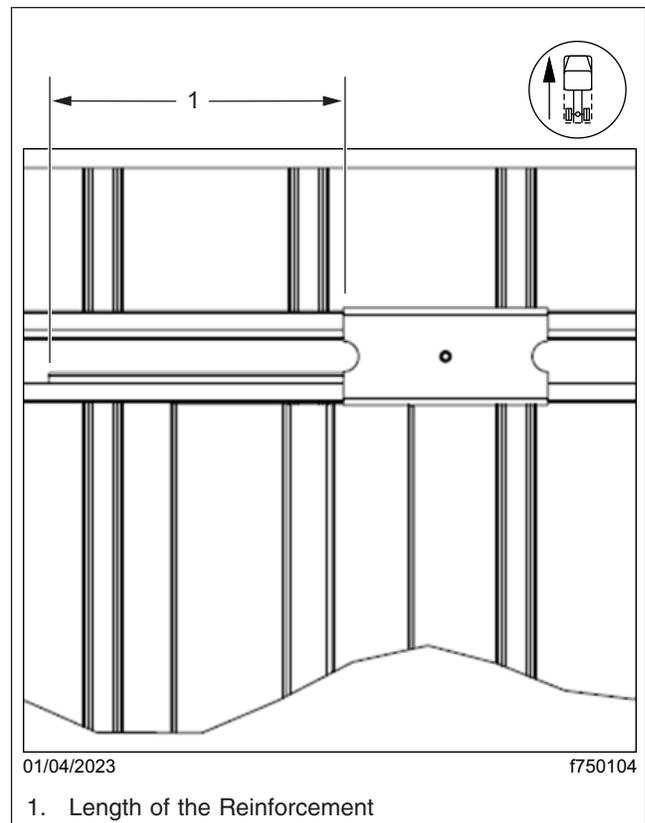
Fig. 2, Location of the Reinforcement

[Figure 2](#) shows the precise location of the reinforcement installation.

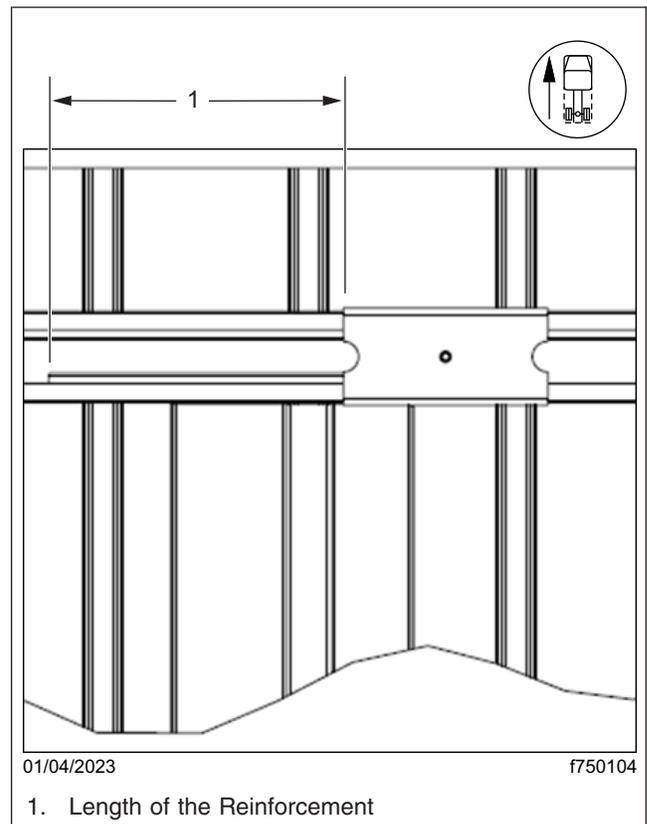
Fig. 4, Location of the Reinforcement

[Figure 4](#) shows the precise location of the reinforcement.

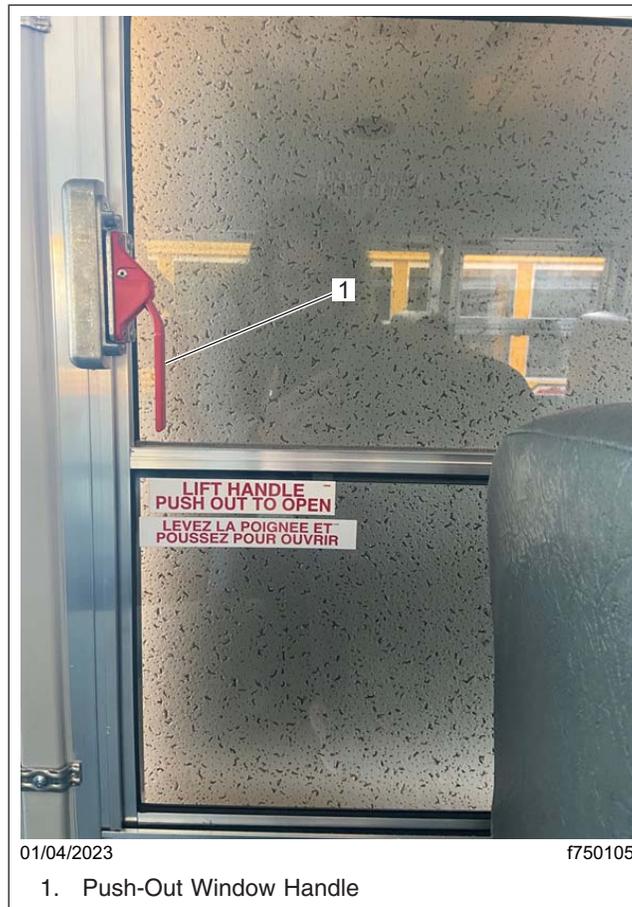
Fig. 5, Inspecting the Push-Out Window Handle Clearance

14. Inspect if the push-out window handle clearance is as per the FMVSS 217 requirement. See **Fig. 5**.

Is a 2-inch clearance on all sides maintained around the push-out window handle?

- 14.1 Switch the push-out window to the second position as per the new seat plan obtained in step 9.
 - 14.2 Shorten the buzzer warning as required.
 - 14.3 Remove the emergency exit label from the interior of the vehicle, above the third window position.
 - 14.4 Install the new emergency exit label at the second window position.
 - 14.5 Remove the existing push-out window emergency label, and install the new one (65009951).
15. Connect the negative battery cables at the batteries.
