# Safety Recall

## Code: 90V2

**Subject** Gateway Control Module

**Release Date** January 20, 2023

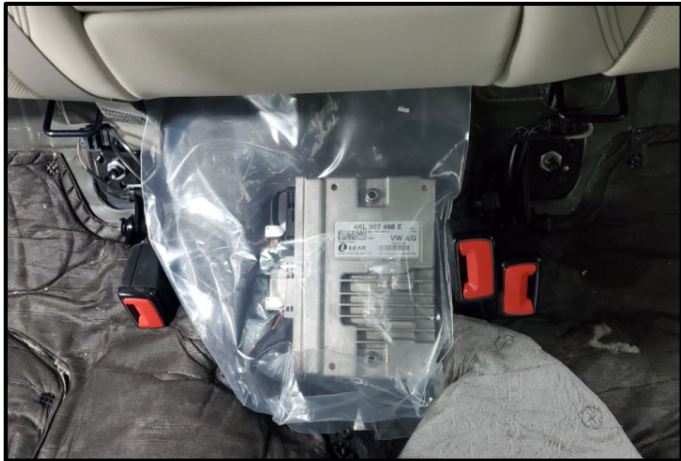
If liquid reaches and enters the gateway control module located under the rear middle seat, usually due to a liquid spill on the rear seats, it is being switched off as part of the safety concept. Water/liquid ingress into the gateway control module may lead to various internal errors due to short circuits within the control unit.

- Install protective cover over Gateway Control Module.

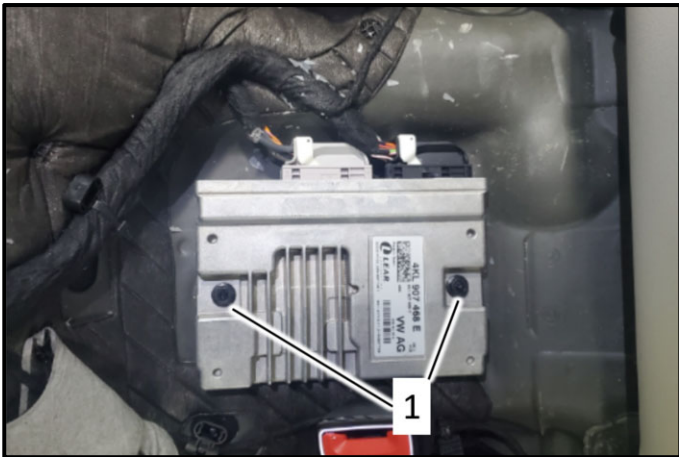
### Unbolt gateway control module:

- Inspect the recessed well that the gateway was in.
- If any liquid or traces of liquid are present:
  - Take photos showing liquid or traces of liquid are present.
  - U.S. Dealers - Upload photos to Doc-It.
  - Canada Dealers - Upload photos to an ATA WEB Ticket
  - The gateway control module must be replaced.
  - The connector pins must be inspected and any corroded pins replaced.

- Remove and discard nuts <1>.
- Do not disconnect the electrical connectors.
- Set the module to the side.

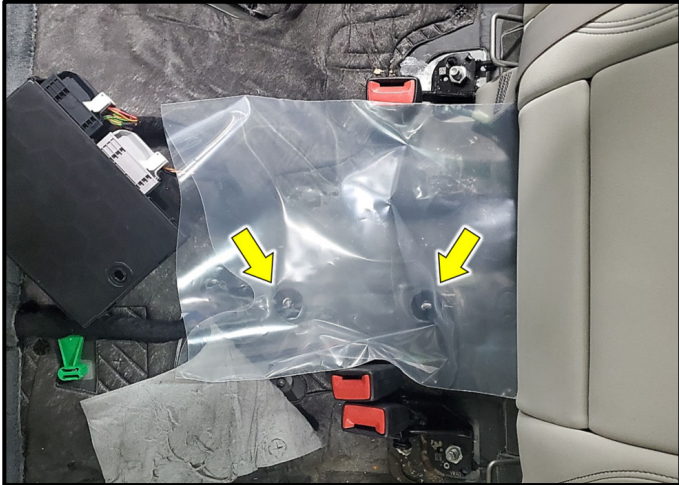
**Continuation for all vehicles: Installing protective cover:**

Ensure the cover is installed correctly. If the cover is folded under the gateway, it's possible to pinch the cover and create a puncture in the cover. Pay very close attention to how the cover is installed and also ensure the nuts are torqued correctly.

- Place new protective cover (without the gateway) over studs <arrows>.

- Press the grommets down completely over the studs by hand, from inside the cover.

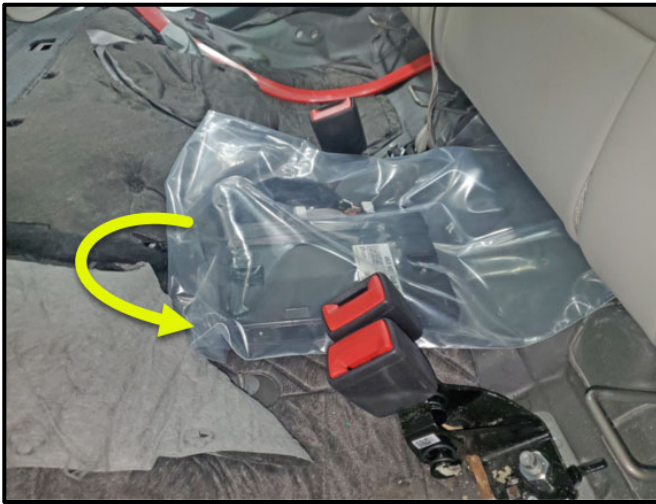
The concept is to prevent any spills from above the gateway from getting on the gateway.

- Fold the front of the cover over, toward the bottom.
- The cover will then be “closed.”

- **Vehicles with seat belt buckle wiring:** place the harness to the right seat belt buckle under the cover.
