Product Safety Recall

N222373320 Rear View Camera Intermittent or Inoperative

Release Date: February 2023
Revision: 01
Revision Description: The service procedure in this bulletin has been updated to include CERTAIN 2019 model year vehicles. It is IMPORTANT to note that the 2019 model year population is divided between two bulletins: N222373320 and N222373321. It is critical that dealers verify the VIN in IVH in order to apply the appropriate procedure for 2019 model year vehicles. Please discard all previous copies of bulletin N222373320.

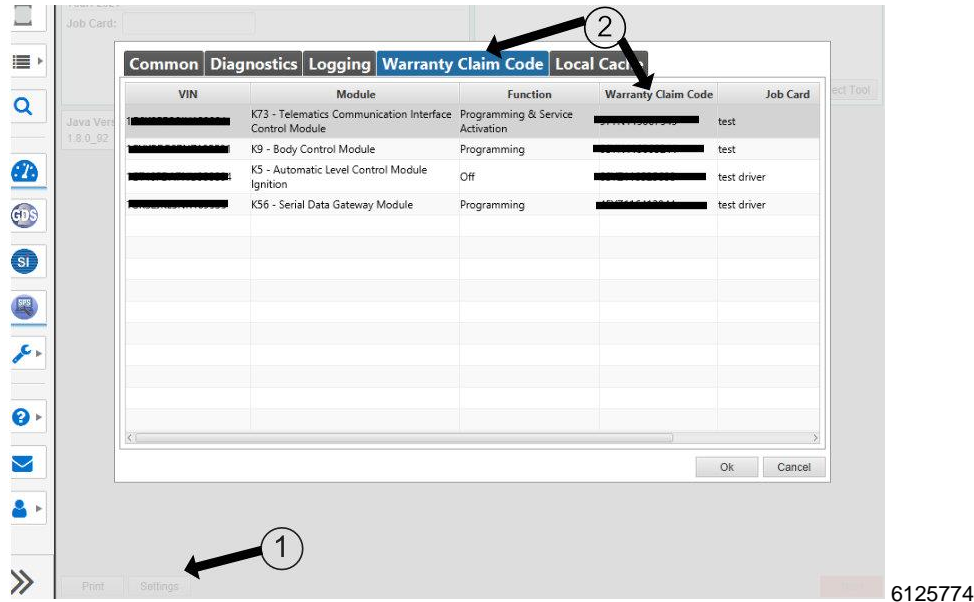
If the Warranty Claim Code was not recorded on the Job Card, the code can be retrieved in the SPS2 system as follows:

1. Open TLC on the computer used to program the vehicle.
2. Select and start SPS2.
3. Select Settings (1).
4. Select the Warranty Claim Code tab (2).

The VIN, Warranty Claim Code and Date/Time will be listed on a roster of recent programming events. If the code is retrievable, dealers should resubmit the transaction making sure to include the code in the SPS Warranty Claim Code field.

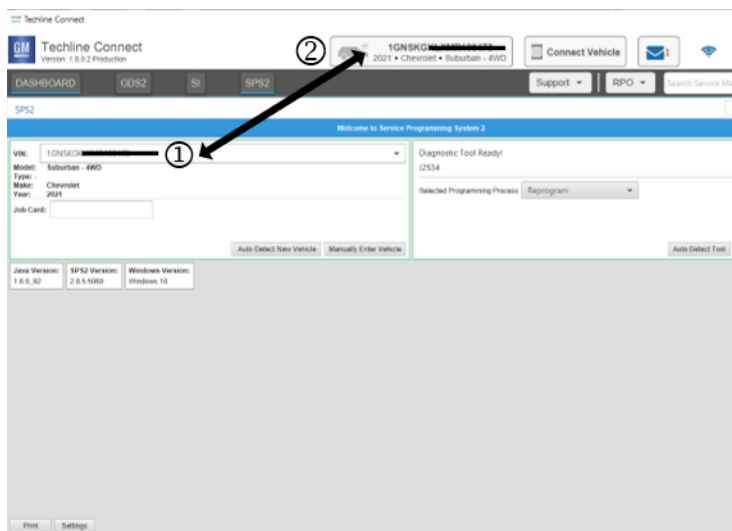
5743643

Caution: Be sure the VIN selected in the drop down menu (1) is the same as the vehicle connected (2) before beginning programming.

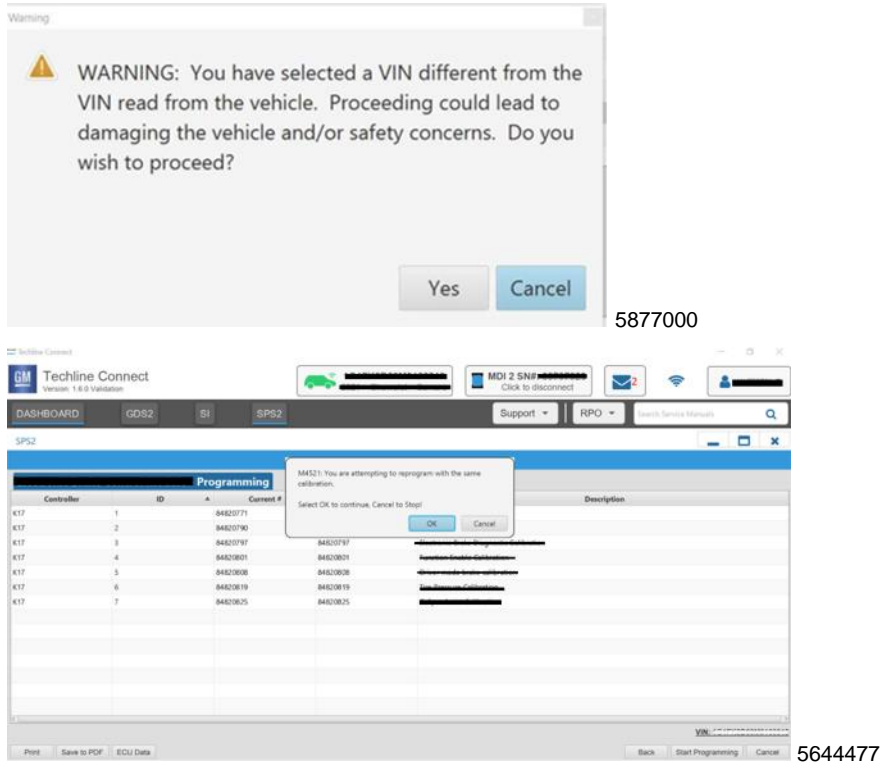
Important: If the vehicle VIN DOES NOT match, the message below will be shown.

Important: Techline Connect screens shown above.

- If the VIN that shows up in the TLC top center window after correctly reading the VIN from the vehicle does not match the VIN plate of the vehicle, manually type in the VIN characters from the vehicle VIN plate into the TLC top center window and use these for programming or reprogramming the subject module with the correct vehicle VIN and software and/or calibrations.

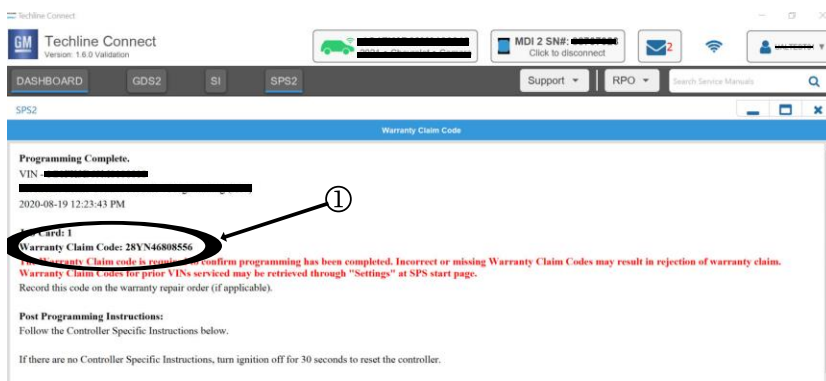
5644478

Note: The screenshot above is an example of module programming and may not be indicative of the specific module that is being programmed. Module selection and VIN information have been blacked out.

Important: To avoid warranty transaction rejections, you MUST record the warranty claim code provided on the Warranty Claim Code (WCC) screen shown above on the job card. Refer to callout 1 above for the location of the WCC on the screen.

1. Reprogram the video processing control module. Refer to *Video Processing Control Module Reprogramming with SPS* in SI.

2. Record SPS Warranty Claim Code on job card for warranty transaction submission.
