Safety Recall

N222373321 Rear View Camera Intermittent or Inoperative

Release Date: February 2023

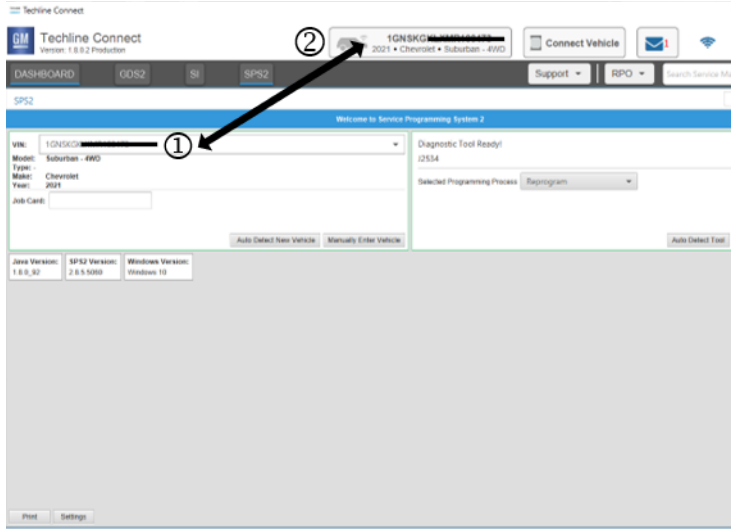
5743643

Caution: Be sure the VIN selected in the drop down menu (1) is the same as the vehicle connected (2) before beginning programming.

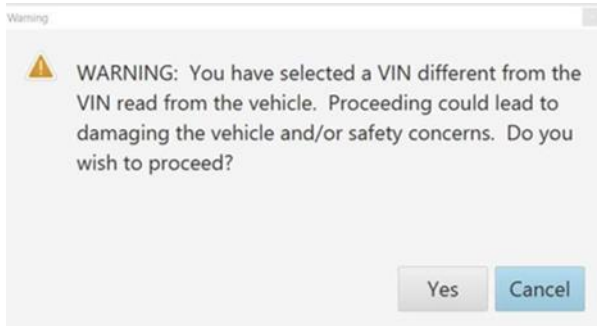
5877000

Important: If the vehicle VIN DOES NOT match, the message below will be shown.

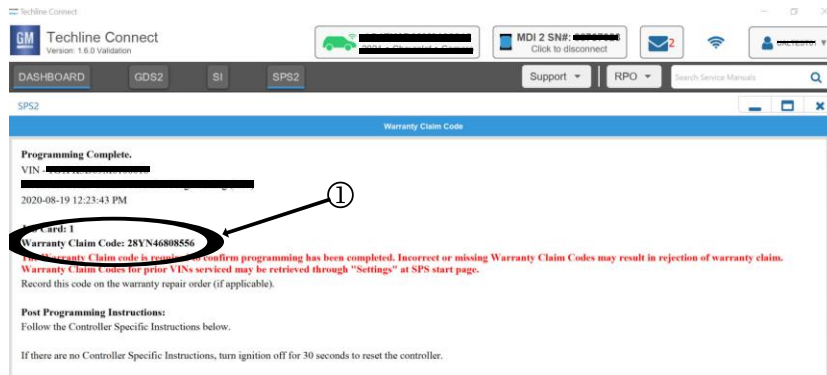
5644478

Note: The screenshot above is an example of module programming and may not be indicative of the specific module that is being programmed. Module selection and VIN information have been blacked out.

Important: To avoid warranty transaction rejections, you **MUST** record the warranty claim code provided on the Warranty Claim Code (WCC) screen shown above on the job card. Refer to callout 1 above for the location of the WCC on the screen.

2. Record SPS Warranty Claim Code on job card for warranty transaction submission.
