# VOLUNTARY RECALL CAMPAIGN

Classification: EL22-016	Reference: NTB23-007	Date: January 19, 2023
-----------------------------	-------------------------	---------------------------

## VOLUNTARY SAFETY RECALL CAMPAIGN 2017 ROGUE; WIRE HARNESS CONNECTOR CORROSION

**CAMPAIGN ID #:** PC934  
**APPLIED VEHICLES:** 2017 Rogue (T32)

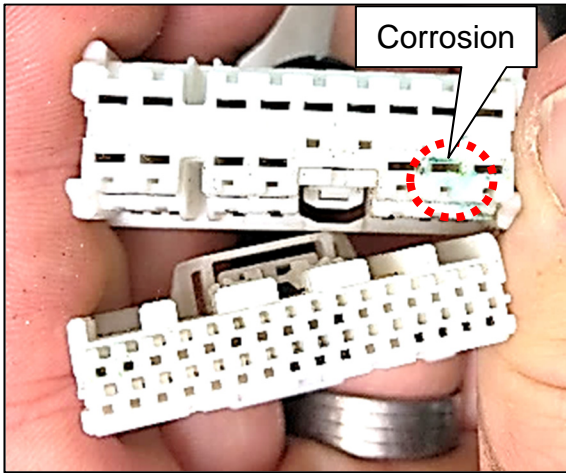
Figure 6

9. Inspect the M74 and B42 wire harness connectors for any signs of corrosion (Figure 6 - Figure 10).
- If signs of corrosion are found, proceed to step 10 on page 7 to replace both M74 and B42 wire harness connectors.
  - If there are no signs of corrosion, skip to step 20 on page 11 to apply white lithium grease to both wire harness connectors.

### Examples of Corrosion

10. Remove and discard the foam tape from the B42 wire harness connector to assist with identifying connector pin locations in the original connector.
11. Replace the M74 and B42 wire harness connectors as follows:
