VOLUNTARY RECALL CAMPAIGN

Classification: EL22-016A	Reference: NTB23-007A	Date: January 20, 2023
------------------------------	--------------------------	---------------------------

VOLUNTARY SAFETY RECALL CAMPAIGN 2017 ROGUE; WIRE HARNESS CONNECTOR CORROSION

CAMPAIGN ID #: PC934
APPLIED VEHICLES: 2017 Rogue (T32)

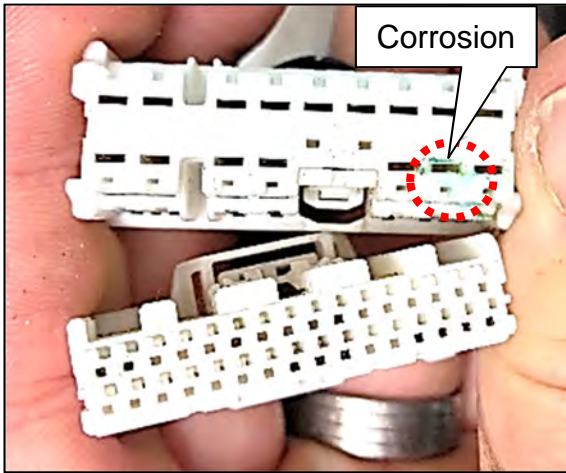
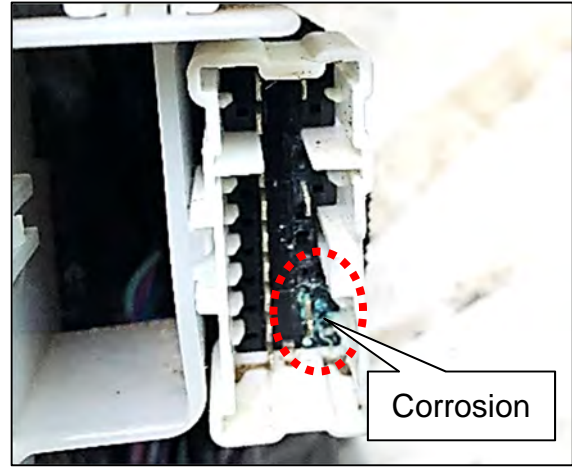
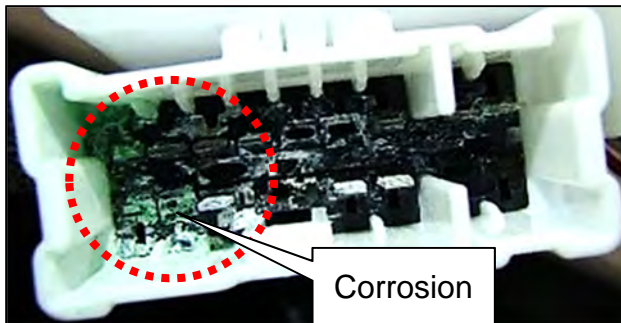
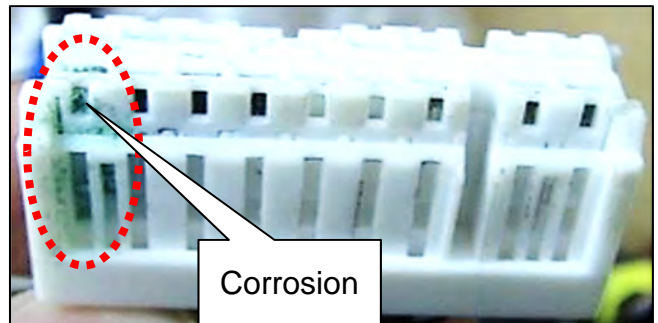
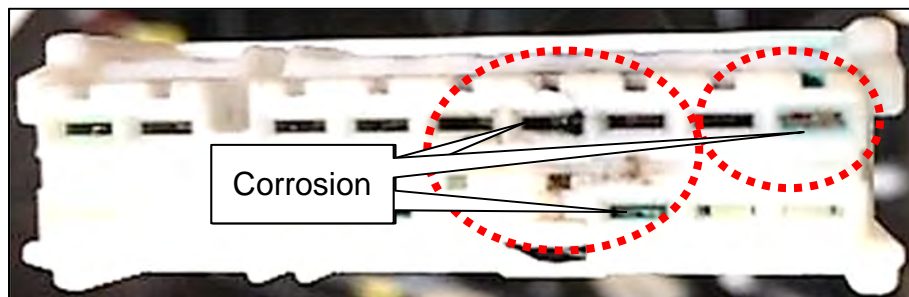
Examples of Corrosion

9. Inspect the M74 and B42 wire harness connectors for any signs of corrosion (Figure 6 - Figure 10).
- If signs of corrosion are found, proceed to step 10 on page 7 to replace both M74 and B42 wire harness connectors.
 - If there are no signs of corrosion, skip to step 20 on page 11 to apply white lithium grease to both wire harness connectors.

10. Remove and discard the foam tape from the B42 wire harness connector to assist with identifying connector pin locations in the original connector.
11. Replace the M74 and B42 wire harness connectors as follows:
 - a. Starting with the M74 wire harness connector, cut and splice in the new wire harness connector, one wire at a time. See **PARTS INFORMATION** on the last page.
