Tesla, Inc.
Service Bulletin

Inspect LH Front Lower Lateral Link

SB-22-31-002

December 7, 2022

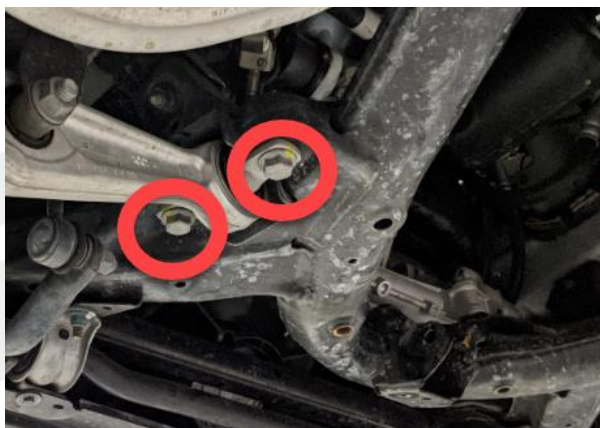
Figure 1

On certain Model Y vehicles, the fasteners that secure the left-hand (LH) front lower lateral link to the subframe may not have been torqued to internal specification. A fastener not torqued to specification may loosen over time or separate from the subframe, which could cause the lateral link to separate from the subframe.

1. Remove the LH front wheel and release the LH side of the front aero shield to gain access to the LH front lower lateral link (refer to Service Manual procedure [31013402](#)).
2. Perform a torque check on the bolts (x2) that attach the LH front lower lateral link to the subframe (torque 115 Nm) (Figure 1).

**NOTE:** If bolt(s) are not installed, install new bolt(s).
