GROUP	MODEL
Safety Recall Campaign	2020MY
	Niro EV (DE EV)
NUMBER	DATE

EPCU LEAK INSPECTION & REPLACEMENT (SC258)

This bulletin provides information to inspect and, if necessary, replace the Electric Power Control Unit (EPCU) assembly on certain 2020MY Niro EV (DE EV) vehicles produced from June 18, 2020 through September 4, 2020. The EPCU assembly in the subject vehicles may have been produced with improper sealing. Due to this improper sealing, coolant can internally leak in the EPCU and contact the EPCU circuit board. If coolant contacts the EPCU circuit board, the vehicle may stall while driving. A vehicle stall increases the risk of crash. Follow the procedure outlined in this publication to inspect the EPCU for an internal coolant leak and, if needed, replace the EPCU assembly. Before conducting the procedure, verify that the vehicle is included in the list of affected VINs.

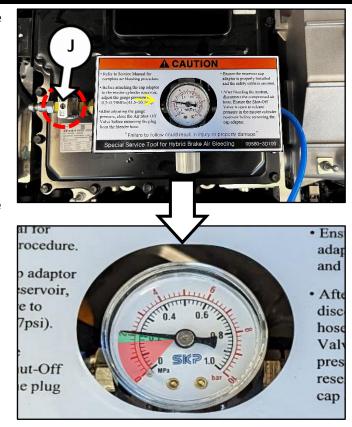
Confirm no air leaks are present. An airtight seal must be maintained to successfully perform and complete this test.
