**PRODUCT CAMPAIGN BULLETIN**

**APPLICABILITY:** 2019-2022MY Ascent

**NUMBER:** WRL-22R

**SUBJECT:** PTC Heater Ground Bolt

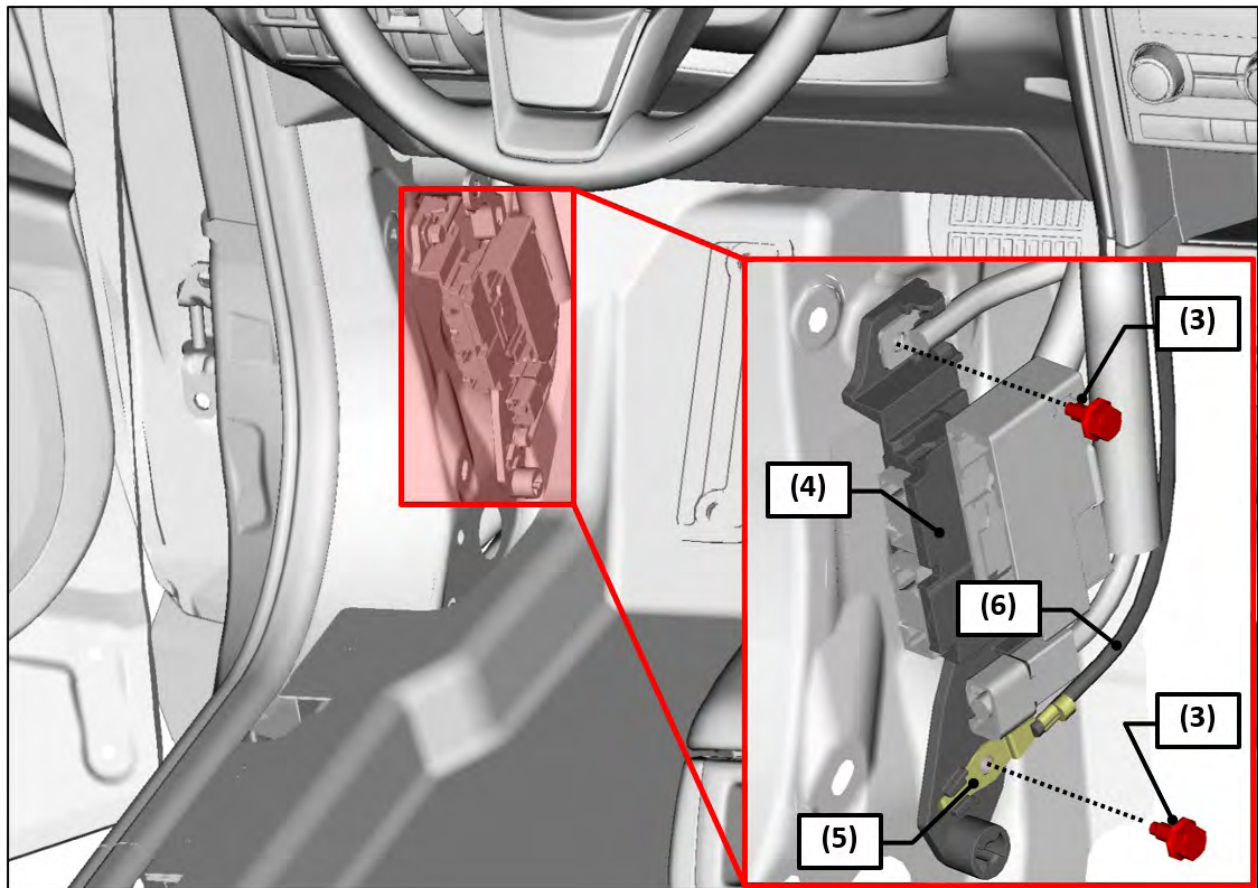
**Diagram 1**

(3) Ground bolts

(5) Ground terminal

**Tightening Torque: 13 N·m**

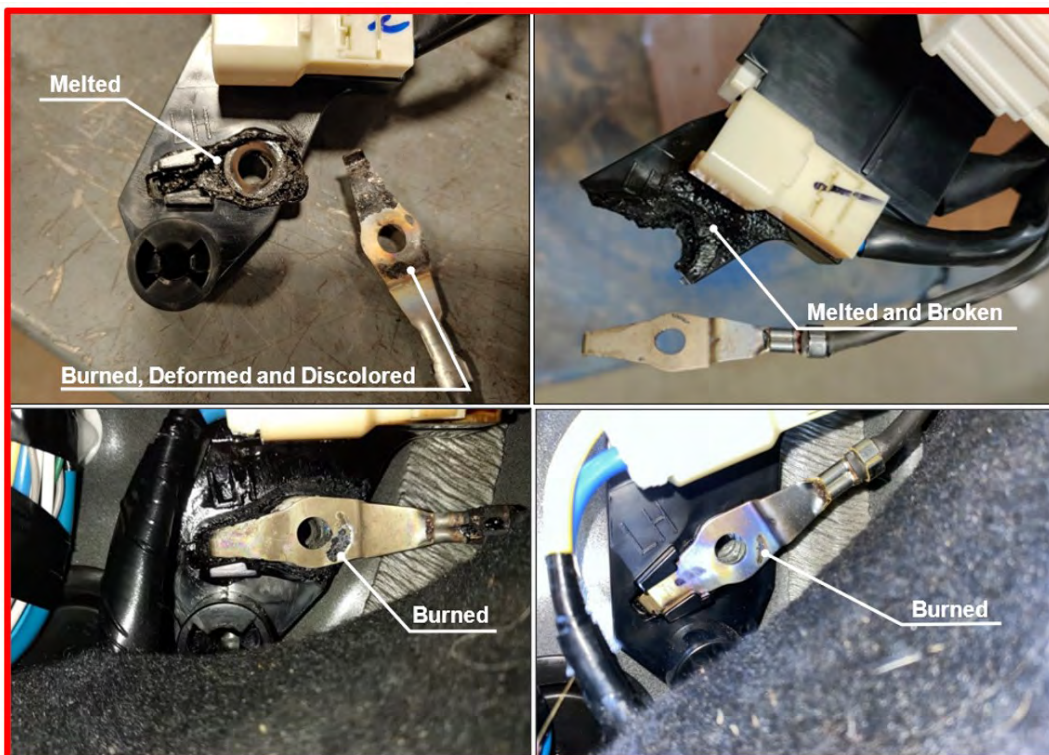
**STEP 10:** CAREFULLY inspect the PTC heater ground terminal and peripheral parts for any damage. See the example images of overheat damage below.

**IMPORTANT:** If any damage is found, a QMR will be required with detailed photos of the damage attached and the repair parts order information noted in the comments section.

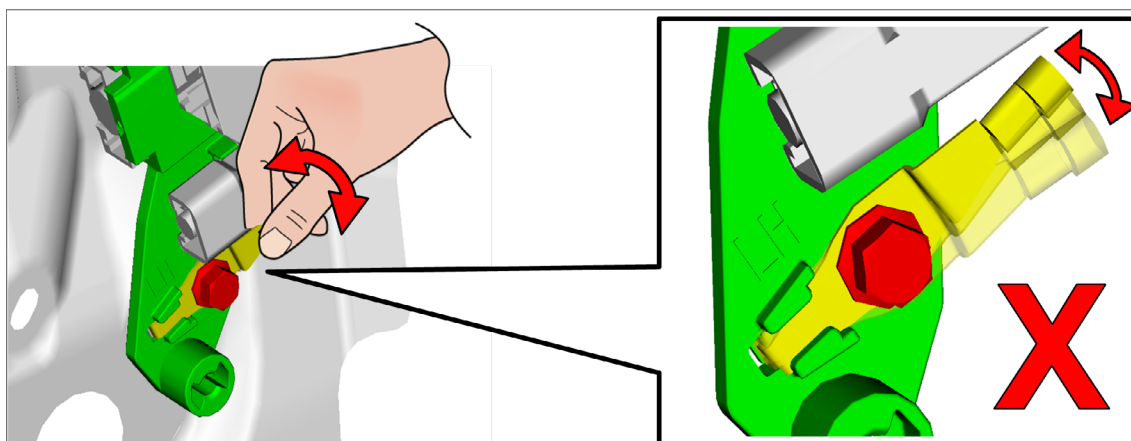
**CAUTION:** Any loose connection could cause a possible thermal event.

**STEP 25:** Confirm there is no movement with the ground terminal. Check for any loose contact by attempting to move the terminal with your fingers in an up/down direction. There is no need to pull the ground cable when checking for loose contact.
