PRODUCT CAMPAIGN BULLETIN

APPLICABILITY: 2019-2022MY Ascent

NUMBER: WRL-22R

SUBJECT: PTC Heater Ground Bolt

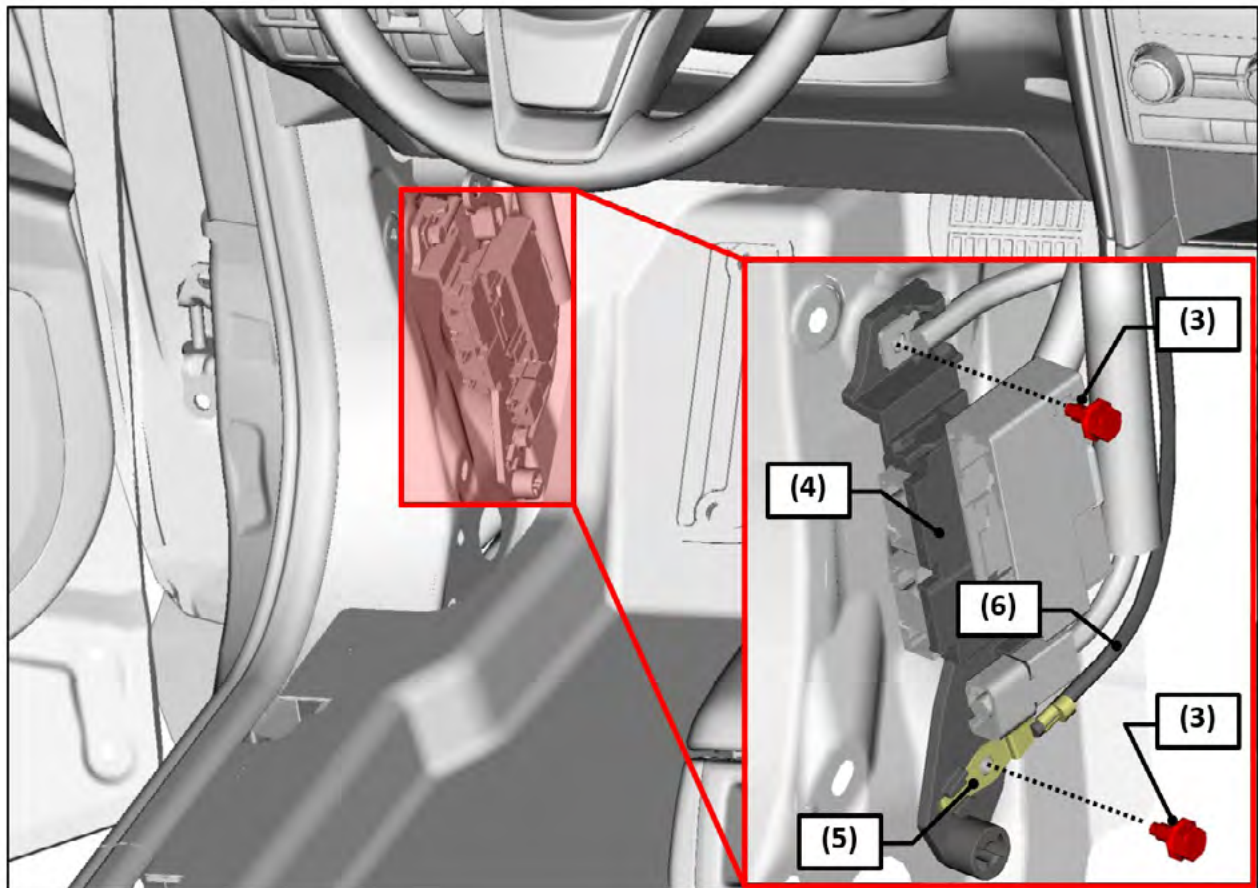
Diagram 1

(3) Ground bolts

Tightening Torque: 13 N·m

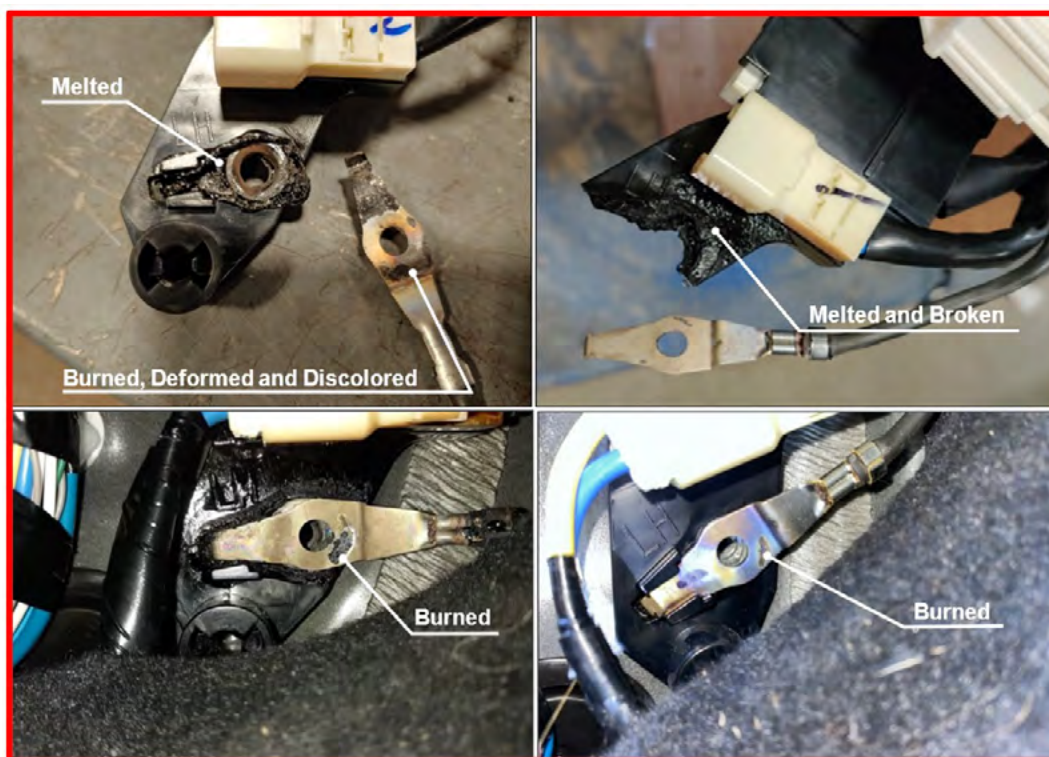
STEP 10: CAREFULLY inspect the PTC heater ground terminal and peripheral parts for any damage. See the example images of overheat damage below.

IMPORTANT: If any damage is found, a QMR will be required with detailed photos of the damage attached and the repair parts order information noted in the comments section.

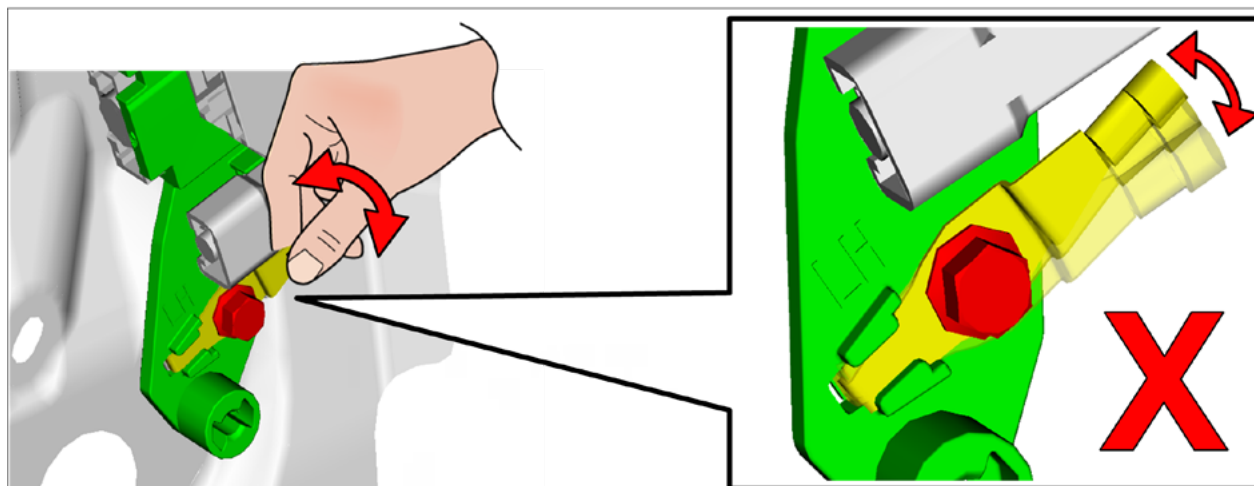
CAUTION: Any loose connection could cause a possible thermal event.

STEP 25: Confirm there is no movement with the ground terminal. Check for any loose contact by attempting to move the terminal with your fingers in an up/down direction. There is no need to pull the ground cable when checking for loose contact.
