SAFETY RECALL NOTICE

McLaren Artura Voluntary Safety Recall – High Pressure Fuel Pipes Potential Replacement

Bulletin type:	Safety Recall Campaign
Reference number:	N/A
Campaign reference:	SRC 16 K 001
Attention:	All Retailer Staff
Affected vehicles:	McLaren Artura
Situation:	Replacement of the High Pressure Fuel Pipes
Procedure:	Action all affected vehicles. Please refer to the information outlined in this document to complete the required work
Date:	20 December 2022

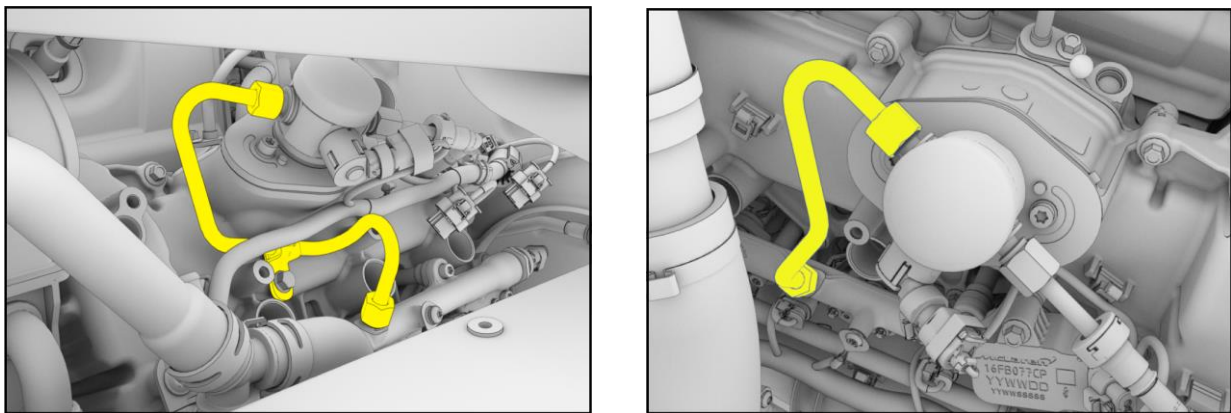
The covered vehicles may have been fitted with an incorrect high pressure fuel pipe which could cause a fuel leak and as a result an increased risk of thermal activity.

Figure 1: Location of RH and LH GDI high pressure fuel pipes

- a. Check the engine serial number found on the vehicle against the engine serial number list attached with this Campaign Bulletin
- b. If the engine serial number found in the vehicle is not in the engine serial number list attached with this Recall Campaign Bulletin, mark this Recall Campaign as completed for the vehicle by submitting the pre-approved Warranty claim attached to its VIN in the Retailer Portal. Please attach clear photos of the VIN number and engine serial number for each vehicle checked in the Warranty claim
- c. If the engine serial number found in the vehicle is is in the engine serial number list attached with this Recall Campaign Bulletin then proceed to replace **both (RH bank and LH bank)** GDI high pressure fuel pipes.

Documents 'HA-RM-05F001-01-065 GDI pipe pump to rail LH' and 'HA-RM-05F001-01-066 GDI pipe pump to rail RH' (attached with this bulletin) contain the relevant work instructions and care points to ensure the inspection and potential re-work is carried out to bring the vehicle up to the current manufacturing standard.

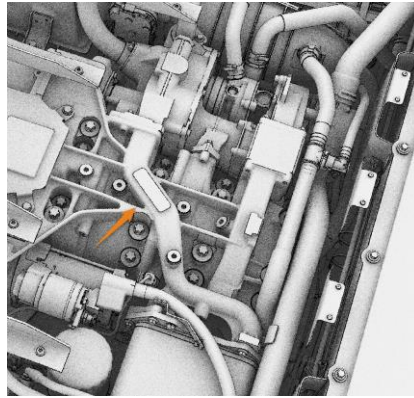
Figure 2: Location of the engine serial number plaque

- a. Inspect the engine serial number. To access the engine serial number please follow SIS Procedure number: 'HA-RM-01A004-02-001 - Remove/Install Floor panel – Engine'
