Product Safety Recall

N222380601 Front Impact Bar Partially Welded

Release Date: December 2022

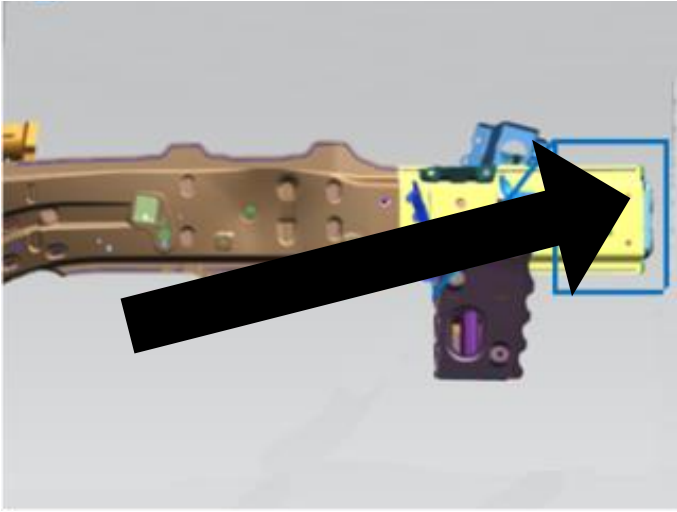
6215494

2. Locate the front section of the left and right lower front motor compartment frame rails where they bolt to the front bumper beam.
3. Carefully inspect the weld joint where the left and right bumper mounting brackets are welded to the frame rails on the outboard side. The brackets should be inserted into the end of the frame rails and secured with welds.
