Stacy L. Balzer
Operating Director
Service Engineering Operations
Ford Customer Service Division

December 15, 2022

SUBJECT: NEW VEHICLE DEMONSTRATION/DELIVERY HOLD - Safety Recall 22S77
Certain 2021-2022 Model Year Bronco Vehicles
Side Impact Sensor Retaining Stud and Nut Inspection

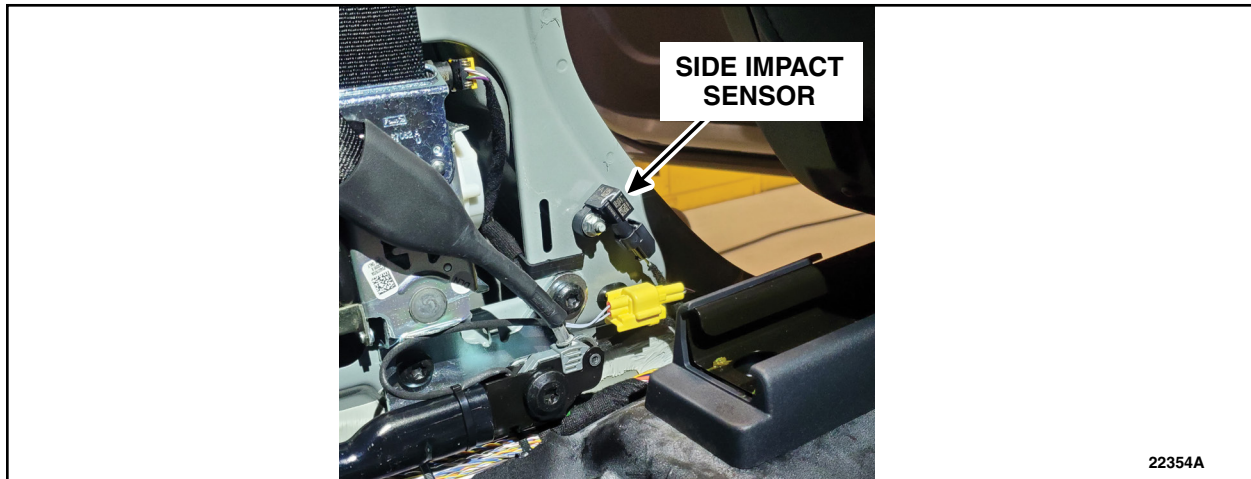
FIGURE 1

1. On both sides, remove the lower B-pillar trim panel to gain access to the side impact sensor.
Please follow Workshop Manual (WSM) Procedures in Section 501-05. See Figure 1.

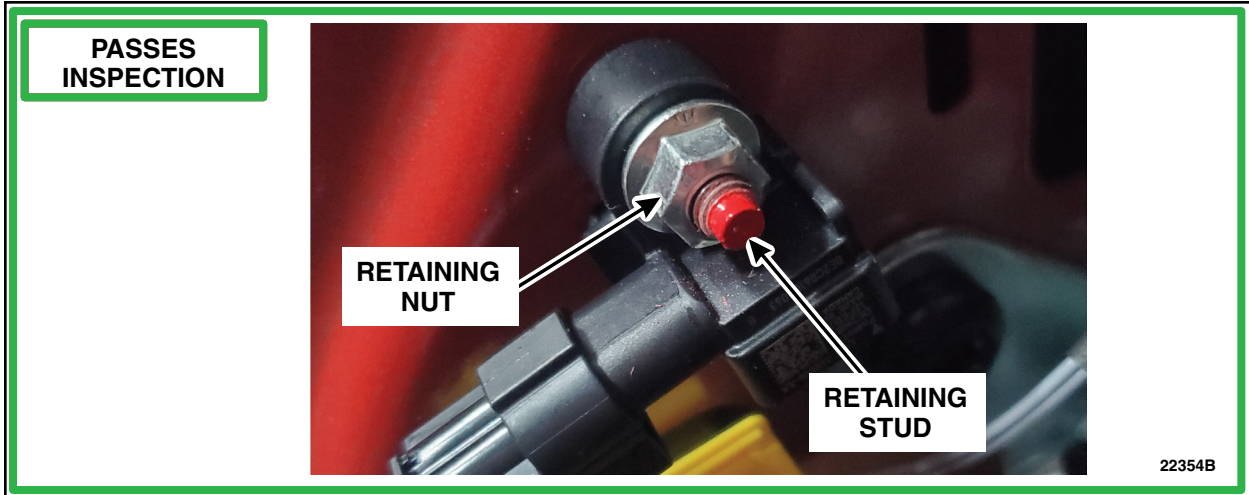
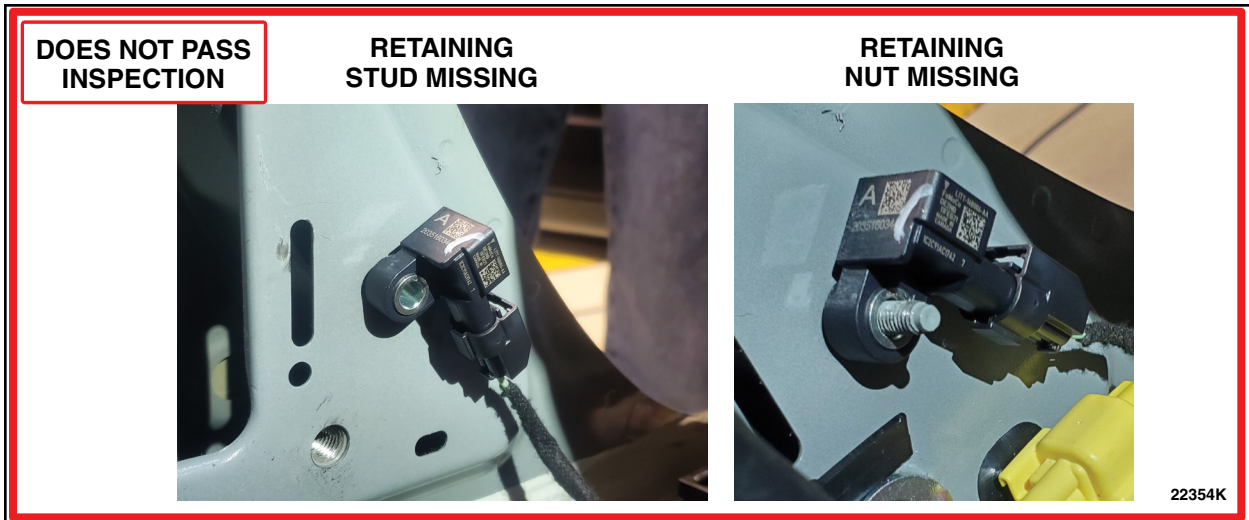
2. Inspect for the presence of the side impact sensor retaining stud and nut on both sides.
See Figures 2 and 3. Is the side impact sensor retaining stud and/or nut missing on either side?

- Nut ONLY Missing – Order a retaining nut through the normal part ordering process, refer to the dealer bulletin. Proceed to step 3.
- Nut AND Stud Missing – Order a new side impact sensor stud and retaining nut through the normal part ordering process, refer to the dealer bulletin. Proceed to step 5.
