## 22PBF – 579 MLU Molded Hood Mirror Safety Recall

Author: Gunnar Nelson

2/7/2023

| <b>Bulletin No.</b> | 22PBF |

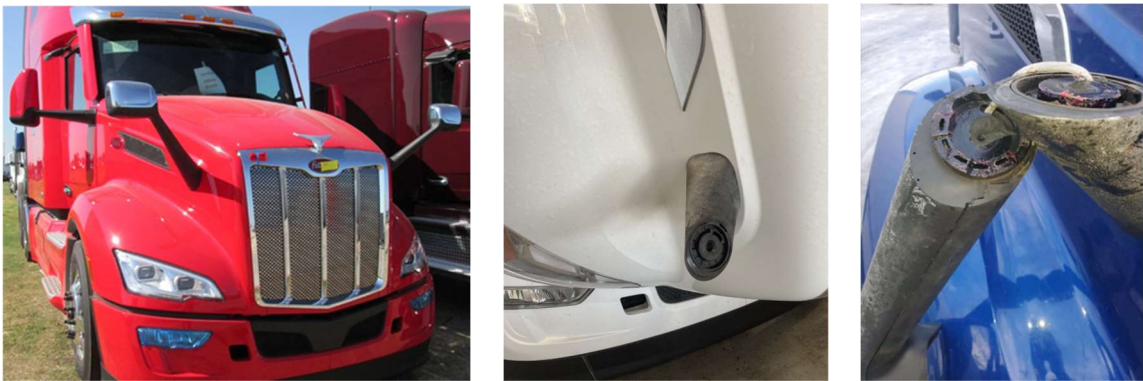
| <b>What's New Abstract</b> | <p>Safety Recall - A mirror with a pivot joint break that does not have a wire harness or tether can result in foreign object debris on the roadway increasing the risk of a crash and/or injury.</p> |
| <b>Condition / Complaint / Introduction</b> | <p>Certain model 579 MLU trucks equipped with molded hood mirrors may experience a mirror, pivot-joint failure. Within that population of trucks, there are mirrors that do not have a wire harness or tether to keep the upper half of the mirror with the truck if the pivot joint fails.</p> |

| <b>Service Action / Resolution</b> | <p><b>Safety Recall</b> - This bulletin will be updated when the repair procedure and parts are available.</p> |
