INSTRUCTION TO SERVICE

ITS: 60596		December 21, 2022
SECTION:	350-Driver's Controls	
WRITTEN BY:	Troy Stutsky	
SUBJECT:	Movement in Steering Column to Upper Steering Drive Shaft Joint	
ISSUE:	An under torque on the pinch bolt between the steering column & upper steering drive shaft has caused movement and wear in the joint.	
SUMMARY:	Torque existing hardware to specification and inspect joints. Remove the steering column & upper steering drive shaft & replace parts if required.

Ref. NHTSA Recall No.	Ref. Transport Canada Recall No.
22V-943	2022-732

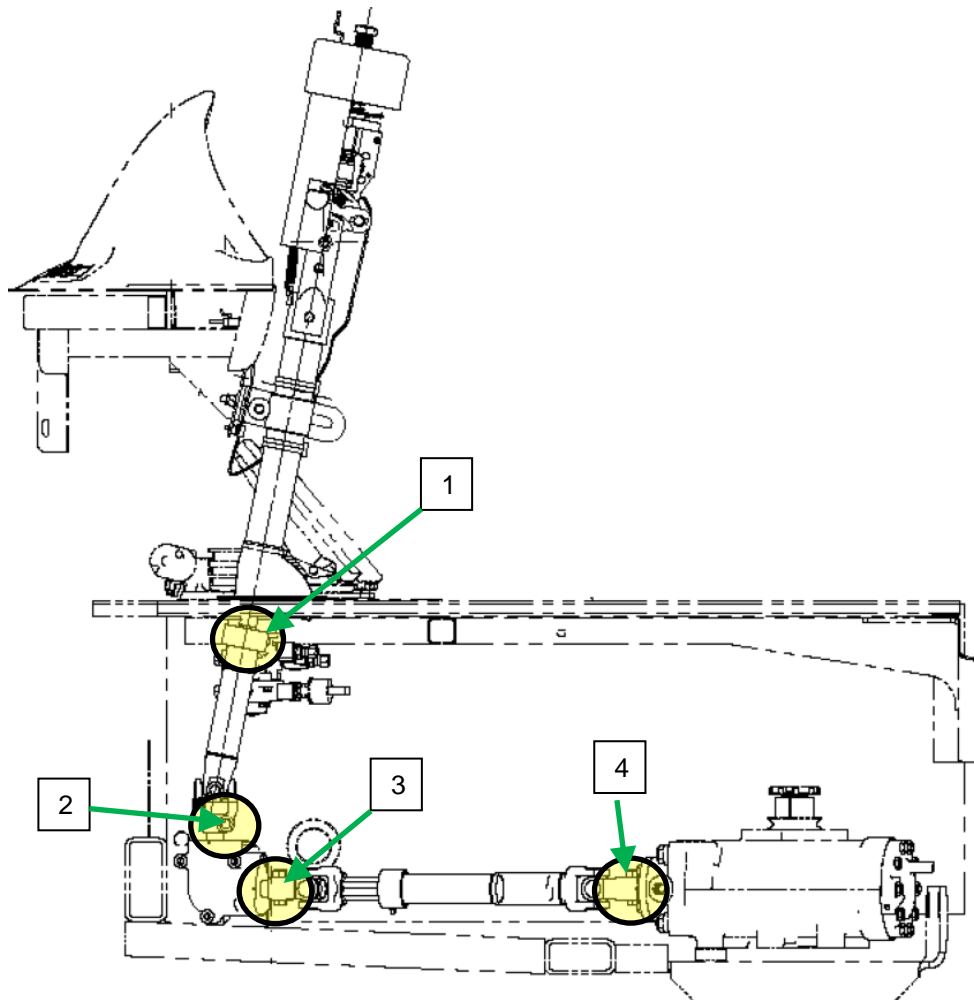
Figure 1: Locations to Torque on Steering System

4. After the new torque has been applied, inspect for any free play at the splined, torqued joint between the steering column and the upper steering drive shaft, which is identified as Area #1 in Figure 1, by grasping the drive shaft mid-length and applying a lateral force. There should be no free play in this torqued joint. If no free play has been found, the bus is safe to return to service.

5. If free play is found at the splined, torqued joint between the steering column and the upper steering drive shaft, which is identified as Area #1 in Figure 1, please proceed to remove the steering column & upper steering drive shaft from the bus for closer inspection on the shop bench.

1. Set park brake and chock wheels.
2. Turn the main battery disconnect switch to the “OFF” position.
3. On the steering assembly of the bus with the steering assembly still installed in the bus, please torque the hardware in the four locations shown in Figure 1 to $70\pm 4\text{Ft/Lbs}$ dry. Please ensure that the bolts are $7/16'' - 20 \times 2.00''$; Grade 8; Zinc (NF PN 6444255) & the nuts are $7/16'' - 20$; Self Locking; Zinc (NF PN 6444254). If any 10MM hardware is found in any of these four locations it should be removed and replaced. Remove existing torque witness marks and re-mark after new torque has been applied.

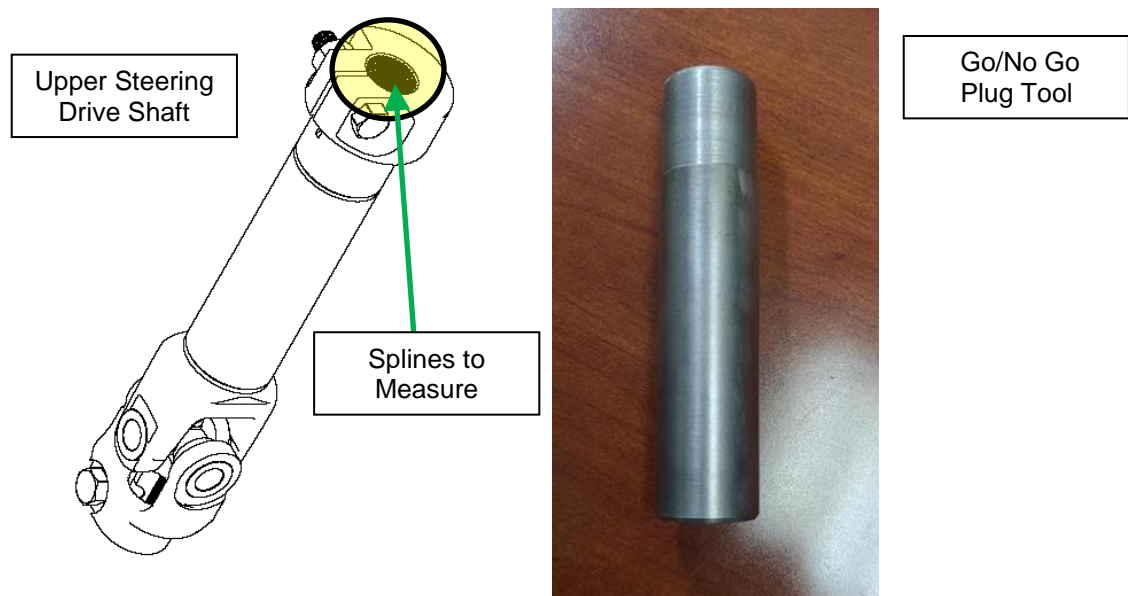
Figure 2: Upper Steering Shaft Measurement

7. Using the PSS Go/No Go Plug tool measure the solid, splined end of the upper steering drive shaft. See Figure 2.
 - a. If the Go/No Go Plug **will not fit** into the splined portion of the drive shaft, the upper steering drive shaft is a pass and can be reused as required.

- b. If the Go/No Go Plug **does fit** into the splined portion of the drive shaft, the upper steering drive shaft is a fail and will need to be safely stored for using in a welded assembly if required.

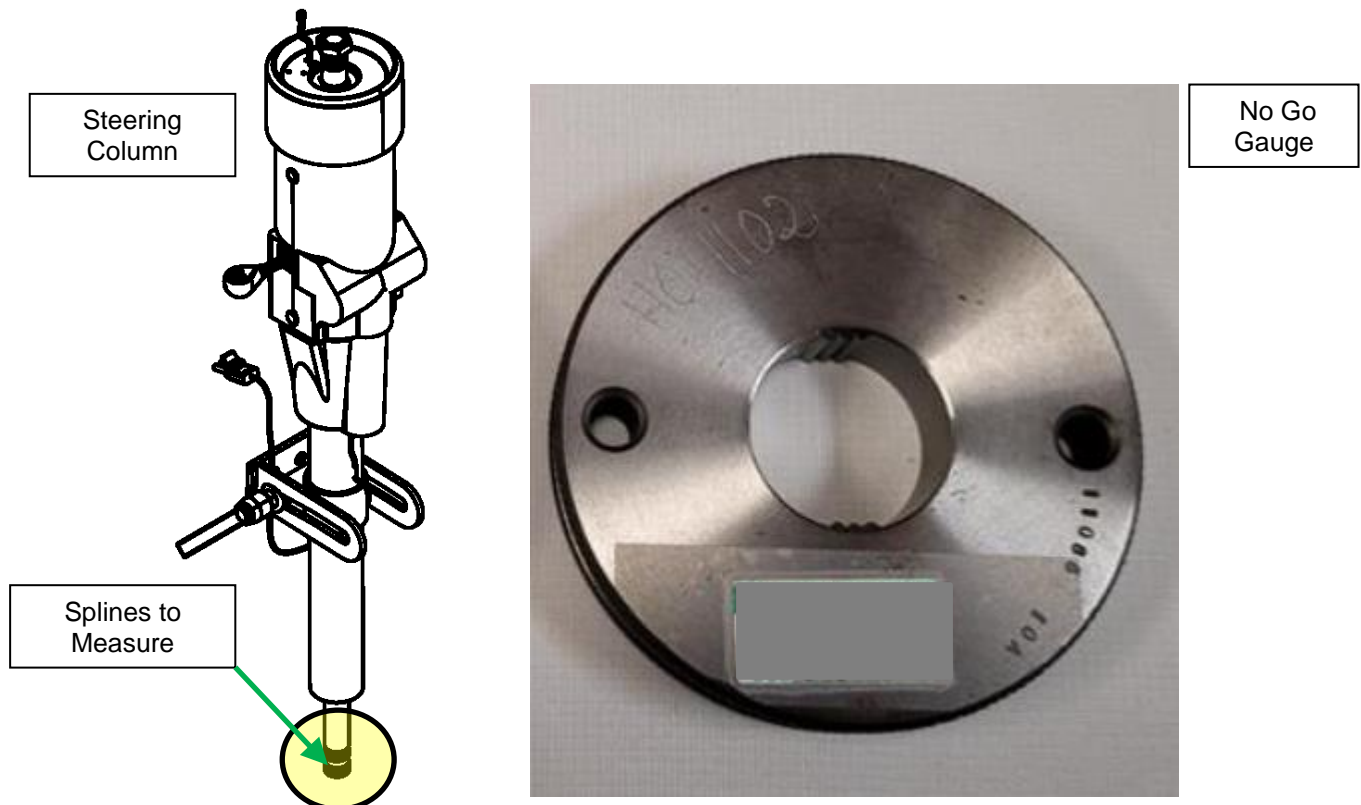
Figure 3: Steering Column Measurement

8. Using the No Go Gauge measure the splined end of the steering column. See Figure 3.
 - a. If the **No Go** Gauge **will not fit** over the splined portion of the steering column, the steering column is a pass and can be reused as required.
 - b. If the **No Go** Gauge **does fit** over the splined portion of the steering column, the steering column is a fail and will need to be safely stored for using in a welded assembly if required.

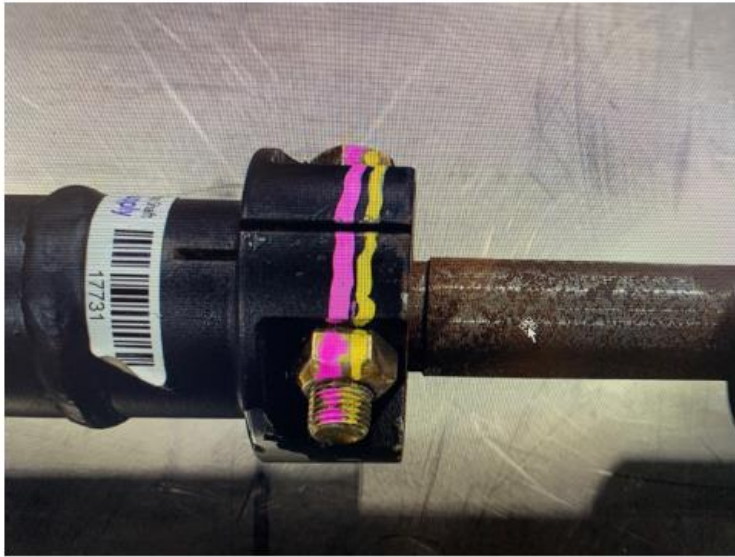
This weld procedure is written in response to the request to reinforce a splined connection in a New Flyer steering column with weld metal. The splined connection has been reported to have deteriorated, necessitating the exploration of a welded connection. A photo of the connection under review is shown below.

Photo of steering column connection under review in this report.

The driveshaft component (at left on photo above) is reported to be fabricated out of 1141 steel, which is a steel formulated with high sulfur content to aid in machining. The steering column (at right on photo above) is reported to be fabricated out of 1018-1020 steel. These materials were identified by the specific suppliers of these parts to New Flyer specific to coaches built for Seattle.

A review of the maximum torque of the steering column suggests that a 5/16" all around fillet weld could be used to transmit the torque through the joint.

Welding of 1141 steel requires consideration for the high amount of sulfur. It is required that a lower heat input process be used to minimize base metal dilution, as well as allowing for a slow cooling rate to allow the sulfur containing compounds to fully freeze during the time of solidification and weld shrinkage. An electrode with a higher Mn content is recommended to be used as a mechanism to tie up sulfur in MnS compounds so that less is available to form the more deleterious FeS compounds. It is recommended that the GMAW weld process be used with a 0.045" diameter ER-80S-D2 electrode.
