Service Bulletin

22-026

Safety Recall: 2022 TLX Bridgestone Tire Inspection

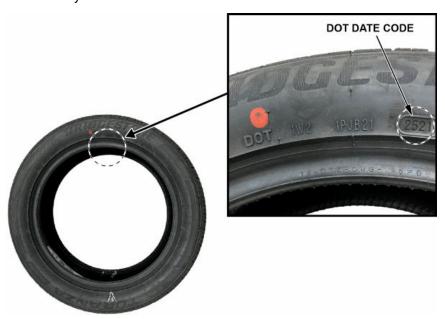
Inspect the last **four** digits of the DOT number on all **four** tires. The tire must display the DOT number listed below:

- DOT date code number 2521
- DOT date code number 2621

- Above the DOT of each tire, mark its location on the vehicle. For example: Left Front (LF), Left Rear (LR), Right Front (RF), Right Rear (RR).
- Clear photos of the door jamb VIN sticker, and the DOT date code of all **four** tires must be submitted with the warranty claim.

If the last **four** digits of the DOT number correspond with one listed above, go to Repair Procedure.
