Vehicle Compliance & Analysis

Recall Campaign Bulletin

Campaign No. 2023010006, January 2023

Check Sliding Roof Bonding

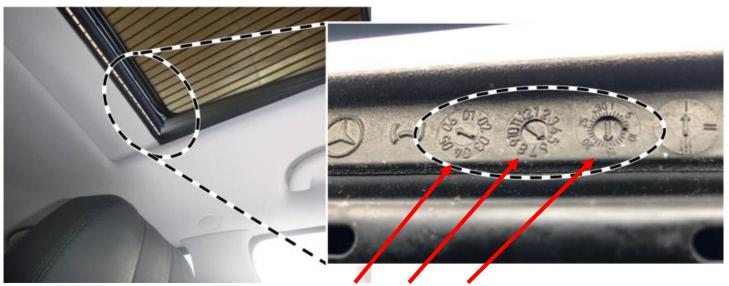
- 1. Move sliding sunroof to tilt position and check production date (figure 1).
 - $oxed{1}$ The production date \emph{must} be on or after 11/25/2005 or on or before 10/31/2007.
 - Vehicles with a registration date that does *not* match with the production date of the sliding sunroof can also be affected.
 - if the production date is **not** at the location shown (figure 1), this vehicle is **not** affected.

Figure 1 (The production date in the sample picture is (06 year / 5 month / 15 day) 5/15/2006)

- a. Production date between 11/25/2005 and 10/31/2007: Perform check/test procedure B.
- b. Production date *not* between 11/25/2005 and 10/31/2007: End measure.
- c. No production date present at location shown (figure 1): End measure.

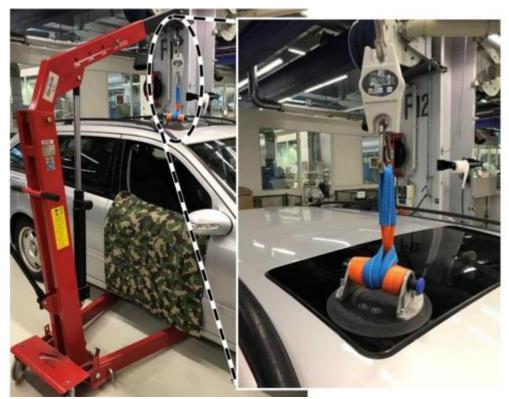
Figure 2

3.	Position suction cup tool (figure 2) and pull as <i>vertically</i> as possible (tolerance of ±10 degrees) using lifting tool. The hanging scale <i>must</i> be adjusted as per the operating instructions before use. Specified force 500 N/700 N (figure 3). Before the start of the measurement, the "(auto) hold function" of the hanging scale (see operating instructions) <i>must</i> be deactivated. No "hold function" may be activated so that the current tractive force is always displayed. Position suction cup tool at 5 positions in the sequence <i>1</i> , <i>2</i> , <i>3</i> , <i>4</i> , <i>5</i> : (Figure 3). The specified force must be monitored during the first minute and adjusted if necessary (tolerance ±10 N). The speciforce must not be exceeded. Pull as vertically as possible (tolerance ±10 degrees) with the specified force. No person shabe inside the vehicle during the check, and the vehicle must not be touched if possible. The holding time per position must be exactly <i>10 min!</i> After the first minute, the holding force per position must be further monitored and readjusted if necessary (tolerance ±10 N). The technician can leave after the first minute if the holding force remains within the tolerance. The test <i>does not have to be</i> monitored during the entire period (5 x10 min). The technician can perform a different task during the test.

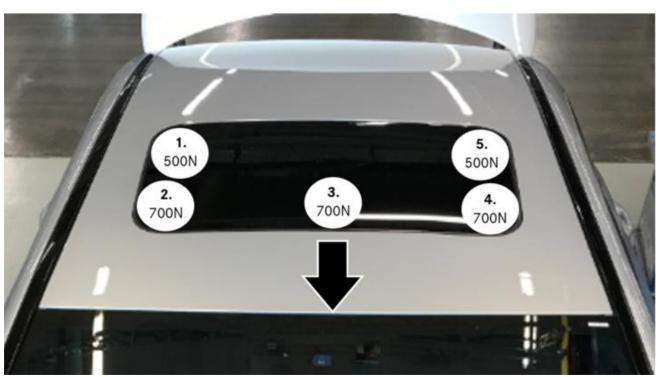
Figure 3 (test sequence 1, 2, 3, 4, 5 – arrow specifies direction of travel)

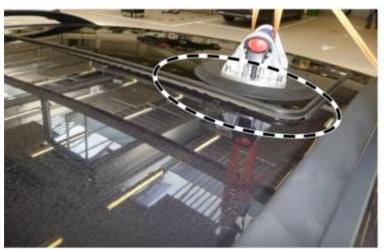
Figure 5 (not OK)

If the sliding sunroof panel detaches from the padding of the tilting/sliding sunroof frame at one of the test positions

(see figure 5), the sliding sunroof panel must be replaced.

- d. If the sliding roof panel detaches from the padding: Carry out work procedure.
- e. If the sliding roof panel does *not* detach from the padding: End measure.
- The **findings** from the check/test procedure must be recorded **in writing in the workshop order** and then stored **in a tamperproof manner**.
- **4.** Perform function test for sliding sunroof.
 - To do this, open and close the sliding sunroof (tilt and slide positions).
