TO: Mercedes-Benz Dealer Principals, General Managers, Sales Managers, Service Managers, Parts Managers	FROM: Gregory Gunther, Department Manager, Vehicle Compliance and Analysis, Engineering Services
RE: <b>Recall Campaign Launch Notification</b> <b>Check for Water Entry in the Spare Wheel Well</b> <b>MY12-20 GLE/ML and GLE Coupe</b> <b>(166 and 292 platform)</b>	DATE: February 10, 2023

Campaign No. 2023010002, February 2023

SUBJECT: **Model GLE/ML and GLE Coupe (166 and 292 platform)**  
**Model Year 2012-2019**

## **Check for Water entry in the Spare Wheel Well**

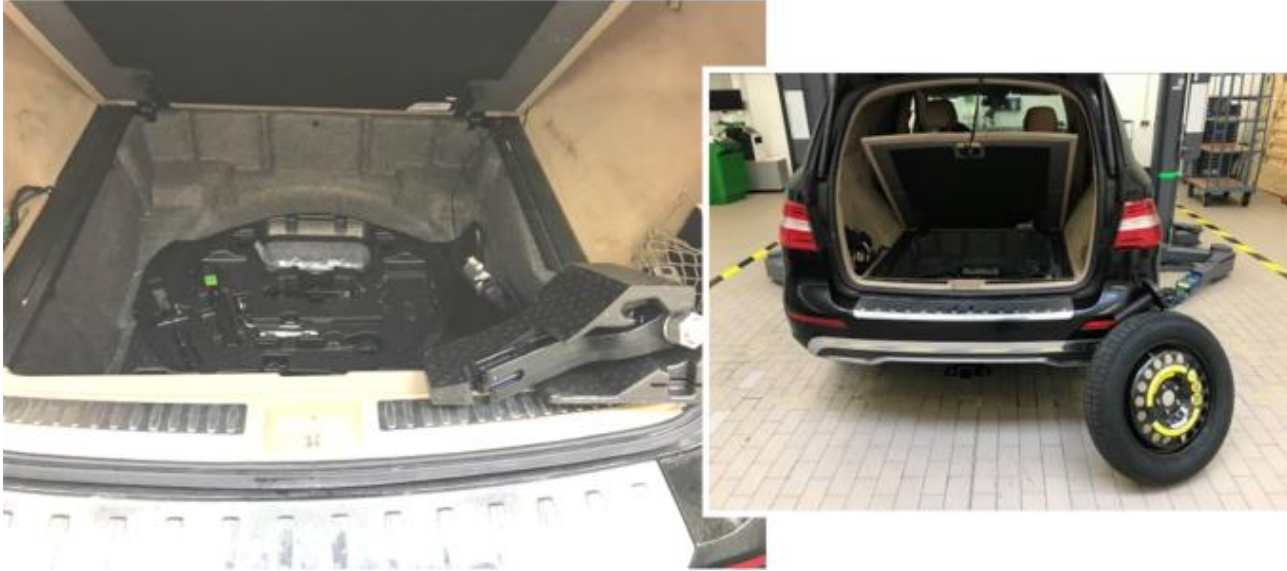
**Figure 1**

1. Open trunk.
2. Lift spare wheel well cover and secure it from falling down.
3. In vehicles with emergency wheel code 690, remove emergency wheel and cover located below , (Figure 1).

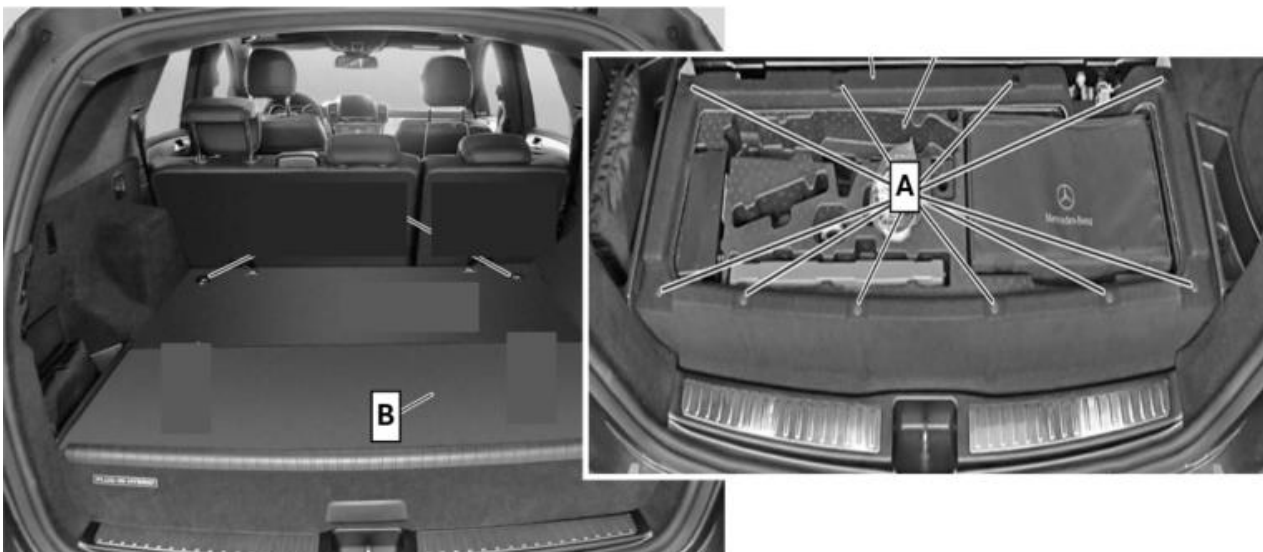
**Figure 12**

4. In hybrid vehicles 166.063, remove load compartment shelf (A, Figure 2) with vehicle tool kit.

**i** Load compartment floor (B, Figure 2) does **not** need to be removed (just folded up).

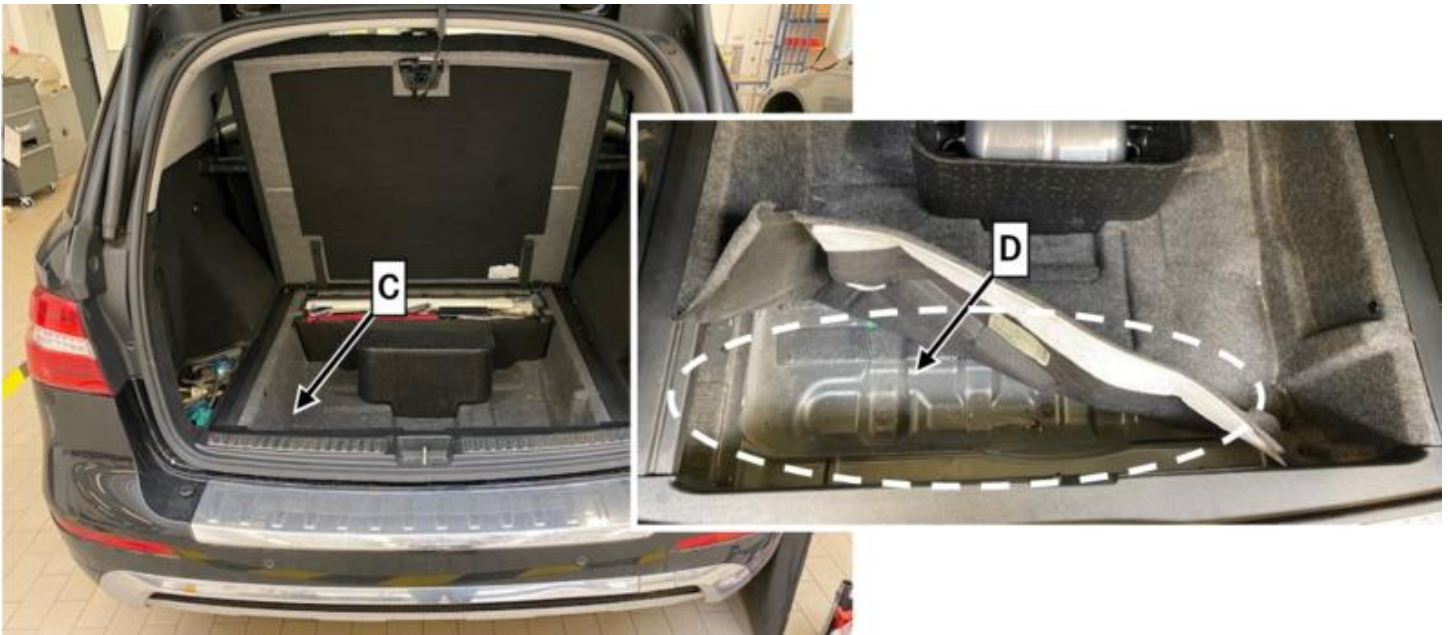
Figure 23

5. Lift left rear felt insert (C, Figure 3) and check for humidity or water deposits in marked area (D, Figure 3).

- a. If humidity or water deposits are **not** present in area (D, Figure 3): Carry out **work procedure A**.
- b. IF humidity or water deposits are present in area (D, Figure 3): Carry out **check/test procedure B**.
