TO: Mercedes-Benz Dealer Principals, General Managers, Sales Managers, Service Managers, Parts Managers	FROM: Gregory Gunther, Department Manager, Vehicle Compliance and Analysis, Engineering Services
RE: <b>Recall Campaign Updated Notification</b> <b>Check for Water Entry in the Spare Wheel Well</b> <b>MY12-20 GLE/ML and GLE Coupe</b> <b>(166 and 292 platform)</b>	UPDATE: April 21, 2023

Campaign No. 2023010003, February 2023

SUBJECT: **Model GLE/ML and GLE Coupe (166 and 292 platform)**  
**Model Year 2016-2020**

## **Check for Water entry in the Spare Wheel Well**

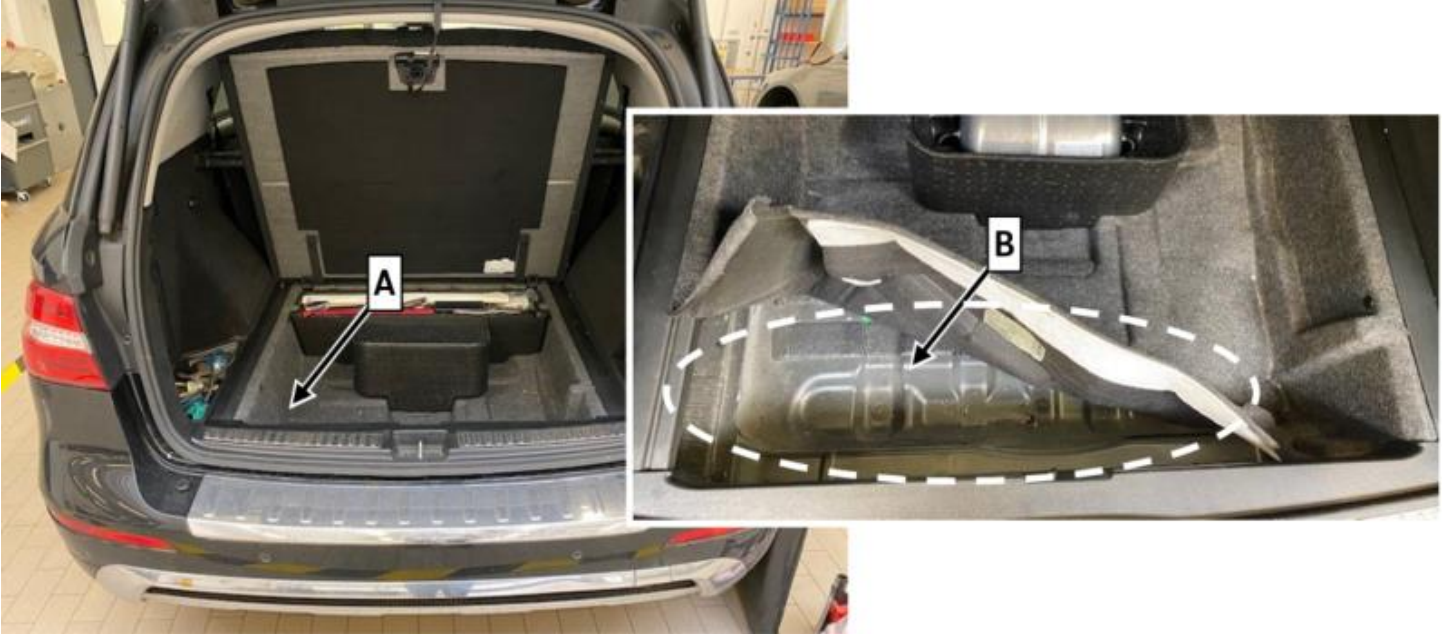
Figure 2

4. Lift left rear felt insert (A, Figure 2) and check for humidity or water deposits in marked area (B, Figure 2).

- a. If humidity or water deposits are **not** present in the area (B, Figure 2): Carry out **work procedure A**.
- b. If humidity or water deposits are present in the area (B, Figure 2): Carry out **check/test procedure B**.

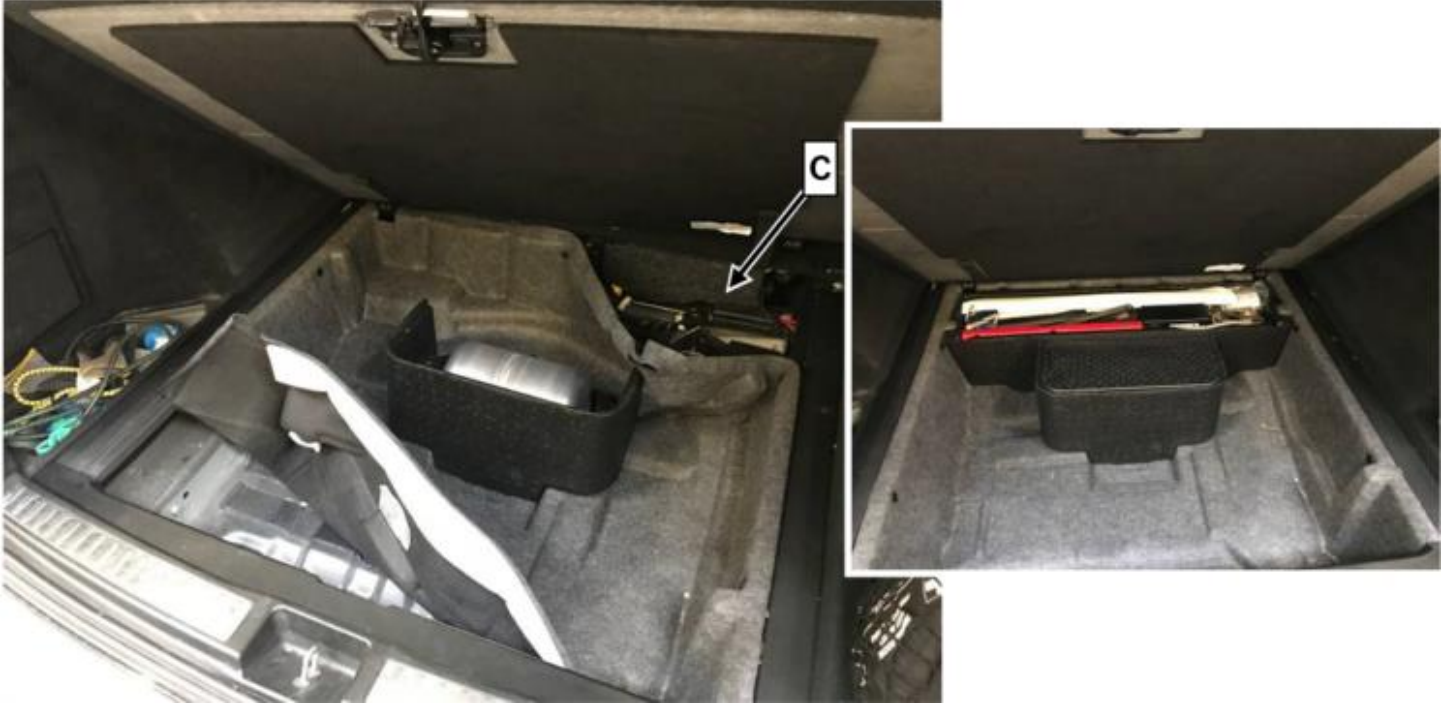
**Figure 3**

1. Lift right front felt insert (C, Figure 3).

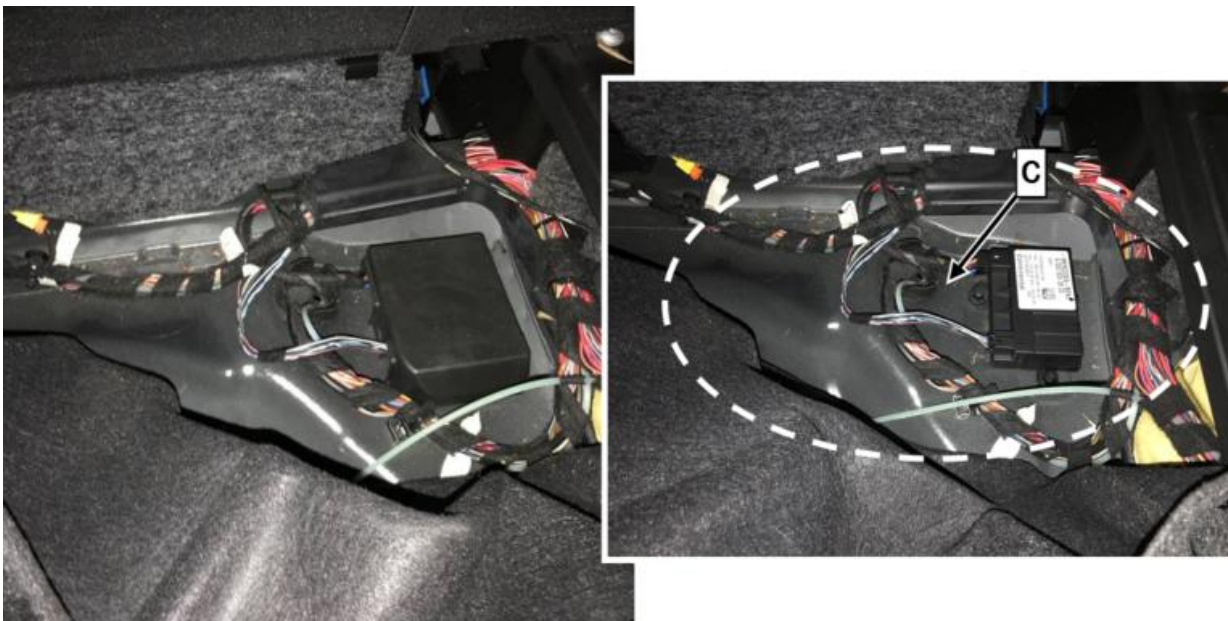
**Figure 4**

2. Check area around fuel system control unit for humidity or water deposits.

- a. If humidity or water deposits are **not** present in area (C, Figures 3 and 4): Carry out **work procedure A** and install remaining parts.
- b. If humidity or water deposits are present in area (C, Figures 3 and 4): Carry out **work procedures A and B**.
