Recall Campaign Bulletin

Campaign No. 2023010003, February 2023

SUBJECT: **Model GLE/ML and GLE Coupe (166 and 292 platform)**
Model Year 2016-2020

Check for Water entry in the Spare Wheel Well

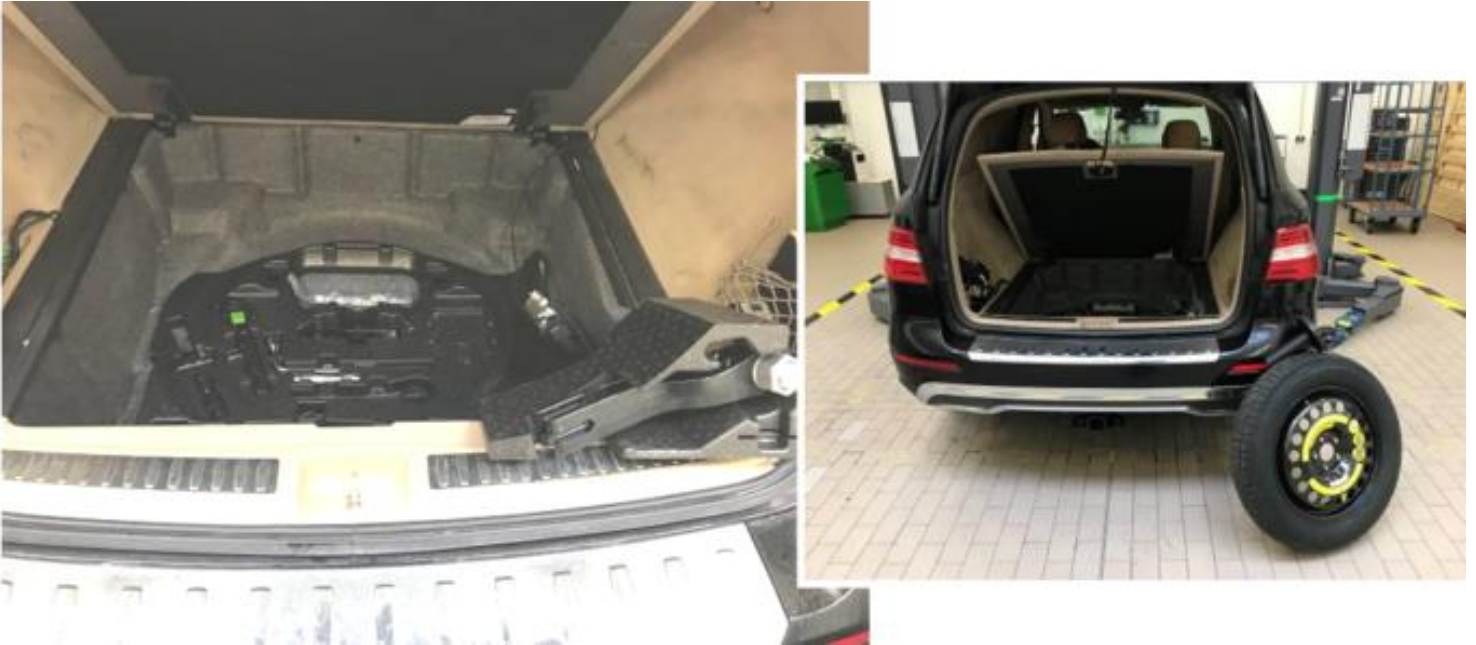
Figure 1

1. Open trunk.
2. Lift spare wheel well cover and secure it from falling down.
3. In vehicles with emergency wheel code 690, remove emergency wheel and cover located below, (Figure 1).

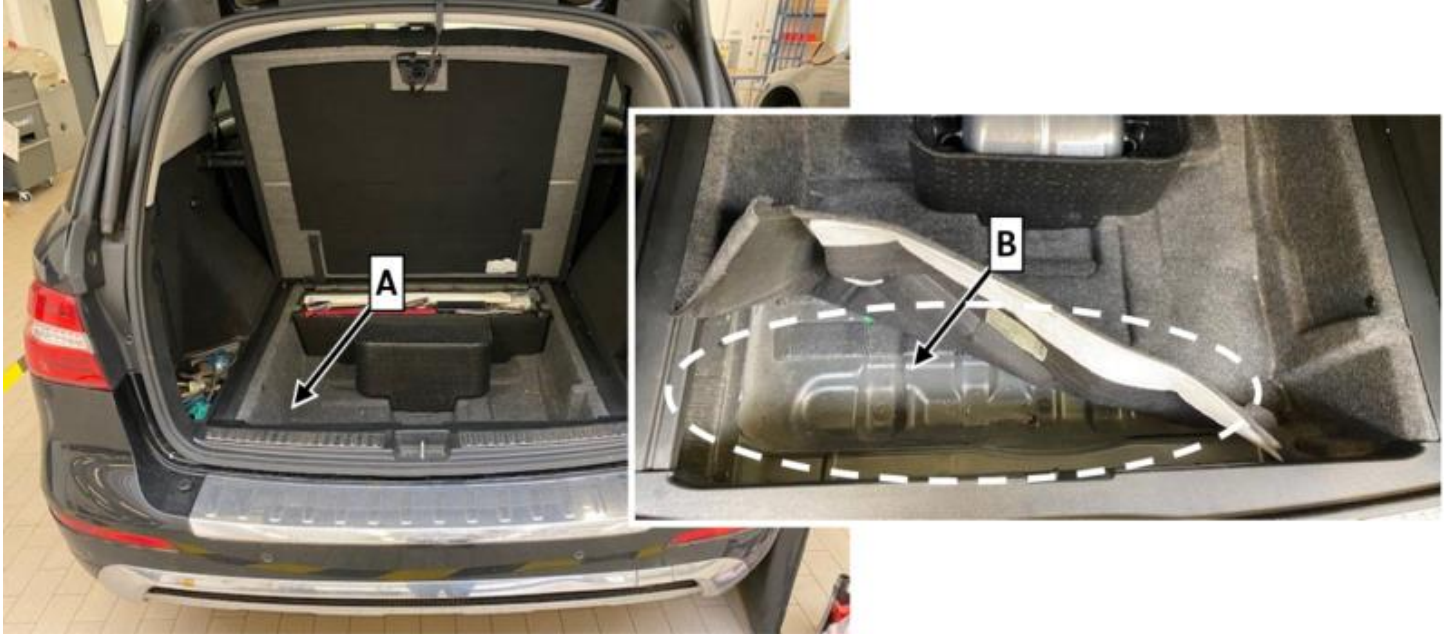
Figure 2

4. Lift left rear felt insert (A, Figure 2) and check for humidity or water deposits in marked area (B, Figure 2).

- a. If humidity or water deposits are **not** present in the area (B, Figure 2): Carry out **work procedure A**.
- b. If humidity or water deposits are present in the area (B, Figure 2): Carry out **check/test procedure B**.
