# Recall Campaign Bulletin

Campaign No. 2023010002, February 2023

SUBJECT: **Model GLE/ML and GLE Coupe (166 and 292 platform)**  
**Model Year 2012-2019**

## **Check for Water entry in the Spare Wheel Well**

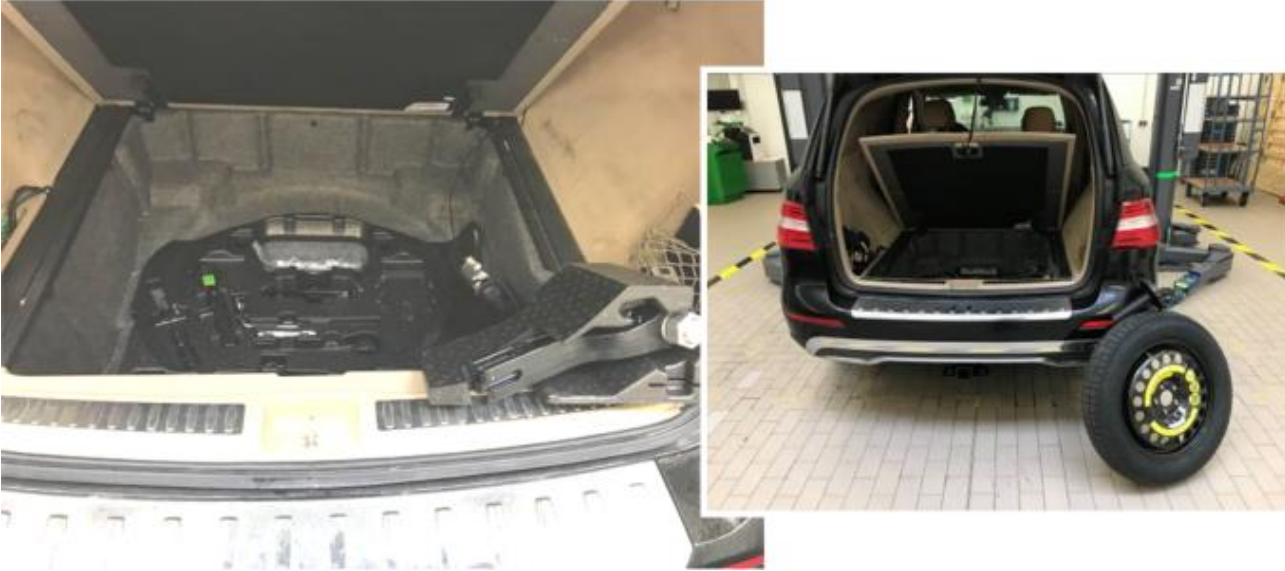
**Figure 1**

1. Open trunk.
2. Lift spare wheel well cover and secure it from falling down.
3. In vehicles with emergency wheel code 690, remove emergency wheel and cover located below , (Figure 1).

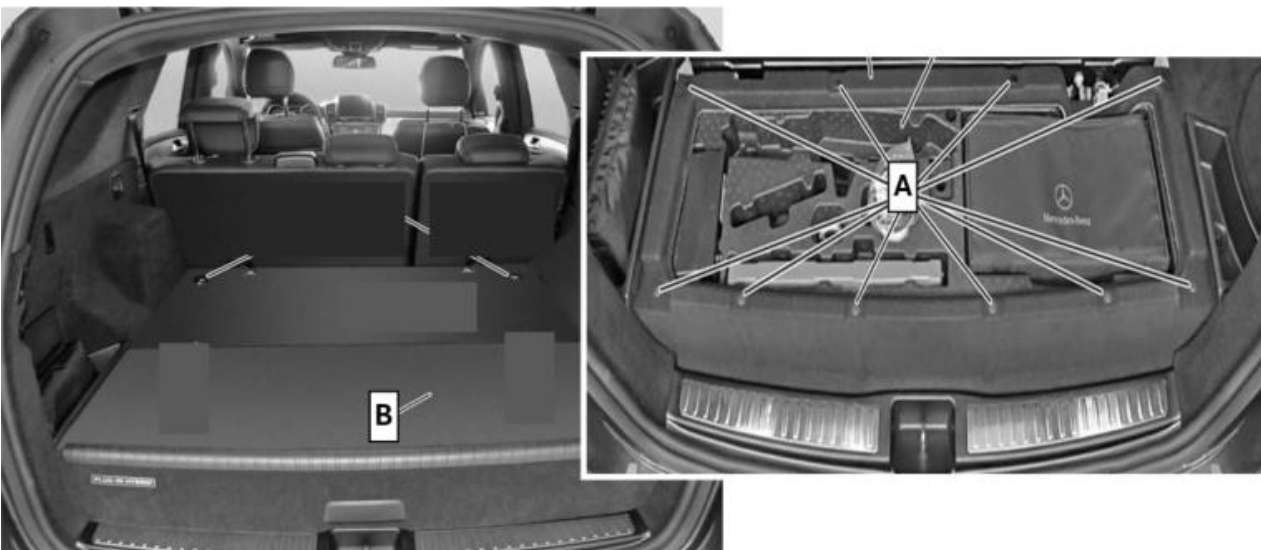
**Figure 2**

4. In hybrid vehicles 166.063, remove load compartment shelf (A, Figure 2) with vehicle tool kit.

**i** Load compartment floor (B, Figure 2) does **not** need to be removed (just folded up).

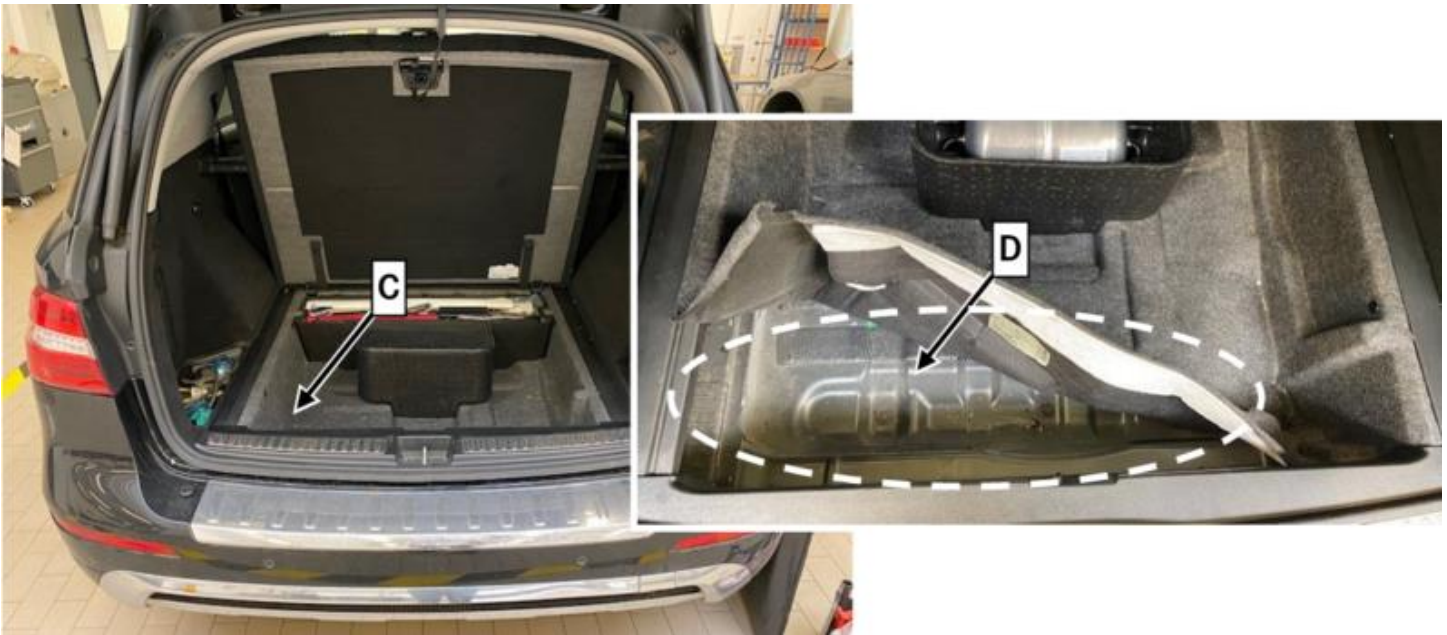
Figure 3

5. Lift left rear felt insert (C, Figure 3) and check for humidity or water deposits in marked area (D, Figure 3).

- a. If humidity or water deposits are **not** present in area (D, Figure 3): Carry out **work procedure A**.
- b. IF humidity or water deposits are present in area (D, Figure 3): Carry out **check/test procedure B**.

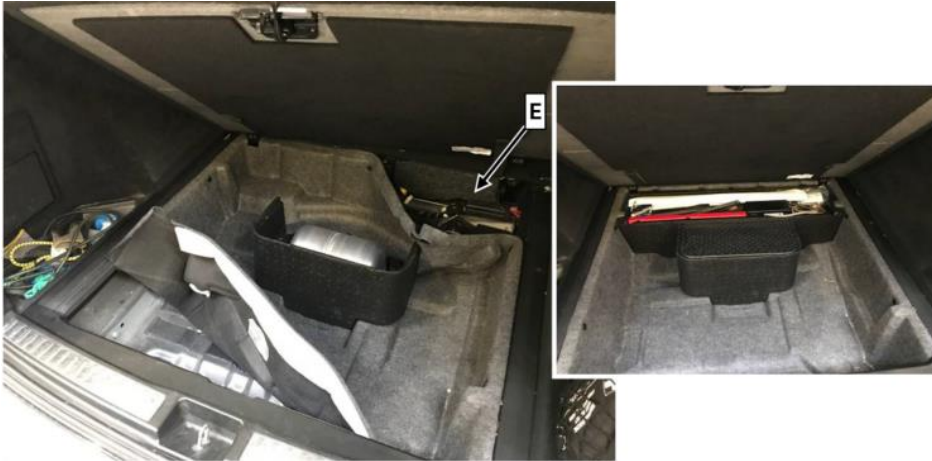
**Figure 4**

2. Lift right front felt insert (E, Figure 4).

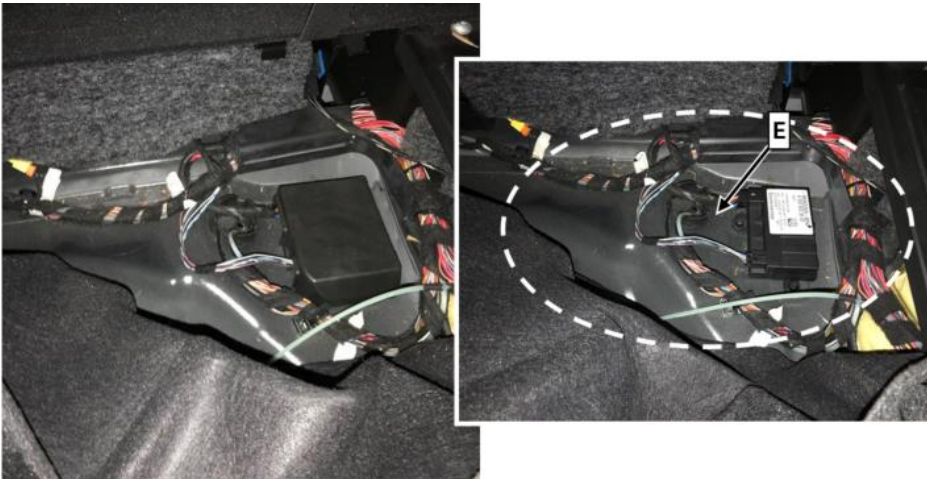
**Figure 5**

3. Check the area around the fuel system control unit for humidity or water deposits.

- a. If humidity or residual water are **not** present in area (E, Figures 4 and 5): Carry out **work procedure A** and install remaining parts.
- b. If humidity or residual water are present in area (E, Figures 4 and 5): Carry out **work procedures A and B**.
