Safety Recall

Code: 97HA

Subject	12V Battery Charging Cable																		
Release Date	January 04, 2023																		
Affected Vehicles

Subject: Safety Recall 97HA -12V Battery Charging Cable

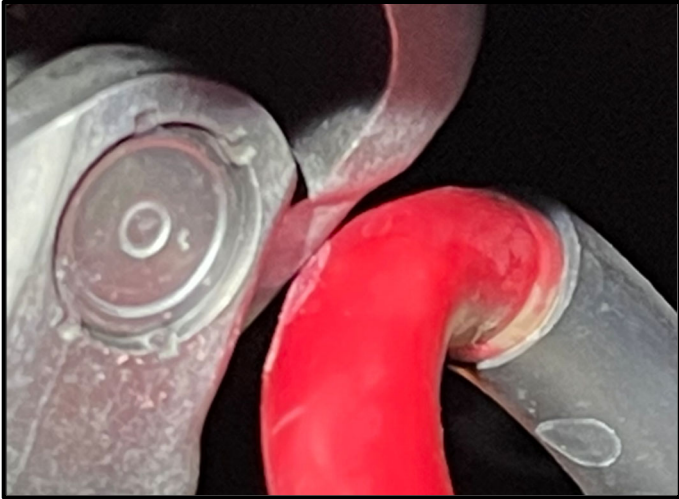
Repair Overview

- Inspect clearance between 12V battery cable and steering shaft.
- If necessary, re-position or replace cable.

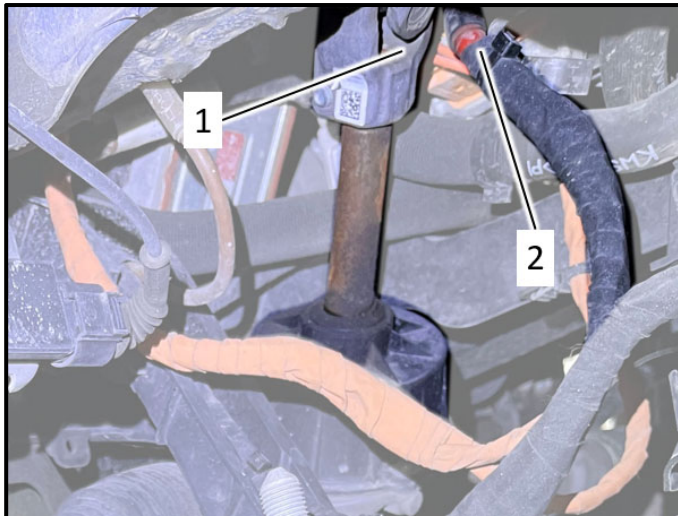
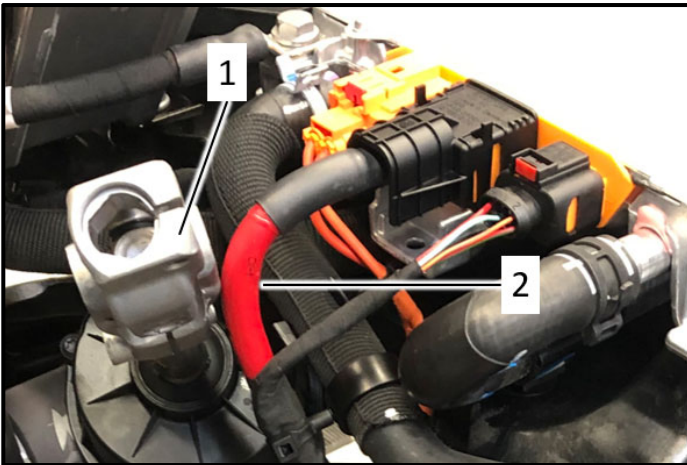
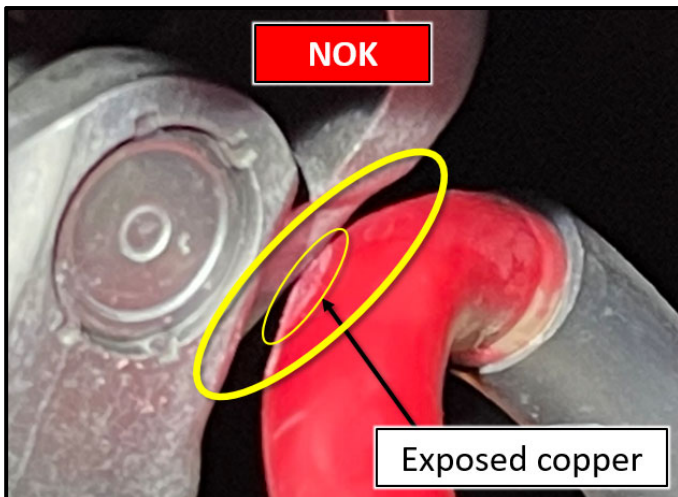
Section B – Inspection Procedure

- Turn the steering wheel all the way to the right.
- From the left front wheel well, inspect the clearance between the steering shaft <1> and the 12V battery cable <2>.

- There should be a minimum clearance of 10 mm. This can be measured with Gap Adjustment gauge -3371-, or an equivalent, non-conductive measuring device.

- The cable must be re-positioned.
 - Proceed to Section C.
- If the 12V battery cable is making contact with the steering shaft, and the cable insulation is damaged to the point that the copper wire is exposed (as shown in the NOK photo):

- If the clearance between the 12V battery cable and the steering shaft is 10mm or more:
 - No further work is required.
 - Proceed to Section E.
- If the clearance between the 12V battery cable and the steering shaft is less than 10mm and the cable insulation is not damaged:

- **THE VEHICLE MUST NOT BE RETURNED TO THE CUSTOMER.**
 - **DO NOT DRIVE THE VEHICLE.**
 - The 12V battery cable must be replaced.
 - Proceed to Section D.

If only light surface wear is present on the insulation, cover the area with fabric tape and re-position the cable as described in Section C.

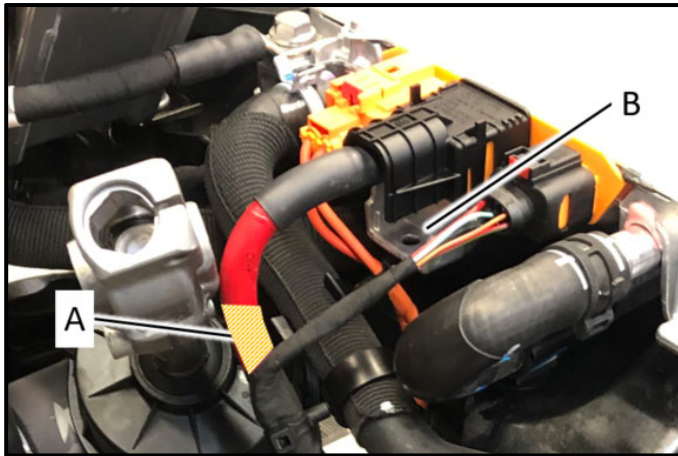
Section C – 12V Battery Cable Re-positioning Procedure

Photo taken from underhood with 12V battery and battery tray removed for clarity.

- A tie wrap will be used to move the 12V battery cable away from the steering shaft.
- Tape must be applied to the 12V battery cable in <area A> to prevent damage to the cable insulation.
- The tie wrap will be installed around the 12V battery cable in <area A> and through hole on the voltage converter.
