Recall Number:	23E-008 Global Latch		
Product:			
Date:	02.23.2023	Labor Rate:	Inspection Only - 0.3 Hour/Inspect & Replace - 0.7 Hour

Purpose

This document refers to the replacement of the door lock assembly with latch on certain motorized entry doors. A portion of the latch is breaking off when attempting to exit the coach. The complete door lock assembly with latch, PN 2021097898, will be replaced with a redesigned part, if needed.

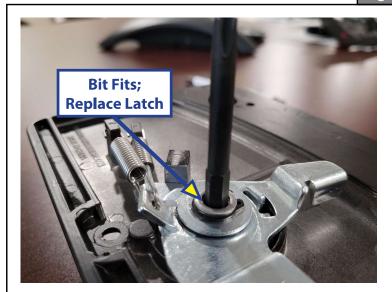
Fig. 5

- 1. Using a 1/4" screwgun bit, try to insert the bit into the spun rivet of the inside latch assembly (Fig. 5).
- 2. If bit fits into rivet opening, replace the complete latch assembly including both inside and outside latch assemblies.
- 3. if the bit does not fit, no action is required. Proceed to latch reassembly instructions.

Replace Complete Latch Asssembly

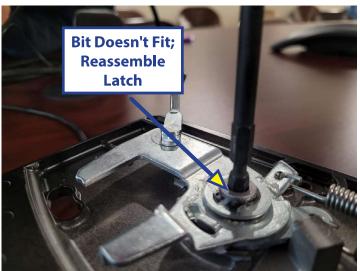
Replacement Not Needed
