INFINITI VOLUNTARY RECALL CAMPAIGN Reference:

BT23-005A

ITB23-016A

VOLUNTARY SAFETY RECALL CAMPAIGN 2022-2023 QX60: DRIVER'S SEAT RAIL INSPECTION

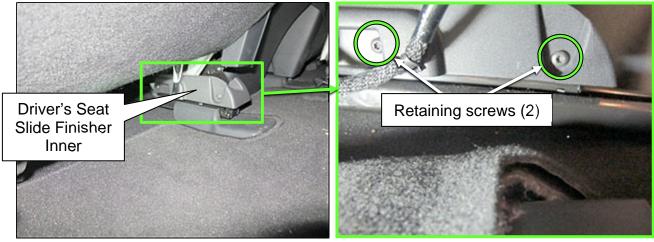
Figure 5

- 5. From the second-row seat area, locate the Driver's Seat Slide Finisher Inner (Figure 5).
- Remove the two (2) Driver's Seat Slide Finisher Inner retaining screws (Figure 6).
 HINT: Attached with T-20 screws.

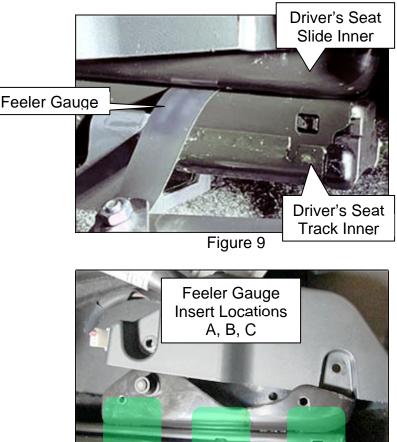
Figure 10

- Using a 0.55 mm (0.022 inch) feeler gauge, attempt to insert the feeler gauge between the Driver's Seat Track Inner and the Seat Slide Inner.
 - Verify the 0.55 mm (0.022 inch) feeler gauge will not insert at locations A, B or C, between the seat track and seat slide (Figure 10).

9. Can the 0.55 mm (**0.022 inch**) feeler gauge be inserted between the seat track and the seat slide at A, B or C (any location or multiple locations), where shown in Figure 10?

YES: Proceed to Step 10 on page 5 for WCC support and review of Driver's Seat Cushion Frame Assembly.

NO: No repair is required. Skip to Step 12 on page 6 to reinstall the Driver's Seat Slide Finisher Inner.
