GROUP	MODEL
Safety Recall Campaign	2023MY Telluride (ON)
NUMBER	DATE
SC262	February 2023

2ND ROW SEAT SAB WIRE HARNESS INSPECTION/REPAIR (SC262)

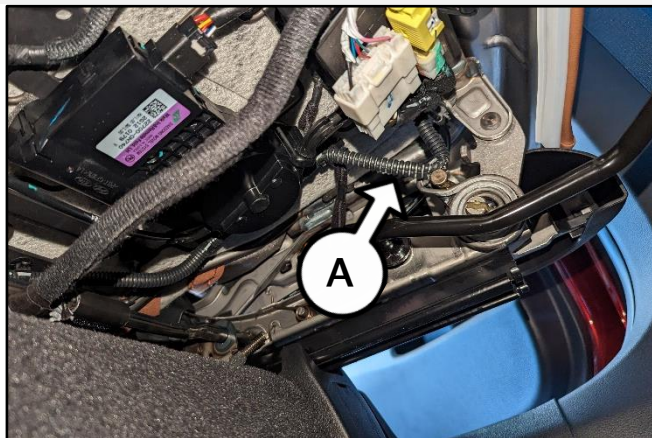
2. Inspect the SAB wire harness (A) plastic conduit flex tubing for damage. (Both LH & RH sides)

If damage to the conduit flex tubing (A) is present (NG) (as shown), disconnect the battery (-) terminal and refer to the shop manual in KGIS to tilt the seat backwards. Carefully cut the plastic conduit flex tubing (as to not damage the enclosed wires) and inspect the two (2) inner wires:

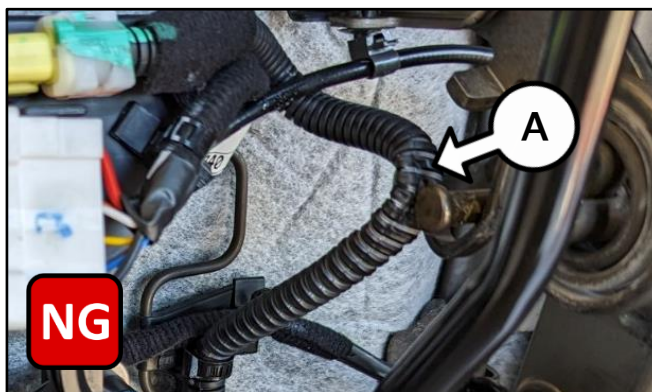
If damage to the wire(s) is not present (as shown) (OK), close the SAB harness (A) conduit flex tubing by wrapping it with 3M™ electrical tape, and then proceed to step 3.

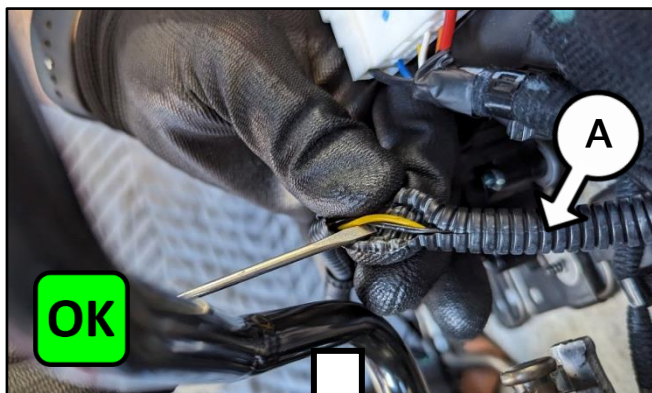
If damage to the wire(s) is present (wires are cut/exposed) (NG), proceed to the 'Repair Procedure' on page 4 to replace the SRS seat harness.

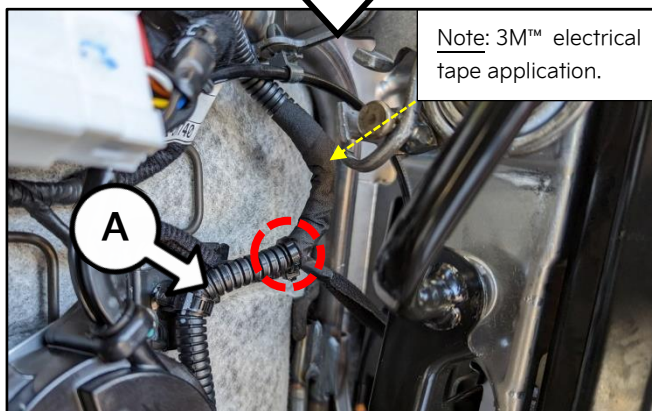
3. Verify that the SAB wire harness is zip-tied to the adjacent wire harness/seat frame as shown, to prevent the wire harness from contacting or getting caught on the seat mechanism.

Ensure there is sufficient clearance between the seat side-frame and SAB wire harness before securing harnesses with a zip-tie.

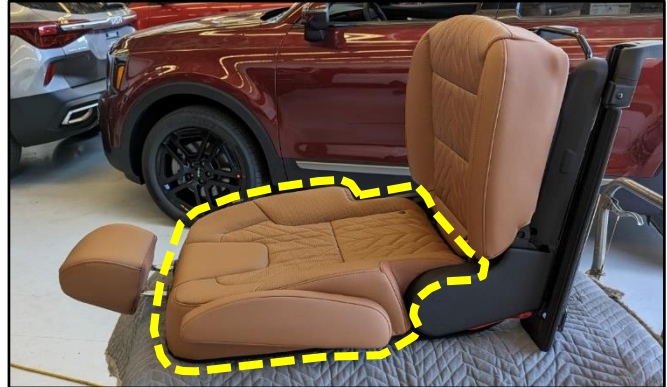
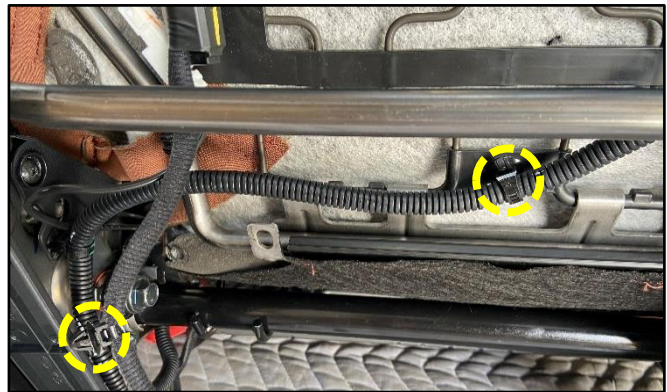
There are several sharp locations on the seat frame which may result in injuries or damage to the harness.

1. Disconnect negative (-) battery terminal.
2. Remove the rear seat back cover referring to the "Body (Interior and Exterior) → Rear Seat → Rear Seat Back Cover → Removal and Installation" chapter in the applicable Shop Manual on KGIS.
3. Detach the SAB wire harness clips from the bottom and back of the seat frame.
