| HYUNDAI Technical Service Bulletin | GROUP RECALL | NUMBER 23-01-029H |
| | DATE MARCH, 2023 | MODEL(S) TUCSON (NX4A) SANTA CRUZ (NXT) |
| SUBJECT: ROOF MOLDING INSPECTION AND REPLACEMENT (RECALL 241) | | |

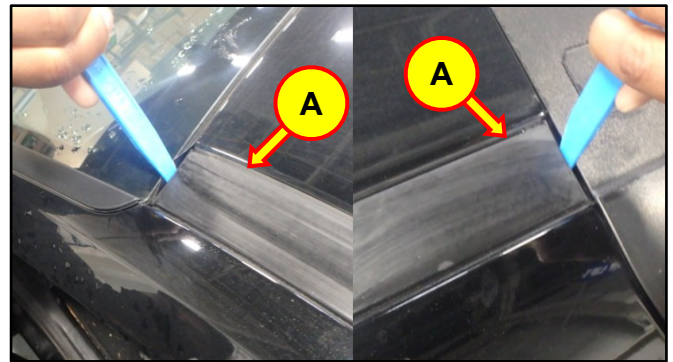
1. Use a thin plastic trim removal tool to inspect the roof moldings (A).

Gently pry up on the roof moldings (A) to measure the gap between the roof body panel.

Inspect both roof moldings (A) at the front, middle, and rear sections.

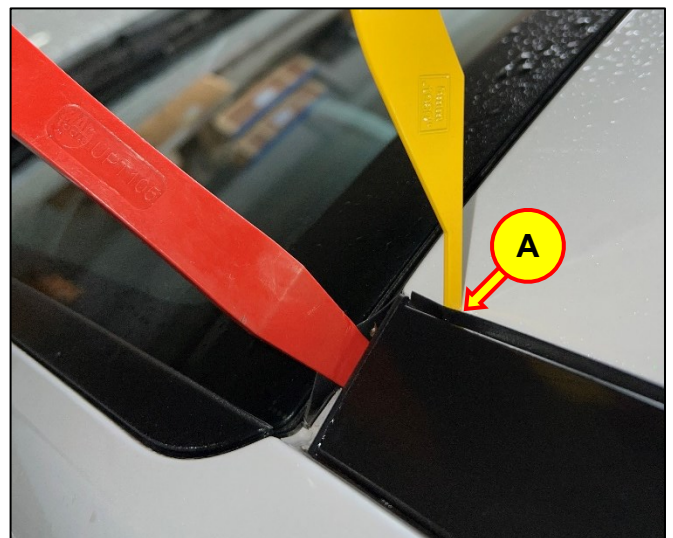
2. If the gaps between the roof moldings (A) and roof body panel are measured to be less than 5 mm (3/16 in) along all front, middle, and rear sections, no further action is required.

If the gaps between the roof moldings (A) and roof body panel are measured to be more than 5 mm (3/16 in.) in any section, the affected roof molding(s) must be replaced. Proceed to the next page.

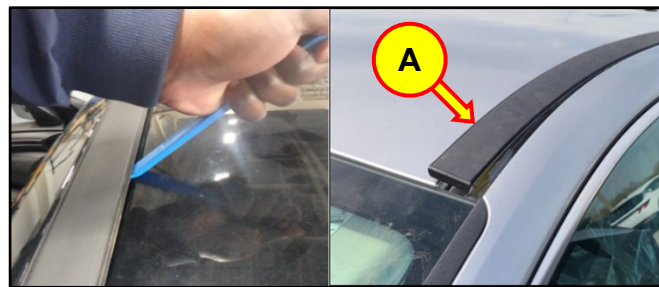
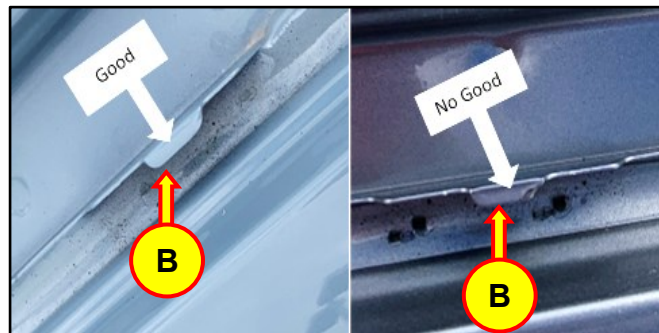
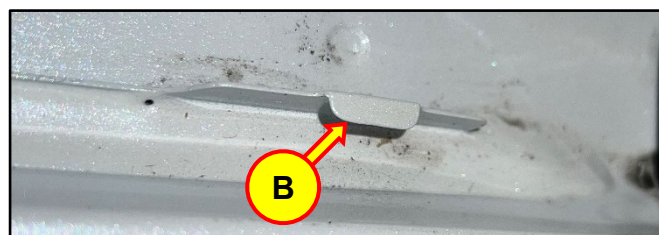
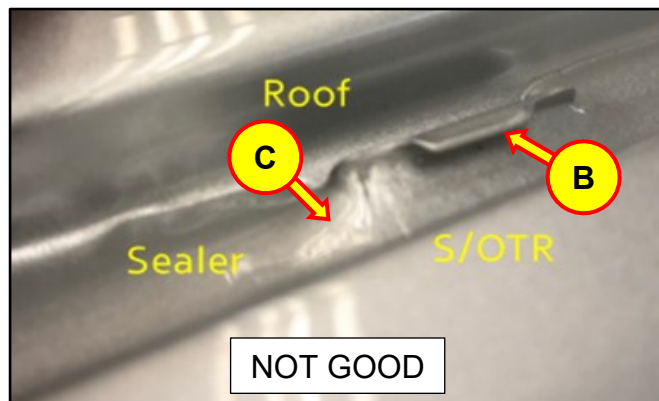
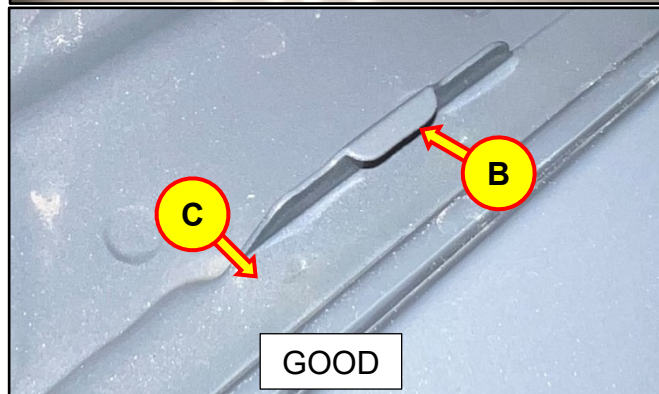
1. Remove the affected roof molding(s) (A) using a plastic trim removal tool.
2. Inspect the roof body panel flanges (B) for any damage, abnormal shape, or excessive seam sealer.
3. If a flange(s) (B) is found to be damaged or has an abnormal shape, repair the flange(s) back to its original shape using the appropriate body repair manual procedures.
4. If the base of a flange(s) (B) has excessive body seam sealer (C), remove the excessive amount using an appropriate sanding tool and disc.

Removing too much sealer may cause a water leak into the cabin. Remove only the necessary amount of sealer to prevent interference when installing the roof molding clips.

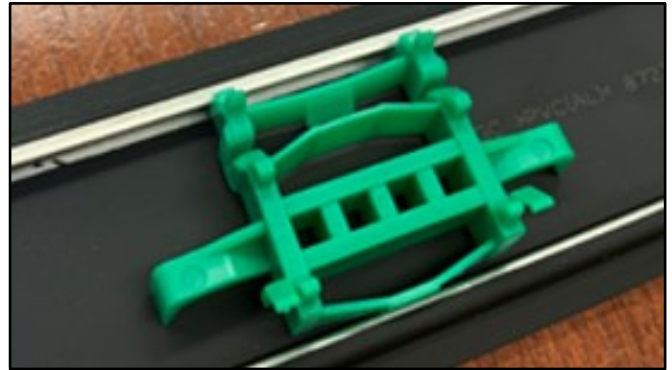
5. Before installing the new roof molding(s), ensure all clips are present and fully secure.

Tucson (NX4A) has 7 clips per molding. Santa Cruz (NXT) has 6 clips per molding.
