SIB 52 01 23

2023-02-14

RECALL 23V-039: SIDE AIR BAG COVER (REAR SEATS)

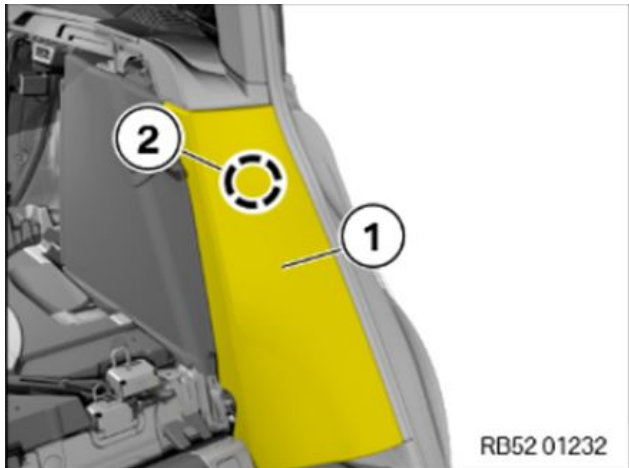
The side air bag cover panel on the rear seats may not have been produced to specifications by the supplier. In certain crashes where side air bag deployment is warranted, the cover panel may crack. If this happens, then the side air bag may not deploy as intended, which could increase the risk of injury.

Supplier backrest side panel material does not meet design criteria.

Replace backrest side panels (left and right) in accordance with repair instructions 52 26 008 (backrest side panel at the rear seat back).

- Unclip and remove the backrest section (1) on the rear seat backrest from the clamp (2).
