SAFETY RELATED RECALL

Global Recall Action
Number: N763

Subject: Camshaft Carrier Drill Hole	Publication No.: N763
	Model: Range Rover (LK)
	Model Year: 2023
	Model: Range Rover Sport (L1)
	Model Year: 2023
	Model: Discovery (LR)
	Model Year: 2023
	Model: Defender (LE)
	Model Year: 2023
	Model: Range Rover Velar (LY)
	Model Year: 2023 - 2024
	Date of Issue: 16 February 2023

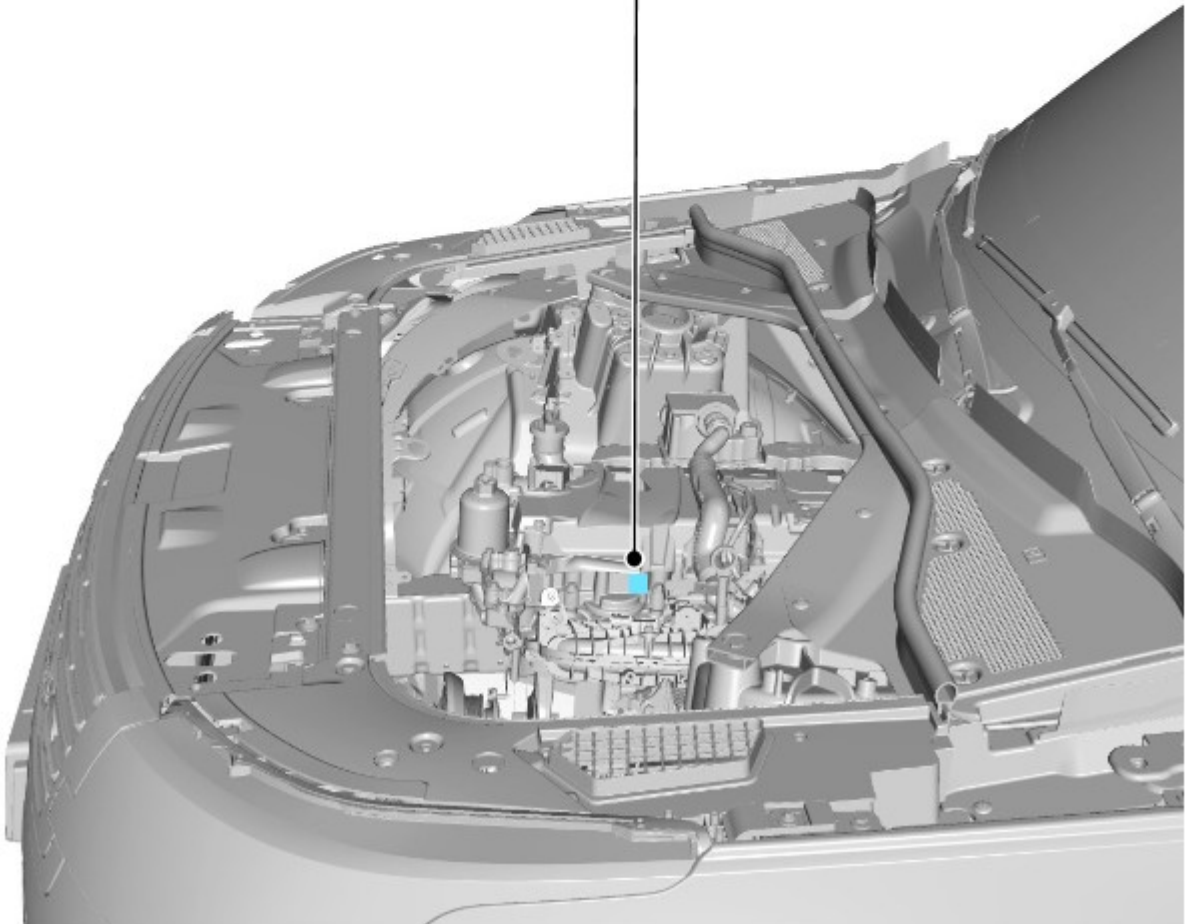
2. Locate the highlighted area of the camshaft carrier shown in the illustration.

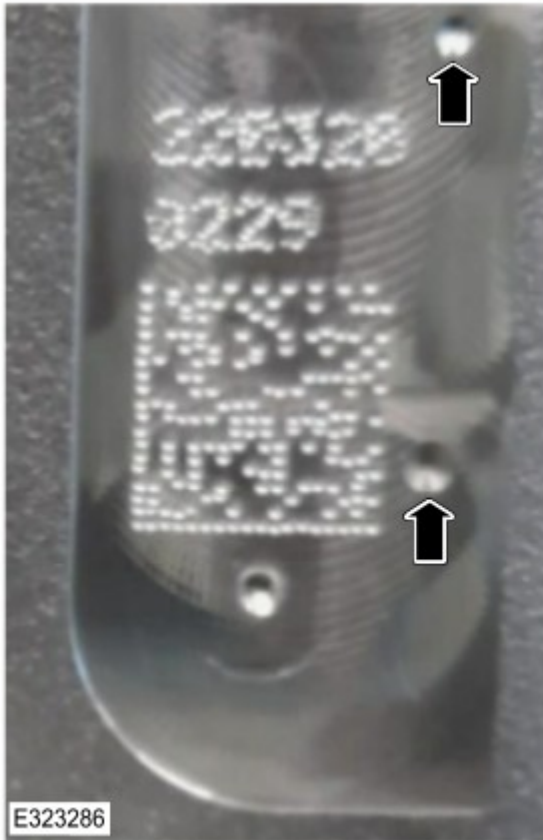
7. The failure condition shown highlights 2 drilled tooling marks in the upper and middle right side of the tooling stamp.

If the 2 drilled tooling marks in the upper and middle right side of the tooling stamp are **BOTH** present, then the vehicle has failed the inspection.

1. Renew the camshaft carrier, (see TOPIx Workshop Manual section 303-01: Engine - INGENIUM I6 3.0L PETROL - Removal and Installation - Camshaft Carrier).
