# SAFETY RELATED RECALL

Global Recall Action Number: N763v2

Subject:  <h2>Camshaft Carrier Drill Hole</h2>	Publication No.: N763v2
	Model: Range Rover (LK)
	Model Year: 2023
	Model: Range Rover Sport (L1)
	Model Year: 2023
	Model: Discovery (LR)
	Model Year: 2023
	Model: Defender (LE)
	Model Year: 2023
	Model: Range Rover Velar (LY)
	Model Year: 2023 - 2024
Date of Issue: 20 February 2023

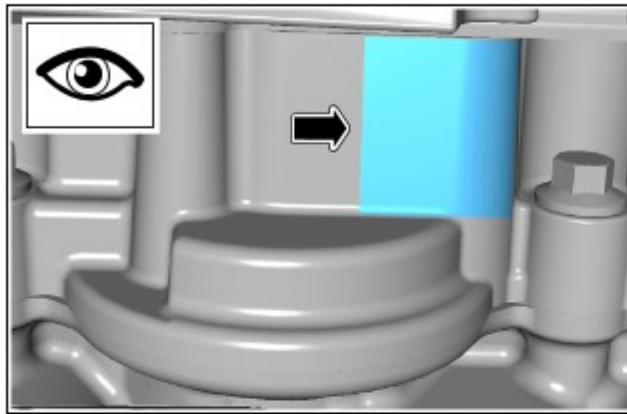
E323282

2. Locate the highlighted area of the camshaft carrier shown in the illustration.

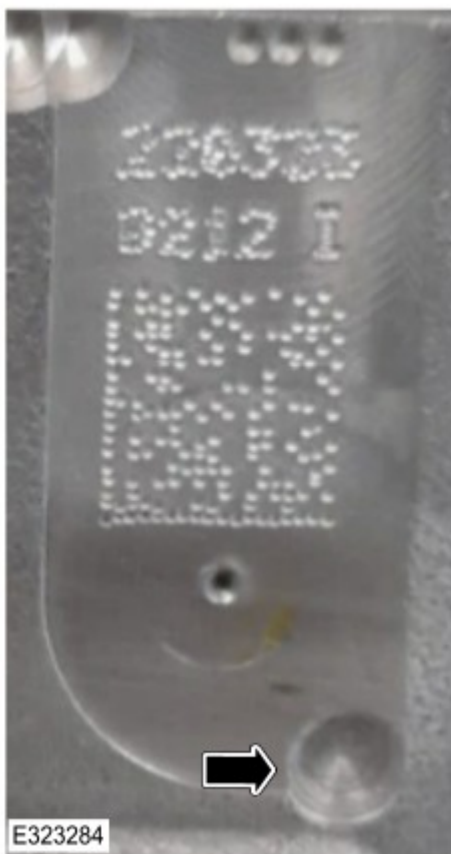
- 4. Steps 5, 6 and 7 show 3 **INDIVIDUAL** failure conditions.
- 5. The failure condition shown highlights 1 drilled tooling mark in the lower right side of the tooling stamp.

If the 1 drilled tooling mark in the lower right side of the tooling stamp is present, then the vehicle has failed the inspection.

1. Renew the camshaft carrier, (see TOPIx Workshop Manual section 303-01: Engine - INGENIUM I6 3.0L PETROL - Removal and Installation - Camshaft Carrier).

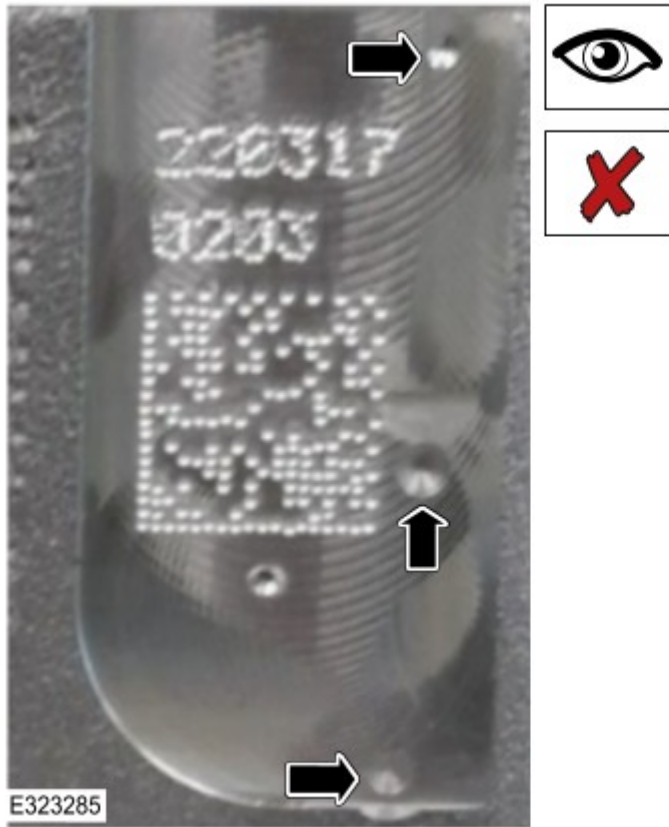
- 6. The failure condition shown highlights 3 drilled tooling marks in the upper, middle and lower right side of the tooling stamp.

If the 3 drilled tooling marks in the upper, middle and lower right side of the tooling stamp are **ALL** present, then the vehicle has failed the inspection.

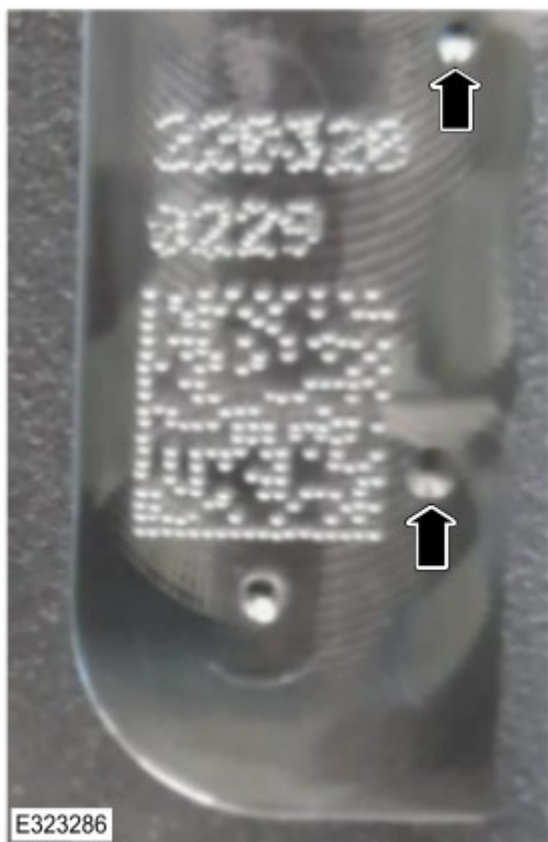
- 7. The failure condition shown highlights 2 drilled tooling marks in the upper and middle right side of the tooling stamp.

If the 2 drilled tooling marks in the upper and middle right side of the tooling stamp are **BOTH** present, then the vehicle has failed the inspection.
