SAFETY RELATED RECALL

Global Recall Action
Number: H426

Camshaft Carrier Drill Hole	Publication No.: H426
	Model: F-PACE (X761)
	Model Year: 2023 - 2024
	Date of Issue: 16 February 2023

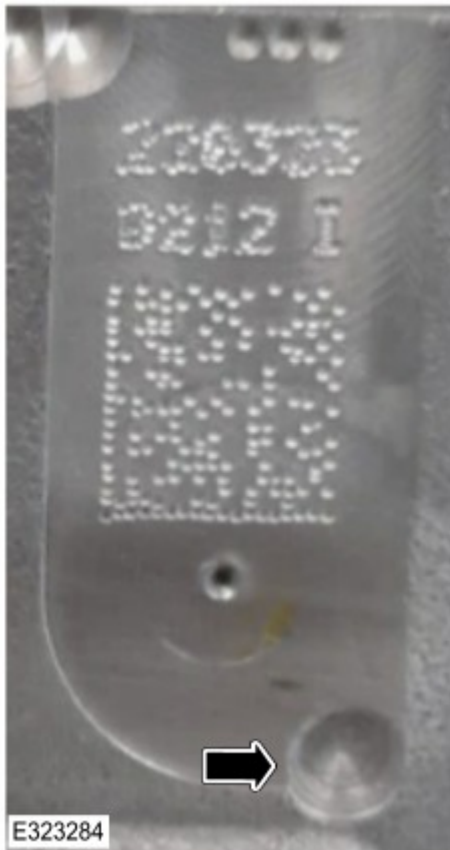
5. The failure condition shown highlights 1 drilled tooling mark in the lower right side of the tooling stamp.

If the 1 drilled tooling mark in the lower right side of the tooling stamp is present, then the vehicle has failed the inspection.

1. Renew the camshaft carrier, (see TOPIx Workshop Manual section 303-01: Engine - INGENIUM I6 3.0L PETROL - Removal and Installation - Camshaft Carrier).

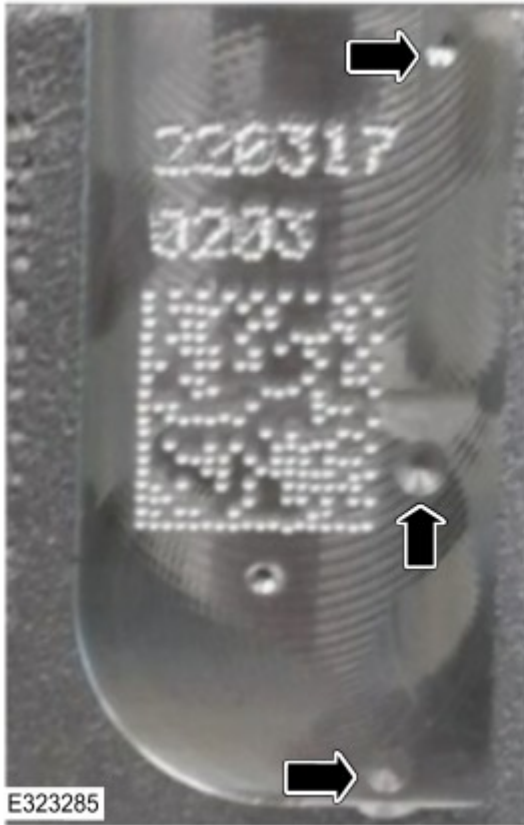
6. The failure condition shown highlights 3 drilled tooling marks in the upper, middle and lower right side of the tooling stamp.

If the 3 drilled tooling marks in the upper, middle and lower right side of the tooling stamp are **ALL** present, then the vehicle has failed the inspection.

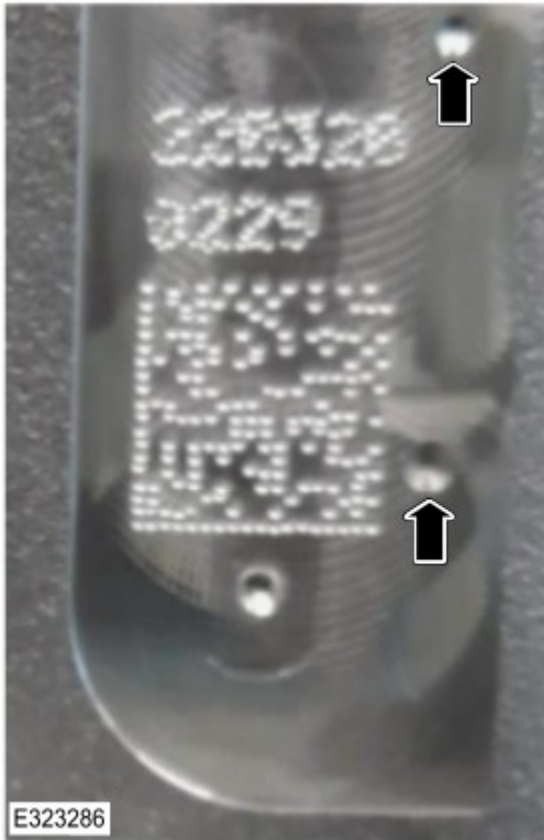
7. The failure condition shown highlights 2 drilled tooling marks in the upper and middle right side of the tooling stamp.

If the 2 drilled tooling marks in the upper and middle right side of the tooling stamp are **BOTH** present, then the vehicle has failed the inspection.
