Product Safety Recall

N222368030 Inadequate Fuel Pump Flow

Release Date: June 2023

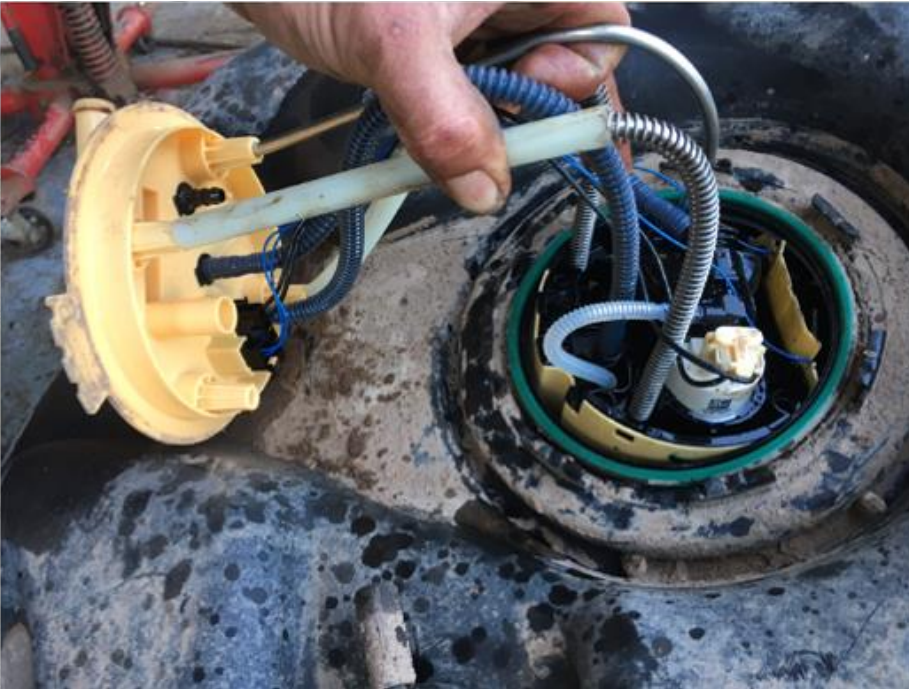
6306751

2. Remove the fuel pump module from the fuel tank and inspect it to see if the rods that hold the fuel pump bucket are bent as shown.
 - If the rods are not bent, replace the O-ring and reinstall the fuel pump module proceed to step 3.
 - If the rods ARE bent, replace the fuel pump module and the auxiliary fuel tank. You may skip step 3 if performing this step.

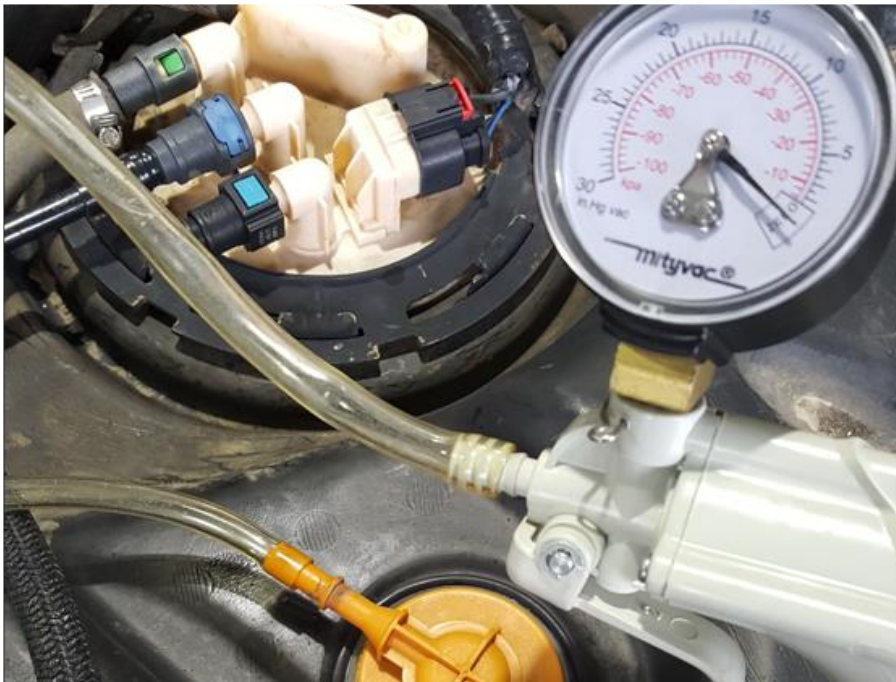
6306752

4. Using a MityVac handheld vacuum pump (or similar device) attempt to pull a vacuum on the vent port on top of the fuel tank. **We are doing this to check for/detect whether there is a blockage in the vent port.**
 - If you are unable to pull any sort of vacuum on the vent port, proceed to step 5.
 - If you manage to pull a vacuum - even a slight one - on the vent port, replace the Auxiliary Fuel Tank.
