IMPORTANT SAFETY RECALL

NHTSA Safety Recall: 22E-055

AWNING INSPECTION AND WELD/SEAM REPAIR

Recall Number	22E-055		
Product	Awnings		
Date	Original: July 15, 2022	Labor Rate	.30 hours inspection only .30 hours repair only
	Current: Sept. 1, 2022		1.5 hours fabric replacement only

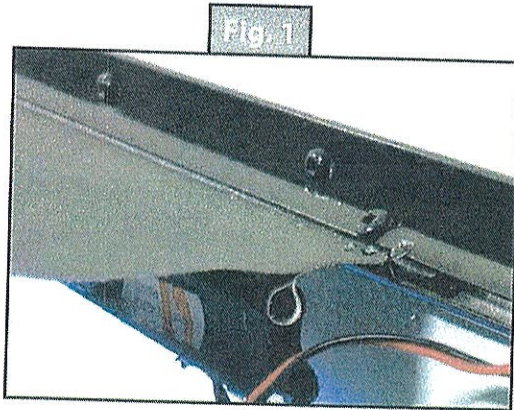
The purpose of this document is to provide guidance, as well as visual aides, to dealers performing inspection on units that may have insufficient awning weld(s). The inspection point is at the awning fabric seam at the awning rail at the wall of the unit (Fig. 1). This only affects awnings manufactured January 17, 2022 – June 14, 2022. The date of manufacture can be located on the variant code label (Fig. 2) located on the awning.

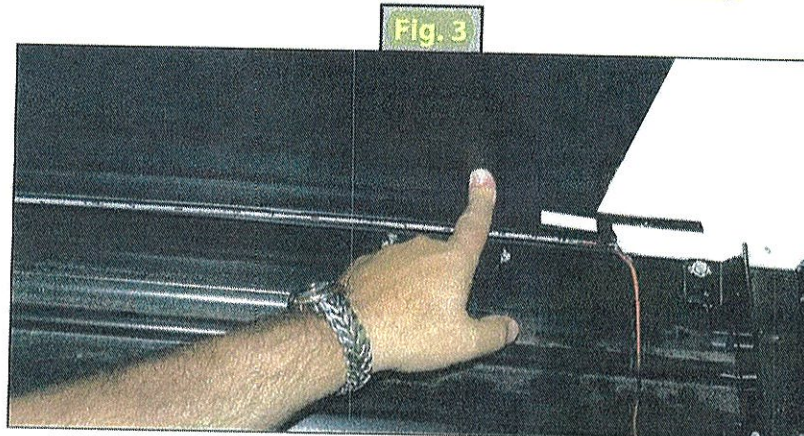
1. Extend the awning.
2. From underneath the awning, about 1" to 1.5" from the fabric edge, push up on the fabric with one finger (Fig. 3) until the awning fabric is flush with the top of the awning rail. Look for any separation or visible daylight at the seam. Perform push test at both ends of the awning.

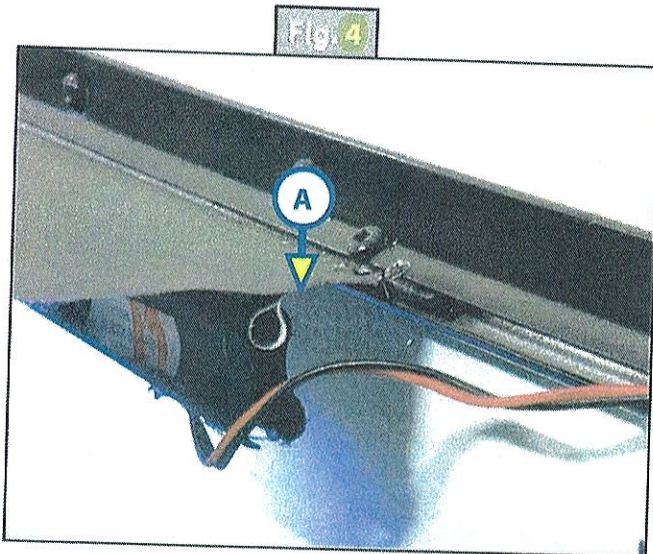
1. Position stepladder next to the unit to view the topside of the awning at the unit wall from either end (drive/idler side).
2. Inspect the weld near the awning rail (Fig. 4A).
 - A. Fig. 4 shows no separation at the seam. It does not require repair or replacement.
 - B. Fig. 5 shows separation at the seam (Fig. 5A).
 - I. If the separation is less than 6 inches, repair can be accomplished using the procedure described in [TI-434](#).
 - II. If the separation is over 6 inches it will require awning fabric replacement using the procedure described in [TI-166](#).
