March 2023
FL964 A
NHTSA #23V-063
Transport Canada #2023-046

Subject: Freightliner Coronado Upper Bunk Wall Mounting

Models Affected: Specific model years 2021-2023 Freightliner Coronado vehicles, manufactured from August 27, 2020 through January 12, 2023.

Upper Bunk Mounting Fastener Replacement

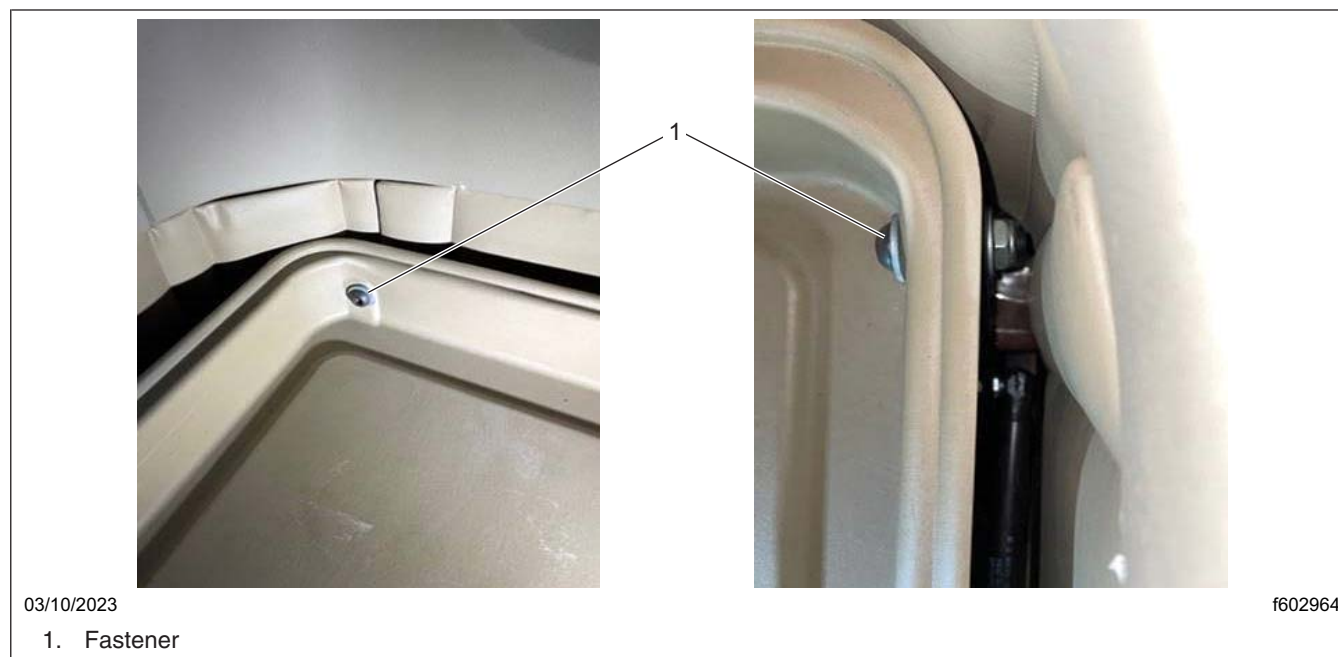
Fig. 1, Location of the Pivot Fastener

On certain vehicles with a foldable upper bunk assembly, the mounting pivot bolts of the upper bunk may not have been fully torqued to spec to properly connect those mounting points. A loose mounting pivot bolt may result in the upper bunk falling, potentially injuring the occupant using the bottom bunk.

1. Check the base label (Form WAR259) for a completion sticker for FL964 (Form WAR260) indicating this work has been done. The base label is usually located on the passenger-side door, about 12 inches (30 cm) below the door latch. If a completion sticker is present, no work is needed. If a completion sticker is not present, continue with the next step.
2. Park the vehicle on a level surface, shut down the engine, and set the parking brake. Chock the rear tires.
3. Remove the upper bunk mattress.
4. Access the two upper bunk pivot fasteners and nuts. See [Fig. 1](#).
