PRODUCT CAMPAIGN BULLETIN

APPLICABILITY: 2023 MY Solterra

NUMBER: WRE-23R

SUBJECT: Solterra Hub Bolt Torque

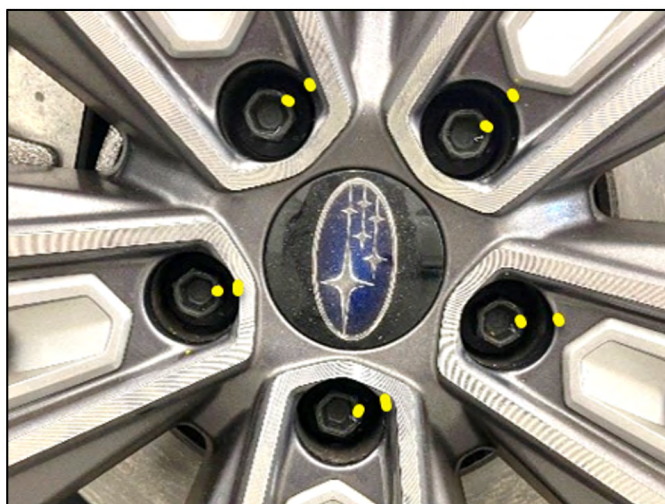
STEP 1: Mark every bolt and wheel using a water-based paint marker or waxed pen so any movement of the bolt will be visible. Ensure you mark both the bolt and wheel in a straight line, so any change can be identified after torque is applied to the bolt.

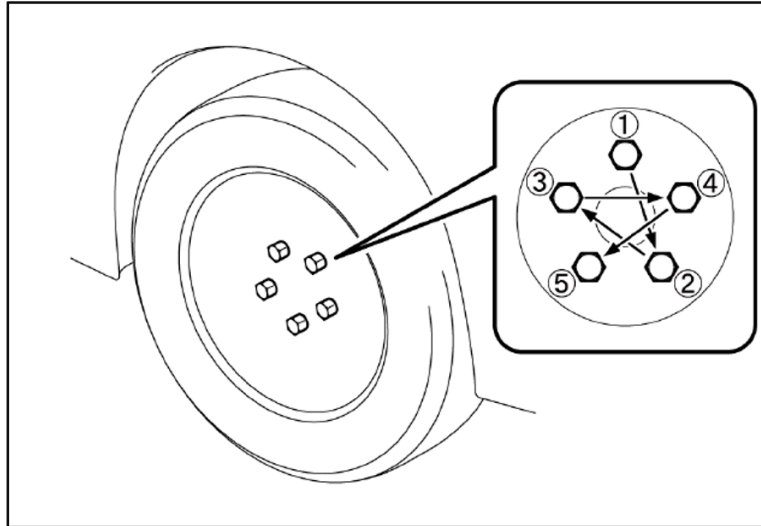
STEP 2: Using a Digital Torque Wrench, set the torque wrench to 90 ft-lbs (122 Nm). **CAREFULLY** torque **ALL** wheel bolts on **ALL** wheels in the pattern shown below.

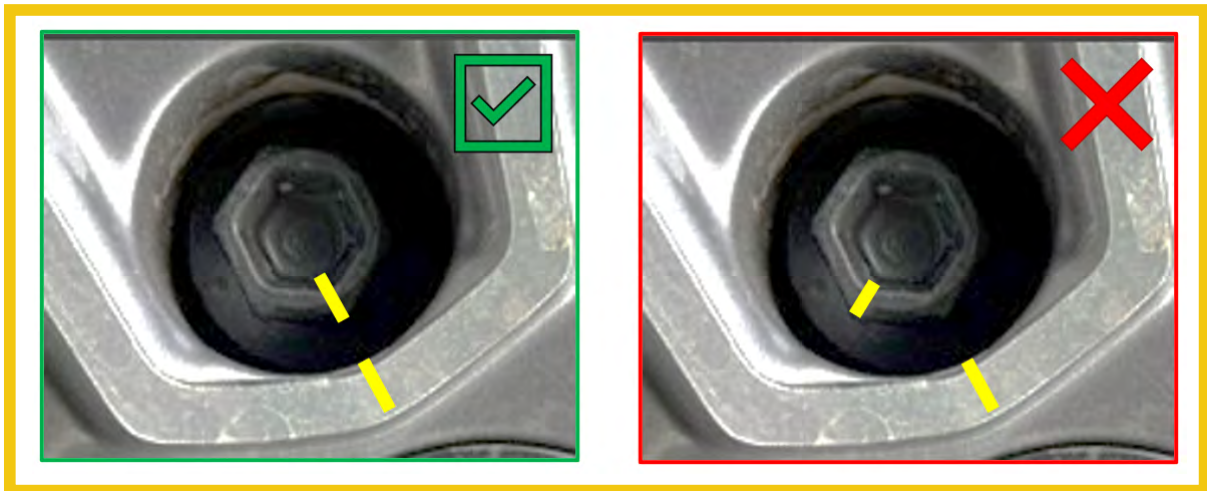
STEP 3: Inspect each wheel bolt identification mark for a deviation from the identification mark on the wheel. If any of the wheel bolts required tightening or showed movement based on the marks, before reaching a torque value of 90 ft-lb (122 Nm), mark the bolt head using a water-based paint marker or waxed pen.

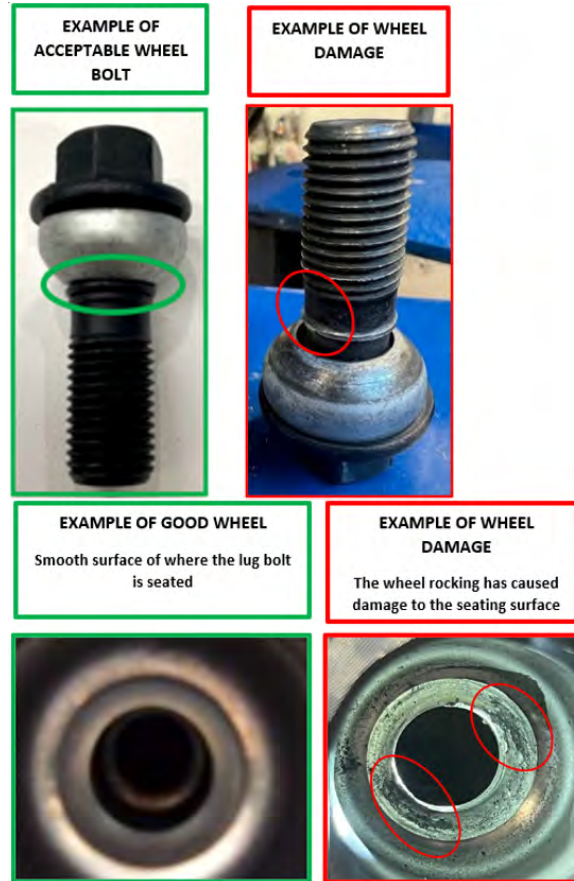
STEP 4: Remove each affected bolt one at a time and inspect the wheel and bolt for any signs of damage, reinstalling and torquing each bolt to 103 ft-lbs. after each inspection detailed in the following Steps. See the example images below.

STEP 6: Is there any damage detected on the affected bolt(s)? Check for damage to the O-ring or to the conical washer or threads would indicate a need to replace the bolt(s).

YES – Replace the affected wheel(s) and the associated bolt(s) and proceed to STEP 7.

YES – Replace the affected bolt(s) and proceed to STEP 7.

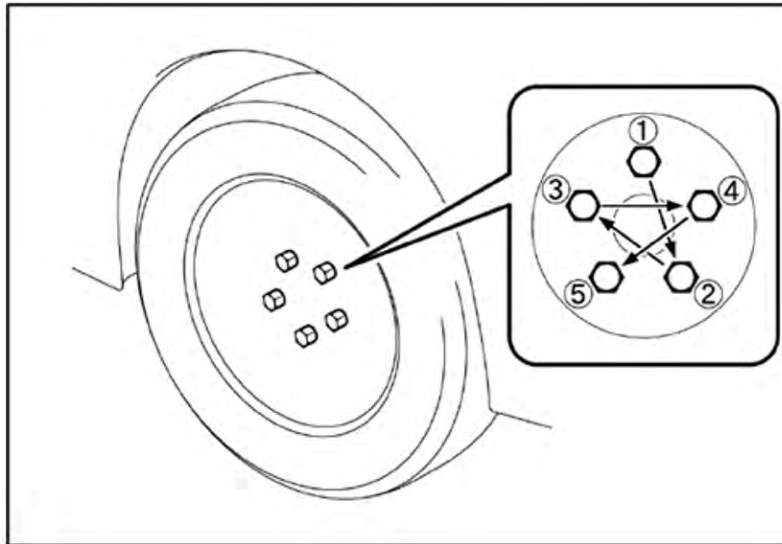
CAREFULLY torque **ALL** wheel bolts in a star pattern to 103 ft-lbs (140 Nm). as shown below.

- Follow the tightening order as shown in the illustration below
- The number 1 bolt is always closest to the air valve and the movement is clockwise
- Do Not continue to tighten the bolt once the torque is reached
