**PRODUCT CAMPAIGN BULLETIN**

**APPLICABILITY:** 2023 MY Solterra

**NUMBER:** WRE-23

**SUBJECT:** Solterra Hub Bolt Torque

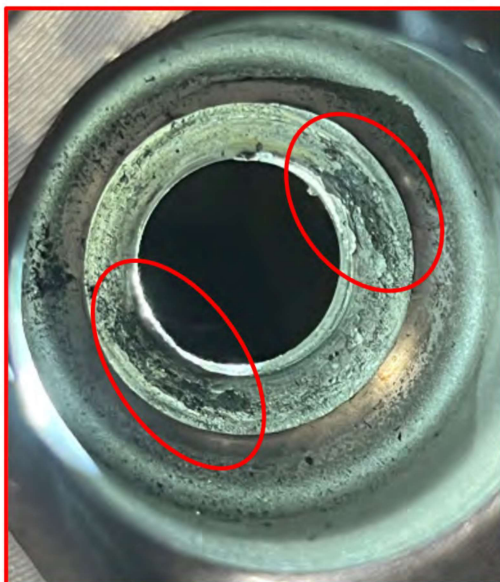
**Example of wheel damage**

**STEP 4:** Remove each affected bolt one at a time and inspect the wheel and bolt for any signs of damage, reinstalling and torquing each bolt to 103 ft-lbs. after each inspection detailed in the following Steps. See the example images below.

**YES** – Replace the affected wheel(s) and the associated bolt(s) and proceed to STEP 7.

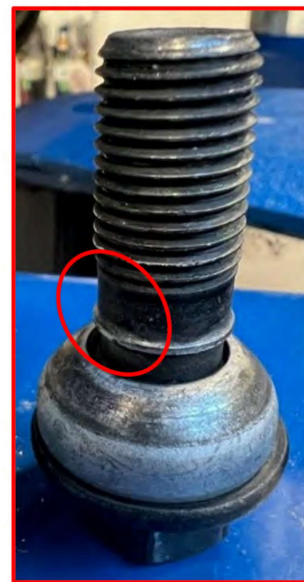
**Example of bolt damage**

**STEP 6:** Is there any damage detected on the affected bolt(s)? Check for damage to the O-ring or to the conical washer or threads would indicate a need to replace the bolt(s).

**YES** – Replace the affected bolt(s) and proceed to STEP 7.
