SERVICE PROCEDURE

23502
APRIL 2023

SUBJECT: SAFETY RECALL
Roof Lining Joints on certain 2022 and 2023 IC Bus® CE and RE Series commercial bus models built 09/01/2021 thru 12/15/2022.

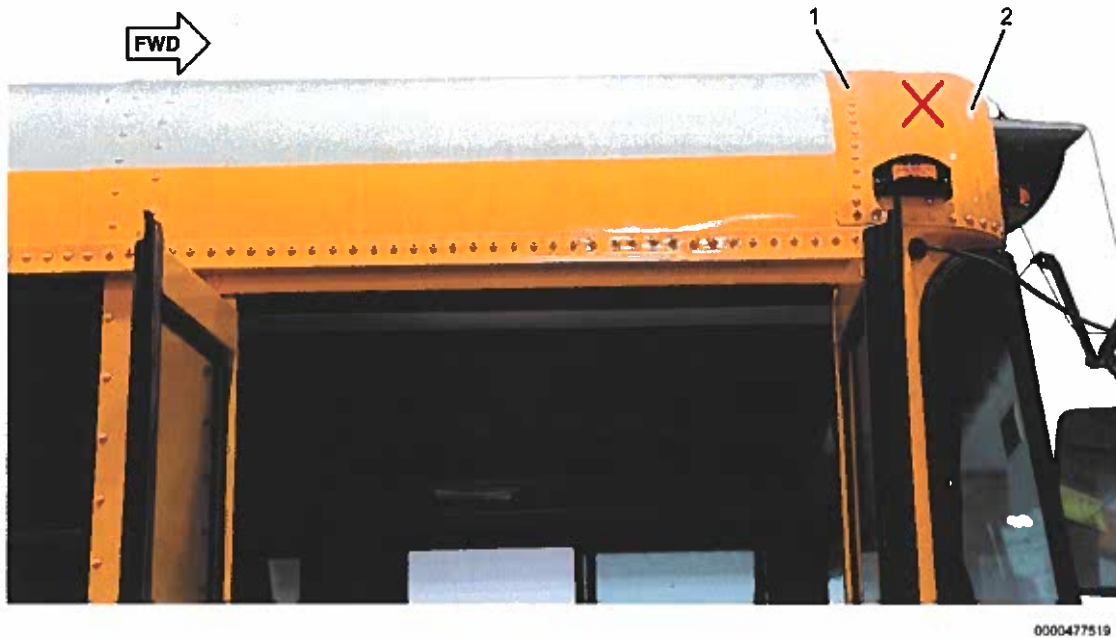
Figure 1. Front Entrance Door Rivets

NOTE: Do not measure the row of rivets (Figure 1, Item 1) of the roof top sheet above the entrance door to the front cap (Figure 1, Item 2); it is not part of the inspection procedure.

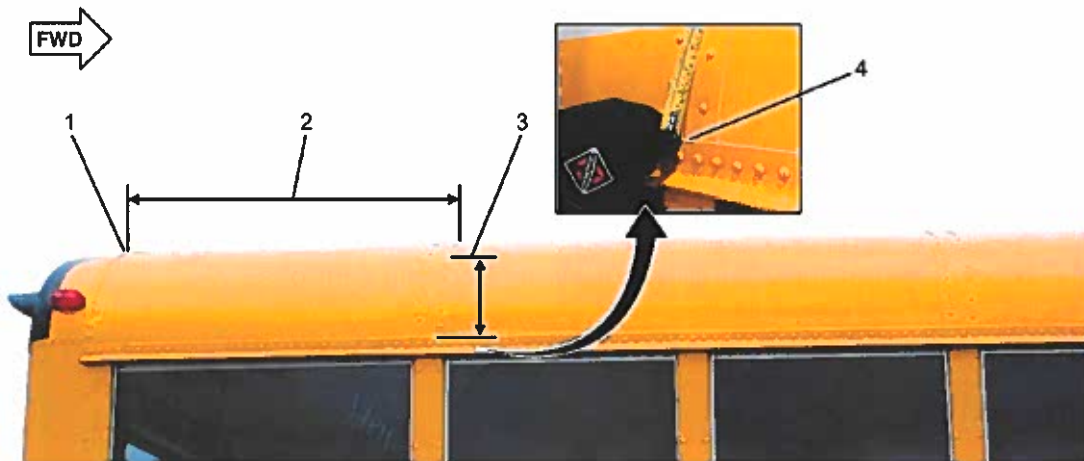
Figure 2. Measurement Guidelines – Drip Rail & Top Sheet

NOTE: The inspection requires measuring the rear edge of the roof top sheet metal, not the sealant edge, to the forward row of rivets of the next forward joint.

NOTE: Start with the rearmost top sheet, and all measurements must start approximately 20 in (508 mm) up, at least 9 rivets up, from the top of the drip rail to the top centerline of the roof (Figure 3, Item 3).

6. Measure and record roof top panels starting at rearmost top panel of bus (Figure 2, Items 1 & 2) using a tape measure. Refer to following detailed instructions:
 - a) Measure up 20 in (508 mm) (Figure 2, Item 3) from top of drip rail (Figure 2, Item 4), approximately 9 rivets.
 - b) Measure from rear edge of top panel (Figure 3, Item 1) to centerline of forward row of rivets (Figure 3, Item 4) on next joint on each panel and not from sealant edge.
 - c) Measure all rivets to centerline of roof (Figure 3, Item 3).

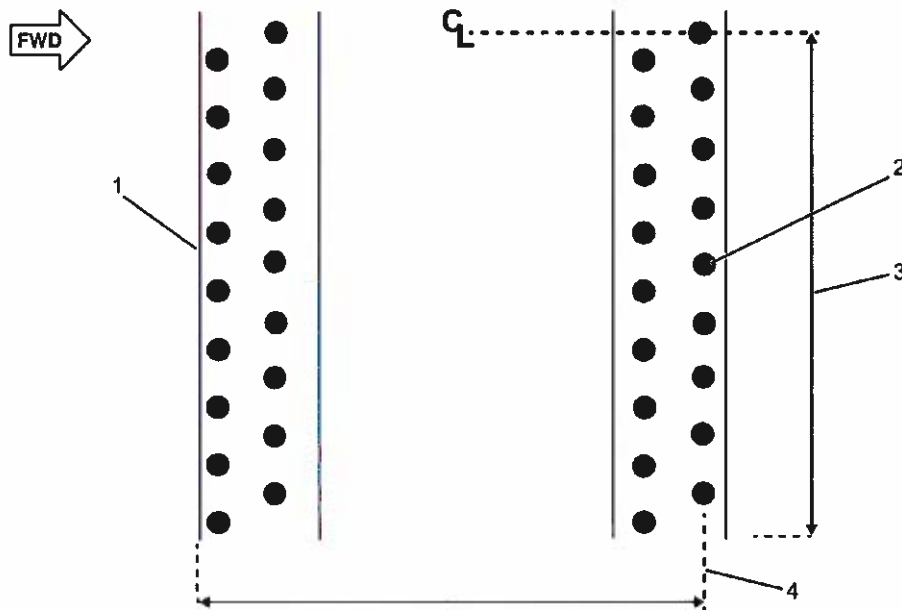
Figure 3. Measurement Guidelines – Rear Edge of Top Sheet to Front Row of Rivets

NOTE: Roof top sheets may vary in length, and maximum dimensions must not exceed 30.25, 39.25, 57.25, or 44.75 in for each roof top sheet you will measure.

7. Determine if measurements meet or exceed maximum dimension.
 - a) If measurement is less than or equal to maximum dimension, repair of joint(s) is not required.
 - b) If measurement is greater than maximum dimension, repair on panel(s) is required.

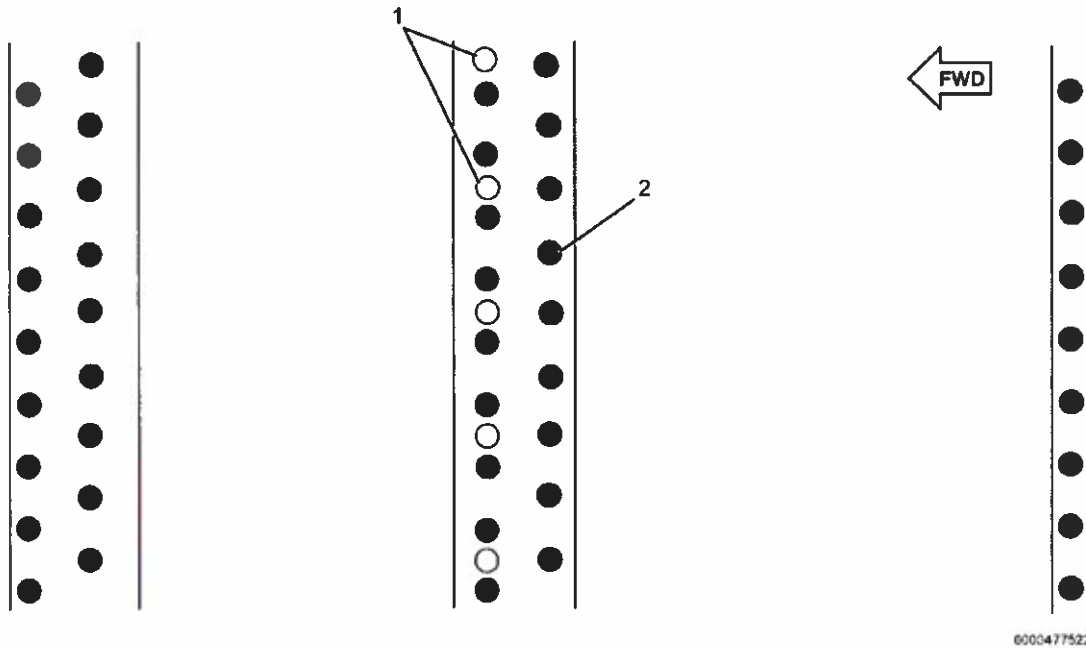
Figure 4. Noncompliant Roof Bow Screw Locations

NOTE: In line with the rear most row of rivets of the noncompliant joint, approximately 24 screws will need to be added. Screws to be added between every other rivet.

9. Install self-sealing screws (Figure 4, Item 1) between every other rivet (Figure 4, Item 2) into noncompliant roof bow. Refer to following detailed instructions:
 - a) Starting at 20 in (508 mm) up from drip rail, mark correct location between every other rivet (Figure 4, Item 1) to be punched and drilled on panel using a marker.
 - b) Punch location for each hole to be drilled on panel using hammer and center punch.
 - c) Install #21 drill bit 0.1590 in (4.0386 mm) diameter into drill.
 - d) Install and set drill stop to 1/2 in (12.7 mm) depth.

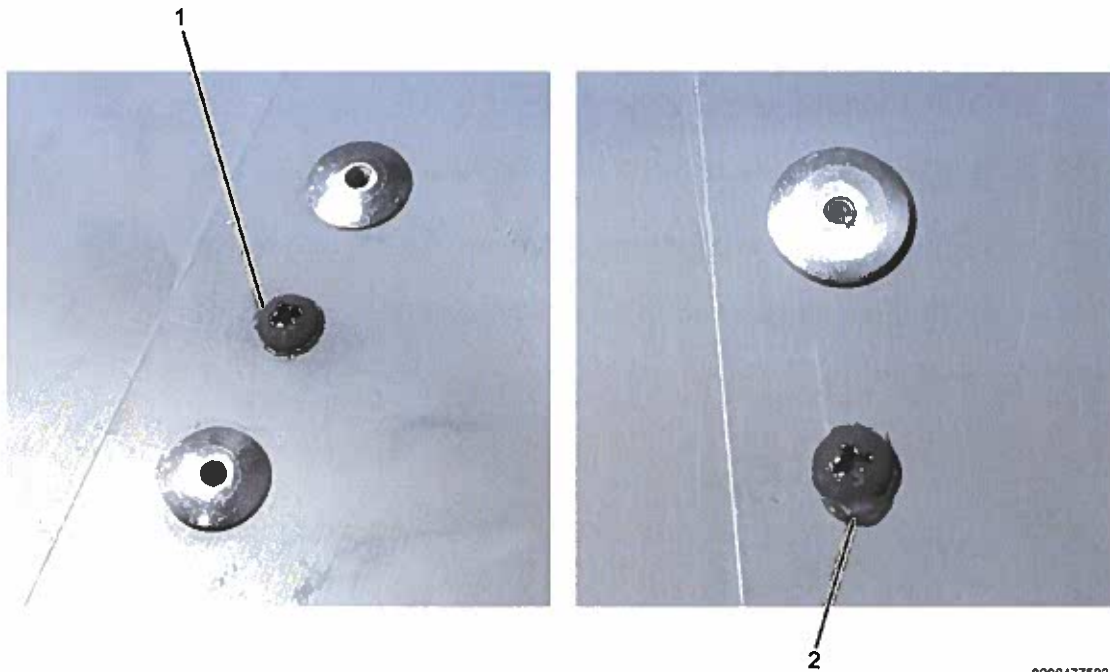
Figure 5. Correct and Incorrect Seal

NOTE: These screws are self-tapping and can easily be stripped. Refer to Figure 6 for correct (Figure 5, Item 1) and incorrect (Figure 5, Item 2) seal. If incorrect seal is made, install new screw to create correct seal.

- e) Drill holes through joint, apply cutting oil to metal surface being drilled.
- f) Remove metal shavings from roof and drill bit using shop vacuum.
- g) Clean surface with non-oil-based cleaner and wipe dry.
- h) Install self-sealing screws. See Figure 5 for correct seal.
- i) Tighten screws until head is fully seated.

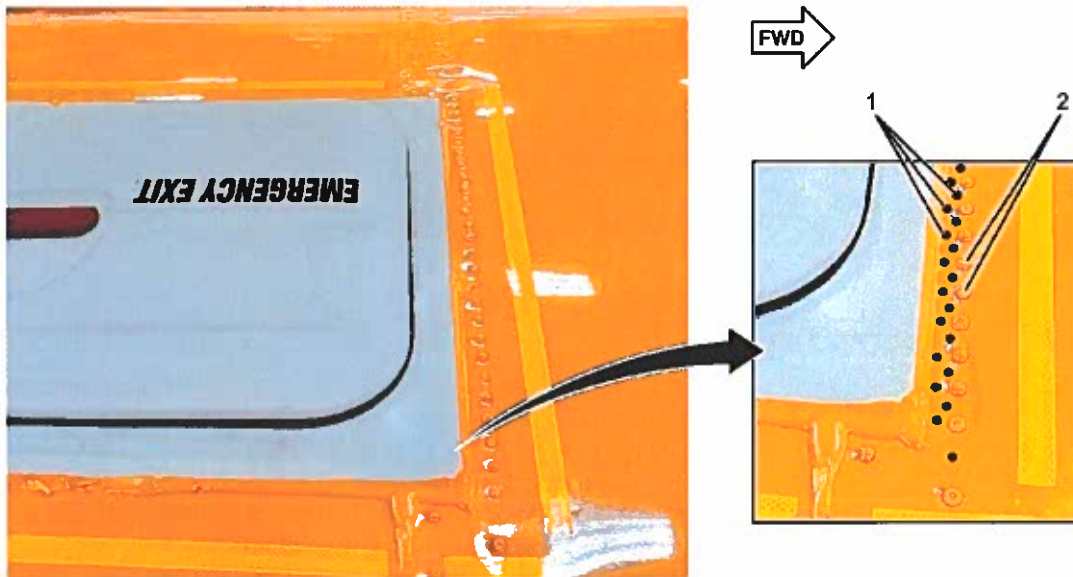
Figure 6. Noncompliant Roof Bow – Roof Hatch Screw Locations

NOTE: If roof hatch is covering a row of rivets by a noncompliant joint, approximately 52 screws will be needed when they are installed every 1/2 in (12.7 mm) and staggered along the forward edge of roof hatch.

10. Install self-sealing screws (Figure 6, Item 1) into roof between roof hatch and forward row of rivets (Figure 6, Item 2) every 1/2 in (12.7 mm) near noncompliant roof bow. Refer to following detailed instructions:
 - a) Mark correct location for each hole 1/2 in (12.7 mm) apart and staggered to be punched and drilled on panel using a marker.
 - b) Punch location for each hole to be drilled on panel using hammer and center punch.
 - c) Install #21 drill bit 0.1590 in (4.0386 mm) diameter into drill.
