**SUBJECT: NEW VEHICLE DEMONSTRATION / DELIVERY HOLD –  
 Safety Recall 23S05**

Certain 2020-2022 Model Year Explorer Vehicles Equipped with 2.3L Engines and  
 10R60 Transmission  
 Transmission Park System Inspection and Repair

## CERTAIN 2020-2022 MODEL YEAR EXPLORER VEHICLES EQUIPPED WITH 2.3L ENGINES AND 10R60 TRANSMISSION — PARK SYSTEM INSPECTION

## CERTAIN 2020-2022 MODEL YEAR EXPLORER VEHICLES EQUIPPED WITH 2.3L ENGINES AND 10R60 TRANSMISSION — PARK SYSTEM REPLACEMENT

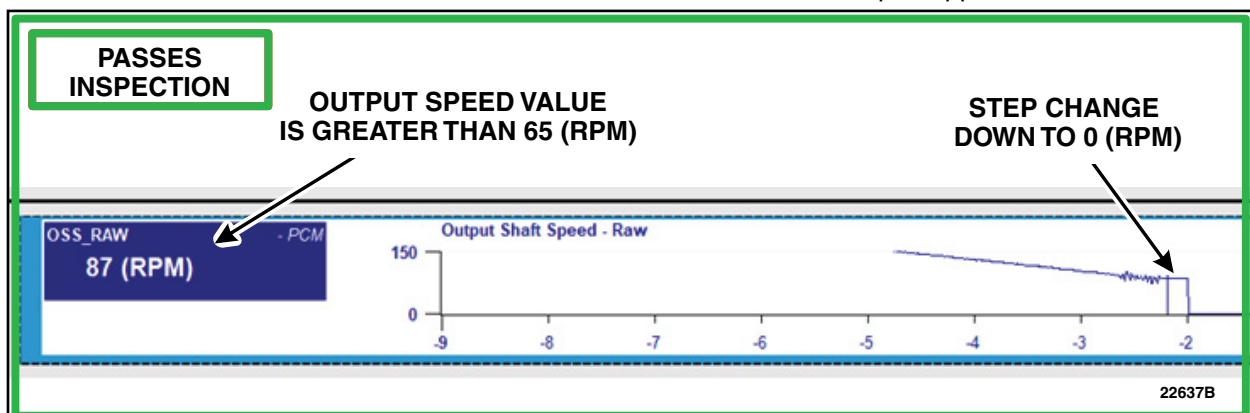
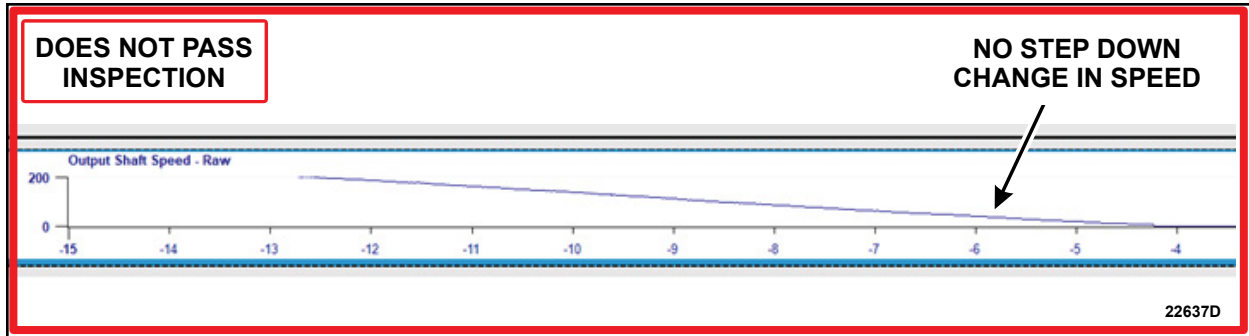
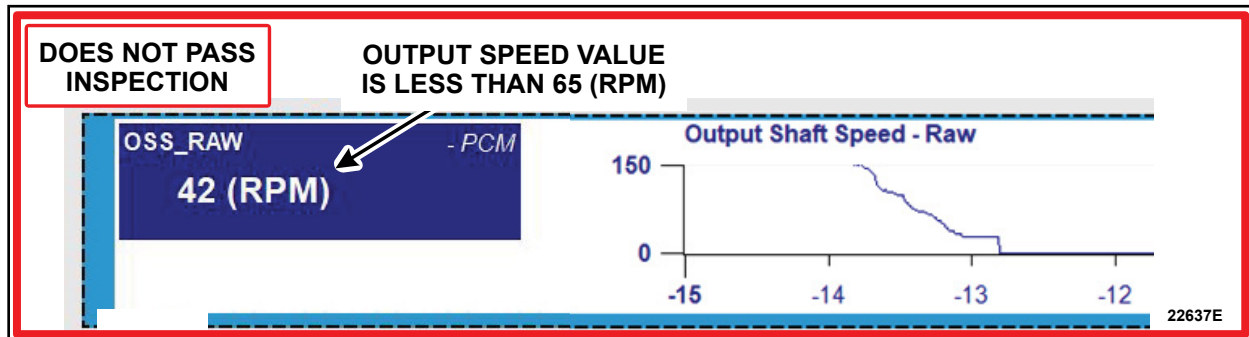
31. Did the output speed decrease in a step change from a speed of 65 rpm or above down to 0 rpm in BOTH tests? See Figures 10 through 12.

Yes – Passes inspection. Reinstall fuse number 28 back into the fuse box and continue Step 32.

No – Does not pass inspection. Reinstall fuse number 28 back into the fuse box, then check and clear codes. Submit both screenshots to SSSC for further repair approval.
