March 22, 2023

**SUBJECT: NEW VEHICLE DEMONSTRATION / DELIVERY HOLD –
 Safety Recall 23S06**

Certain 2022-2023 Model Year Bronco, Explorer, F-150, Mustang and 2023 Aviator
 Vehicles Equipped With 10 Speed Automatic Transmission
 Transmission Assembly Inspection

**REF: NEW VEHICLE DEMONSTRATION / DELIVERY HOLD - Advance Notice -
 Safety Recall 23S06 - *Supplement #2***

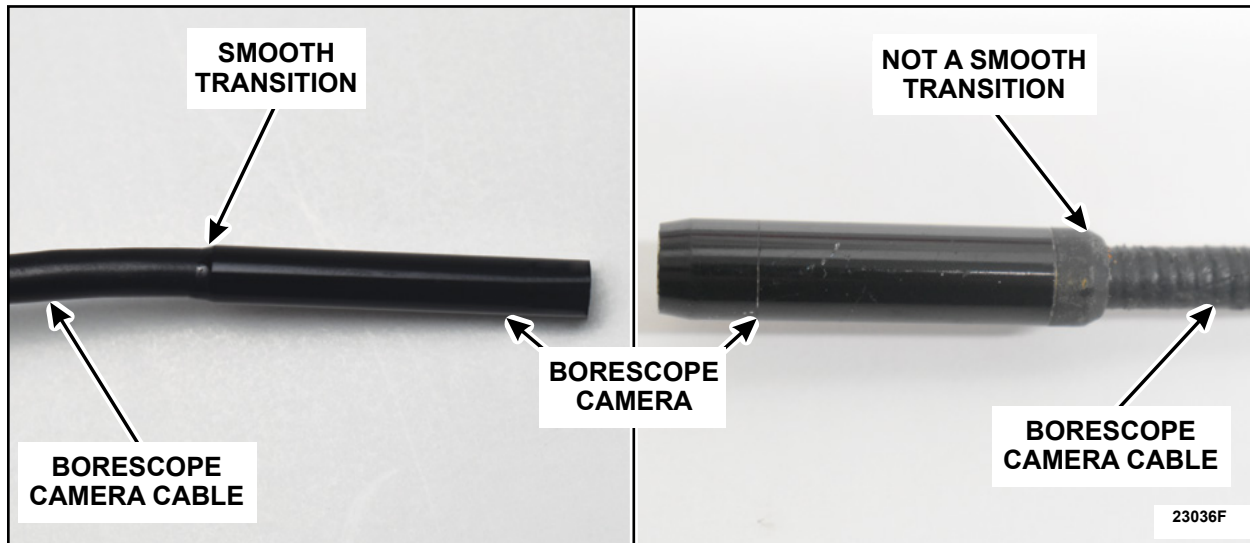
FIGURE 1

NOTE: The camera to cable transition **MUST** be smooth so there are no raised edges. See Figure 1. A raised edge or lip at the camera connection could cause it to get stuck in the transmission and require complete disassembly. **Metal braided cable is highly recommended.**
DO NOT attempt to use a bore scope that has a camera larger than 6.0 mm diameter.

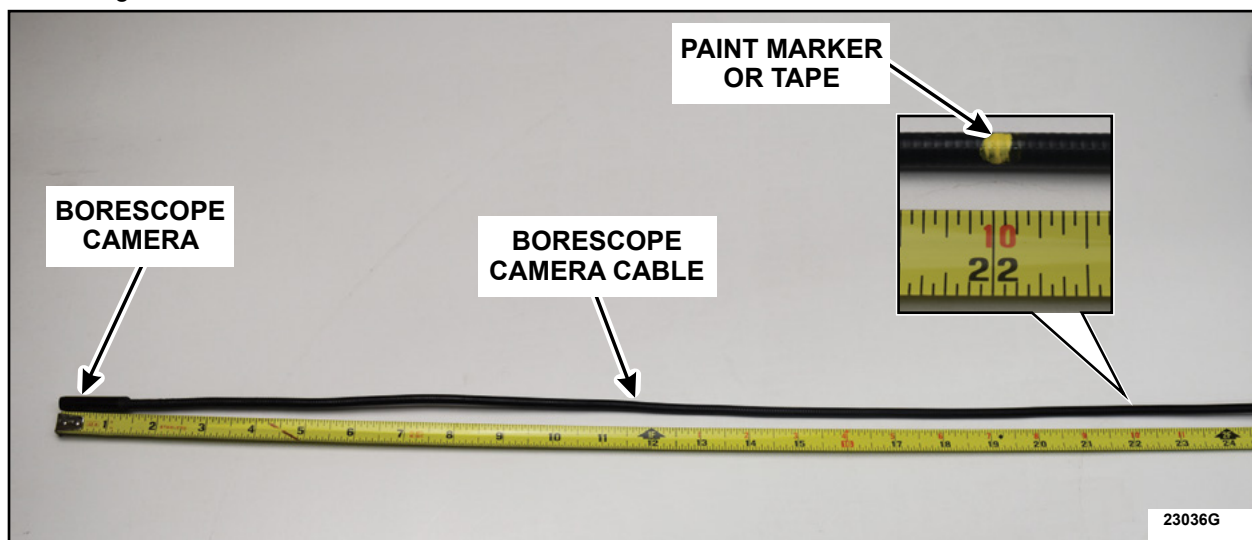
FIGURE 4

6. Measure 22 in (558 mm) from the tip of the camera and place a mark using a paint marker or tape. See Figure 4.

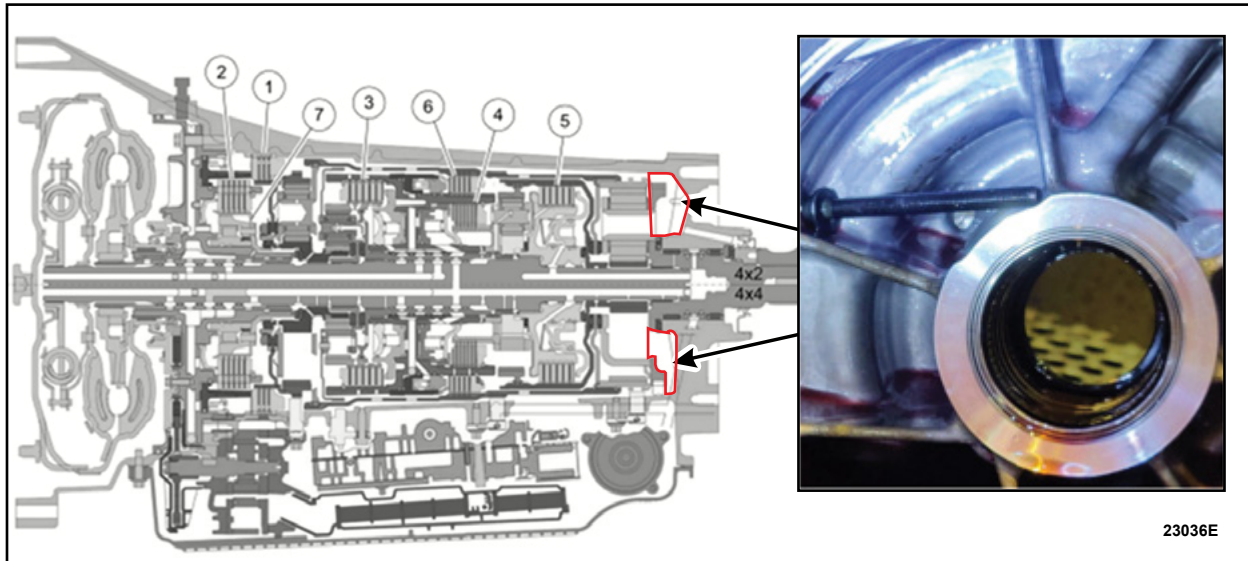
FIGURE 5

NOTE: See Figure 5 for examples of possible bolt location.

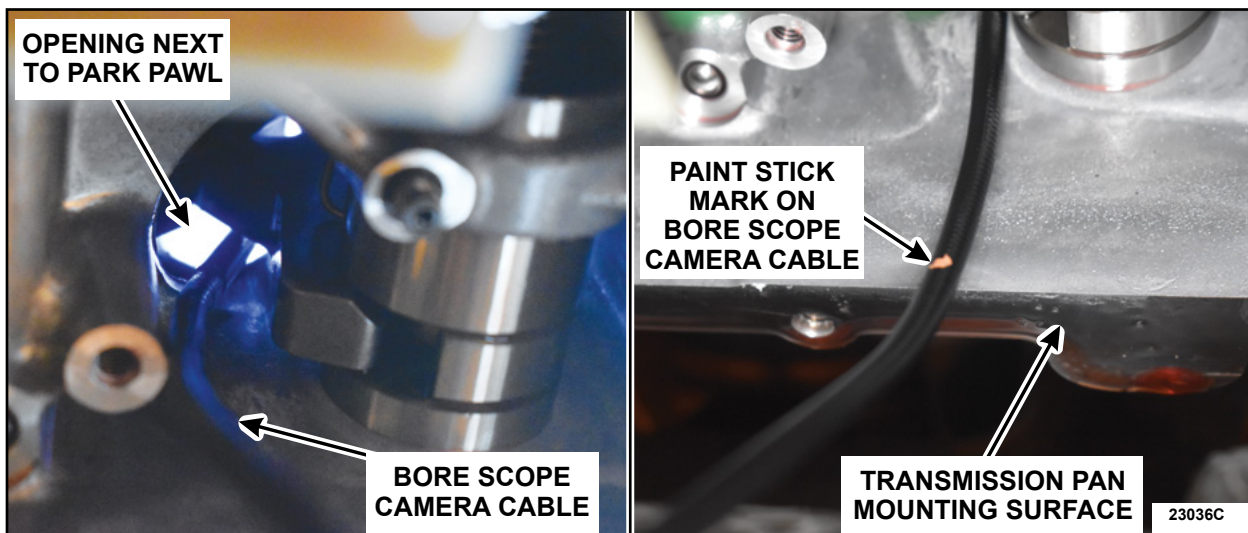
FIGURE 6

7. Insert the borescope through the opening beside the park pawl until the mark placed in the previous Step lines up with the transmission fluid pan mounting surface. See Figure 6.

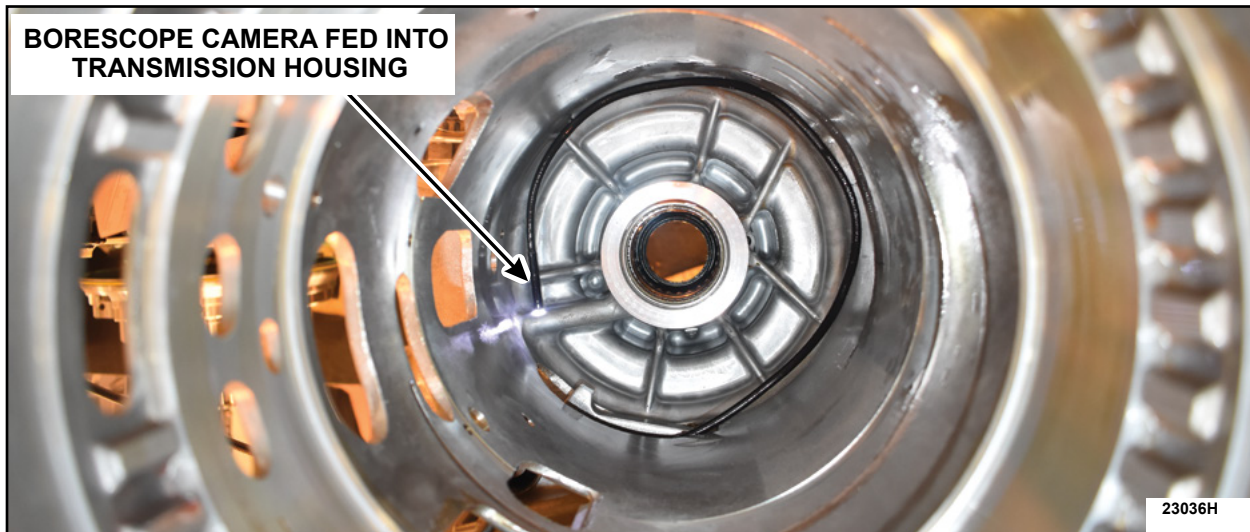
FIGURE 7

NOTE: If you see transmission gears on the bore scope display screen, the camera cable fed through the wrong area remove the bore scope and repeat Step 7. Bending a curve in the cable can assist in directing the camera to the proper location. See Figure 7.

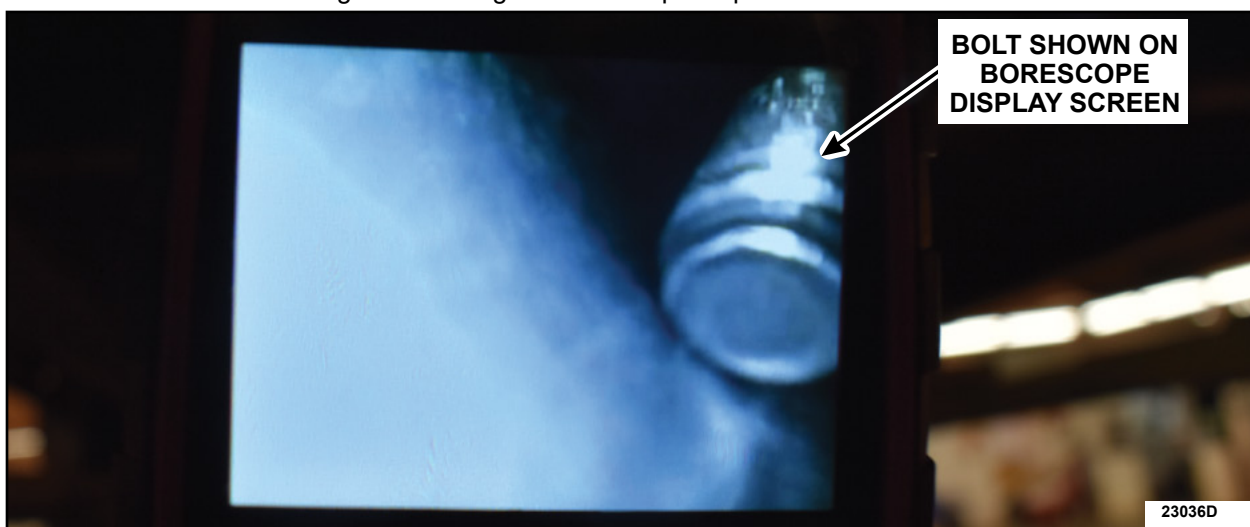
FIGURE 8

8. While watching the borescope display screen for a bolt, slowly remove the borescope camera cable. See Figure 8. Was a bolt found using the borescope?

NOTE: There is a very low probability that a bolt will be found in the transmission. If there is a bolt in the transmission, there will typically be other indicators such as excess metal debris or marks on the interior of the housing found during the bore scope inspection.

YES - Submit a photo of the bolt found in the transmission assembly, the VIN, and the transmission oil pan removed. Replace the transmission. Please follow the WSM procedures in Section 307-01. This completes the FSA.

NO - Repeat Steps 7 through 8 a total of 5 times. If no bolt is found after 5 inspections. Reassemble the vehicle by reversing the disassembly procedures. This completes the FSA.
