February 16, 2023

**SUBJECT: NEW VEHICLE DEMONSTRATION / DELIVERY HOLD
Compliance Recall 23C01**
Certain 2023 Model Year F-150 Limited and Platinum
Passenger Instrument Panel Cover Replacement

CERTAIN 2023 MODEL YEAR F-150 VEHICLES — PASSENGER SIDE INSTRUMENT PANEL COVER REPLACEMENT

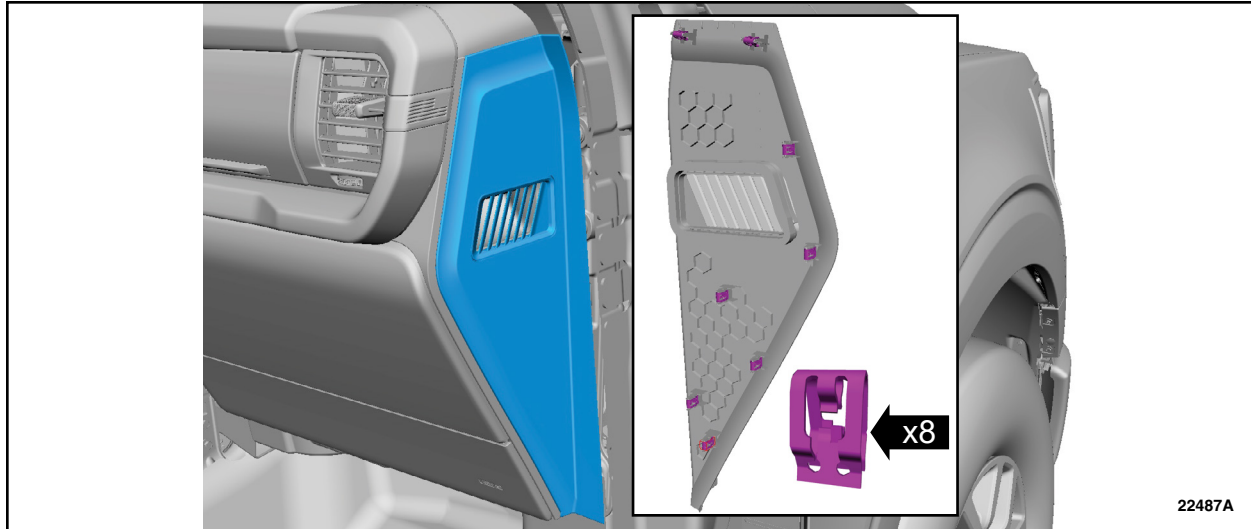
FIGURE 1

1. Depower the Supplemental Restraint System (SRS). Please follow the Workshop Manual (WSM) procedures in Section 501-20B.
2. Remove the A-pillar trim panels. Please follow the WSM procedures in Section 501-05.
3. Release the clips and remove the Right Hand (RH) instrument panel trim panel. See Figure 1.

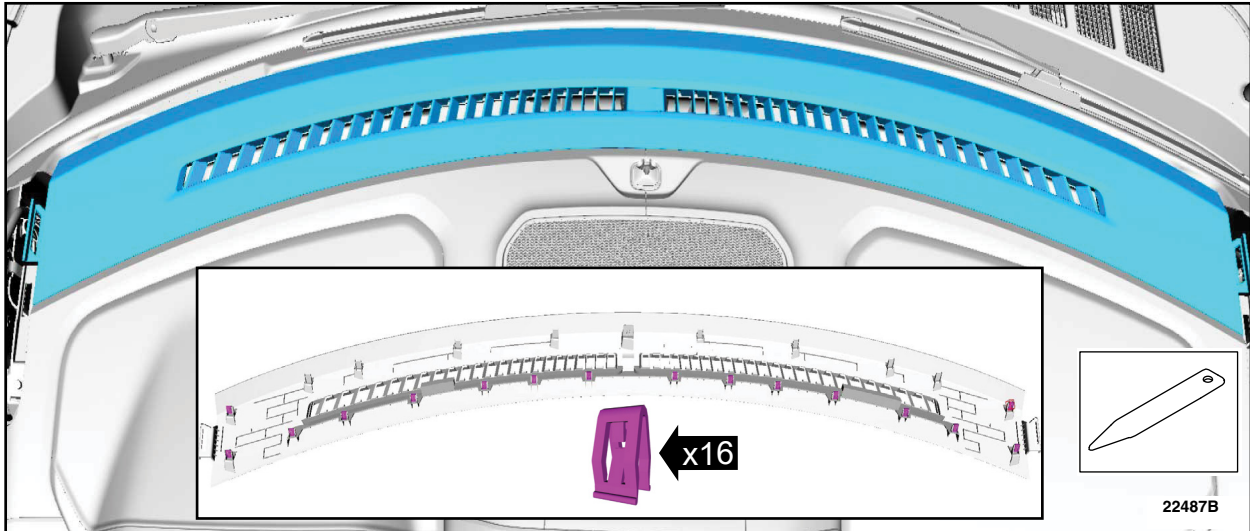
FIGURE 2

4. Release the clips and remove the defrost grille trim panel. See Figure 2.

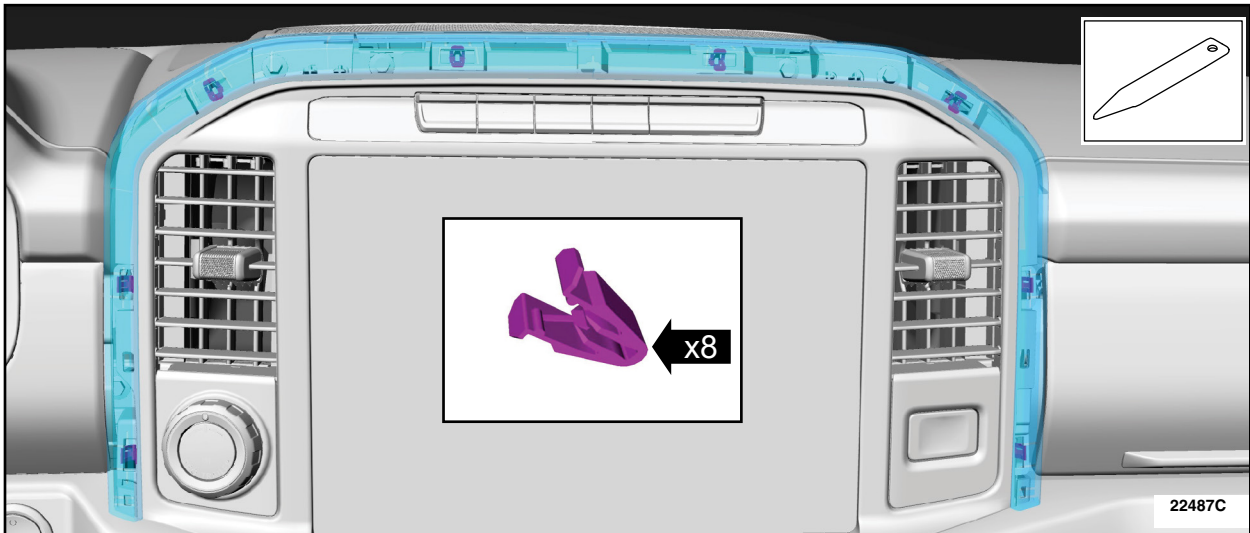
FIGURE 3

5. Release the clips and remove the trim panel. See Figure 3.

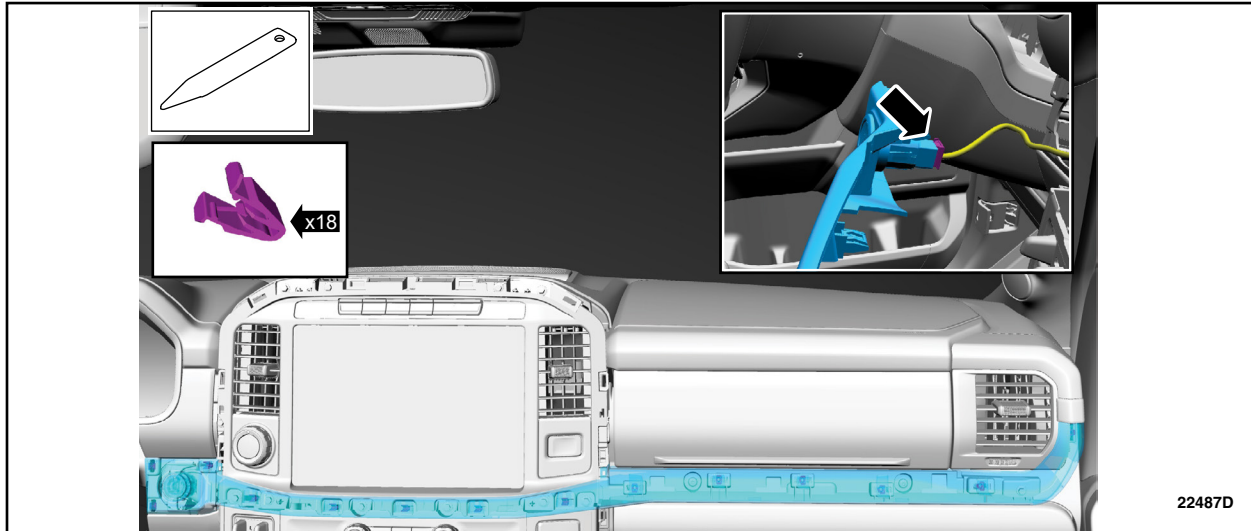
FIGURE 4

6. Release the clips, disconnect the electrical connector and remove the center finish trim. See Figure 4.

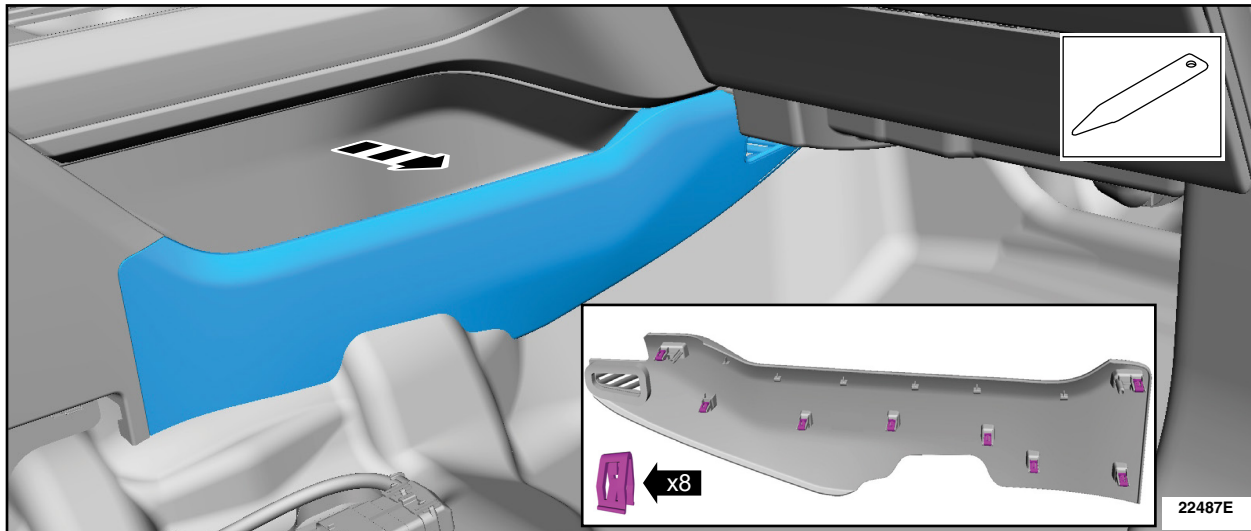
FIGURE 5

7. Release the clips and remove the floor console lower RH trim panel. See Figure 5.

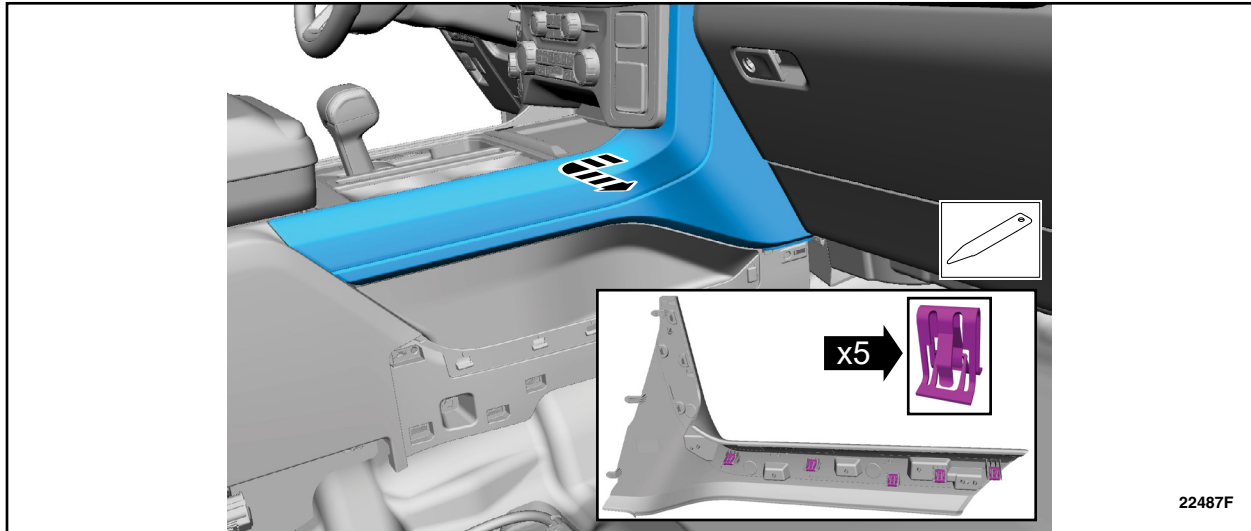
FIGURE 6

8. Release the clips and remove the floor console upper RH trim panel. See Figure 6.

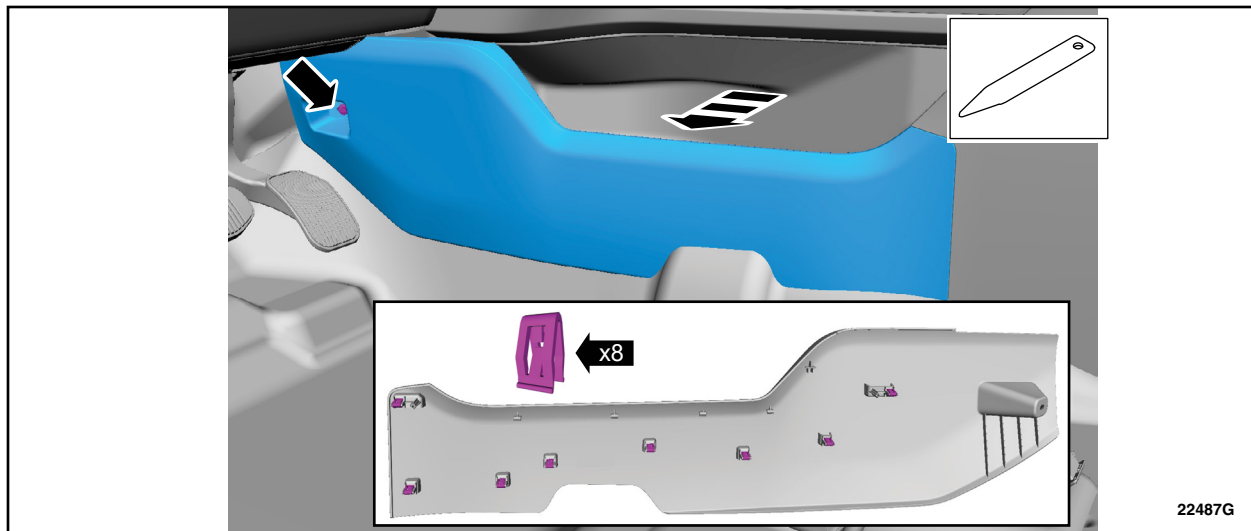
FIGURE 7

9. Remove the bolt, release the clips and remove the floor console lower Left Hand (LH) trim panel. See Figure 7.

- Torque 22 lb.in (2.5 Nm).

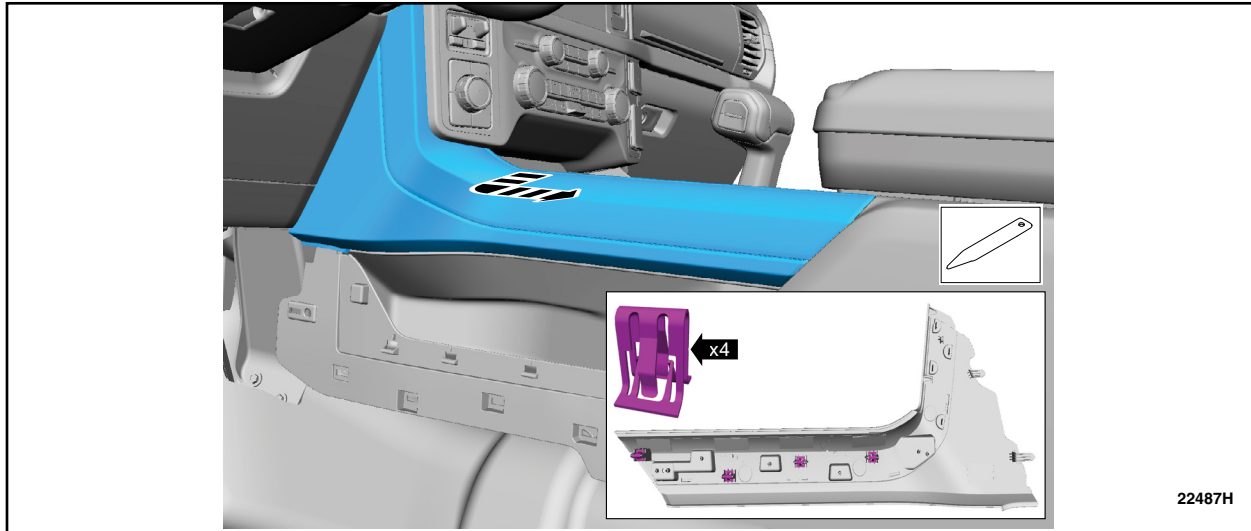
FIGURE 8

10. Release the clips and remove the floor console upper LH trim panel. See Figure 8.

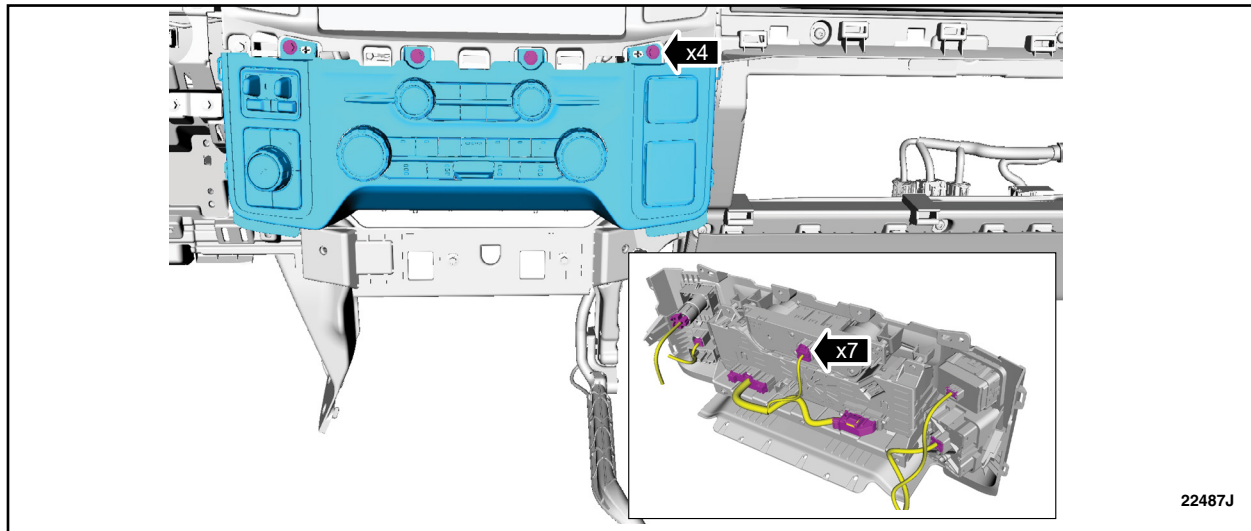
FIGURE 9

11. Remove the bolts, disconnect the electrical connectors and remove the Front Controls Interface Module (FCIM). See Figure 9.

- Torque 22 lb.in (2.5 Nm).

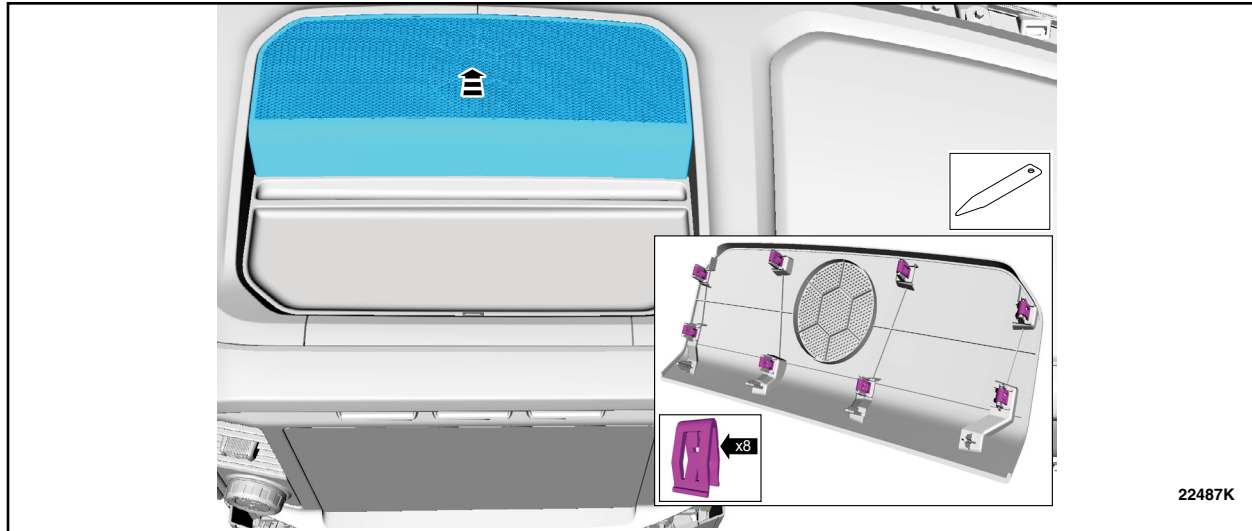
FIGURE 10

12. Release the clips and remove the speaker grille. See Figure 10

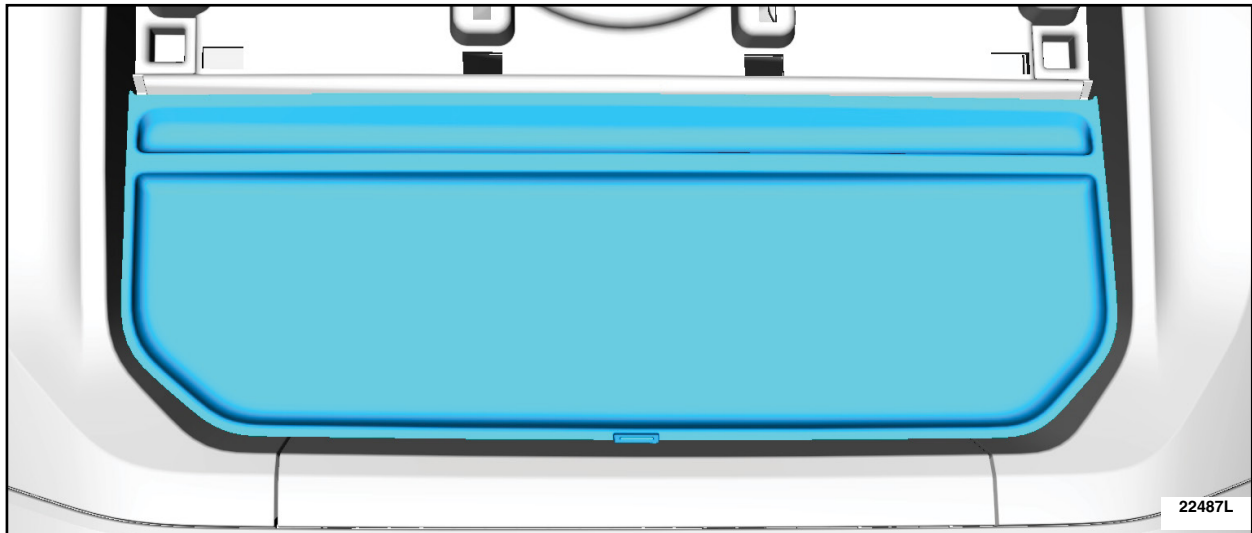
FIGURE 11

NOTE: If equipped remove the rubber pad. See Figure 11.

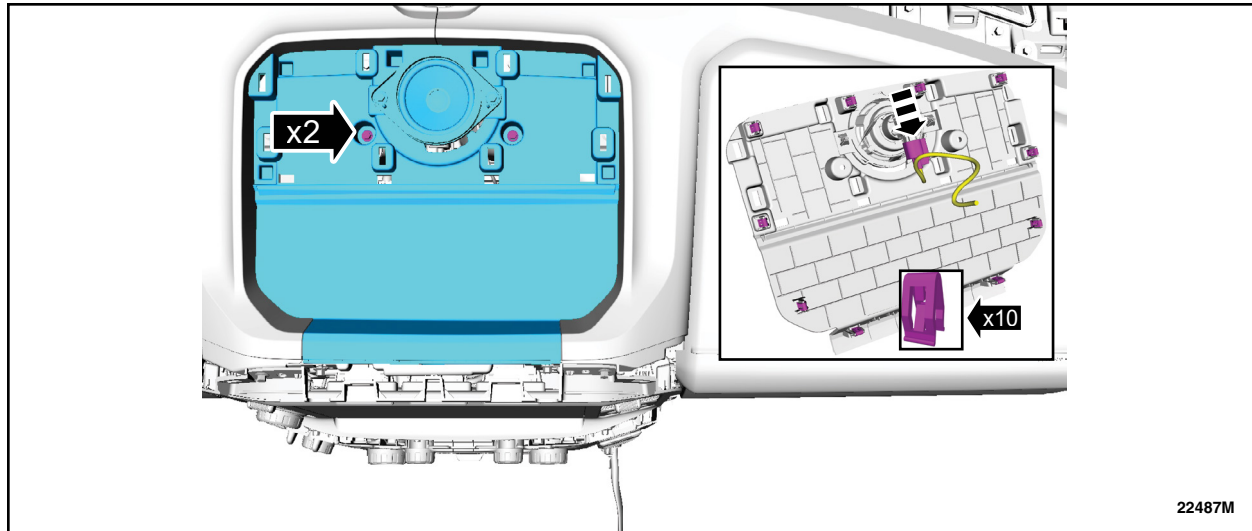
FIGURE 12

13. Remove the bolts, disconnect the electrical connector and remove the upper instrument panel storage tray. See Figure 12.

- Torque 22 lb.in (2.5 Nm).

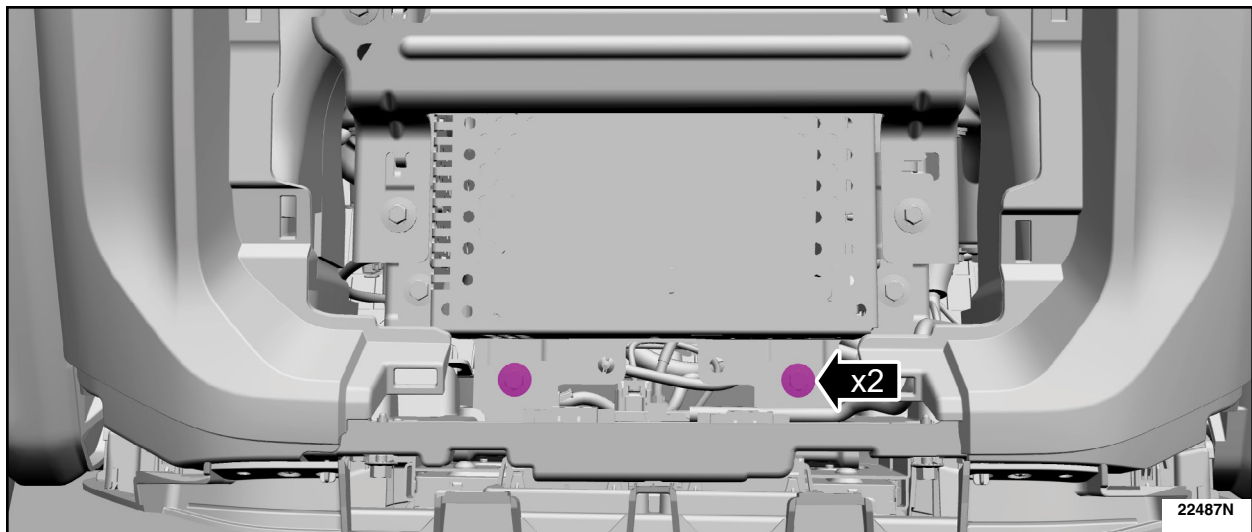
FIGURE 13

14. Remove the bolts. See Figure 13.

- Torque 42.48 lb.in (4.8 Nm).

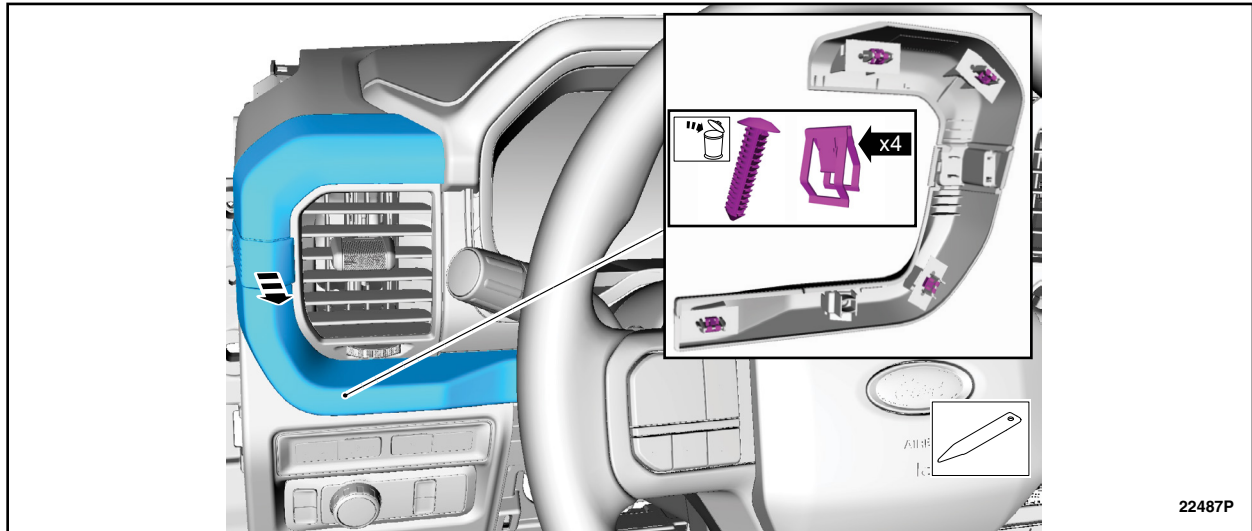
FIGURE 14

15. Release the retainers, remove and discard the push pin and remove the LH register bezel.
See Figure 14.

NOTE: The push pin must be replaced each time the bezel is removed.

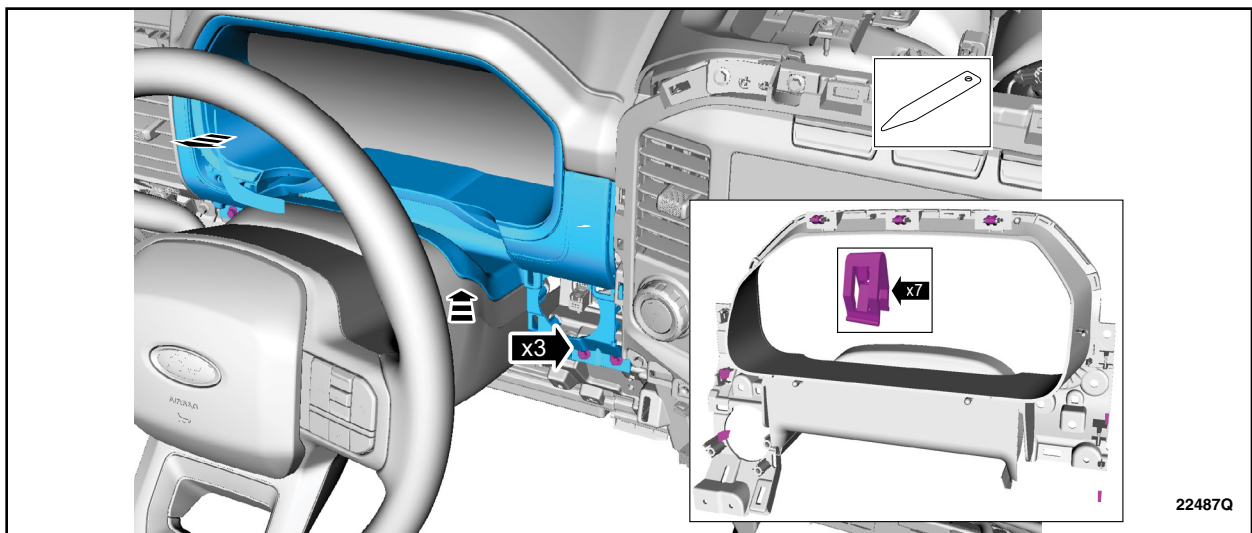
FIGURE 15

16. Remove the bolts, separate the gap hider from the upper steering column shroud, release the 7 clips and remove the IPC bezel. See Figure 15.

- Torque 36 lb.in (4.1 Nm).

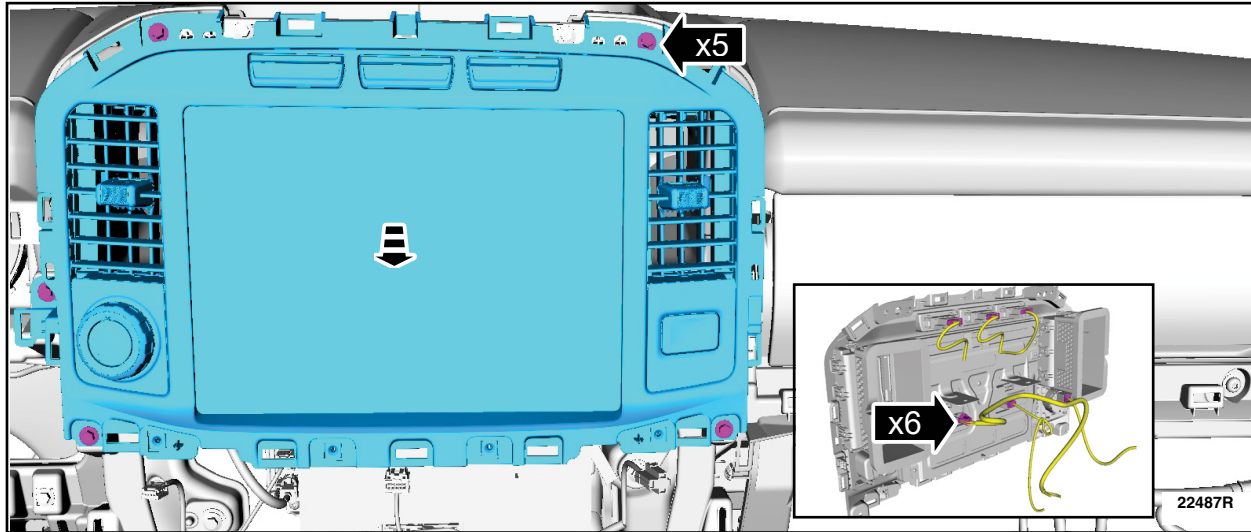
FIGURE 16

17. Remove the bolts, disconnect the electrical connectors and remove the display unit. See Figure 16.

- Torque 22 lb.in (2.5 Nm).

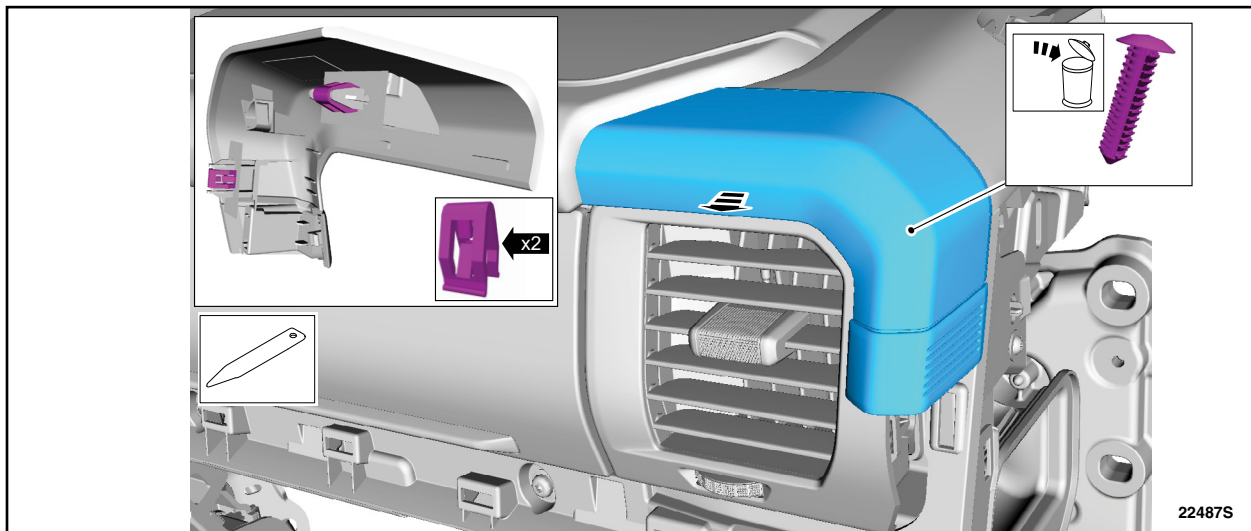
FIGURE 17

18. Release the retainers and remove and discard the push pin. Remove the RH register bezel. See Figure 17.

NOTE: The push pin must be replaced each time the bezel is removed.

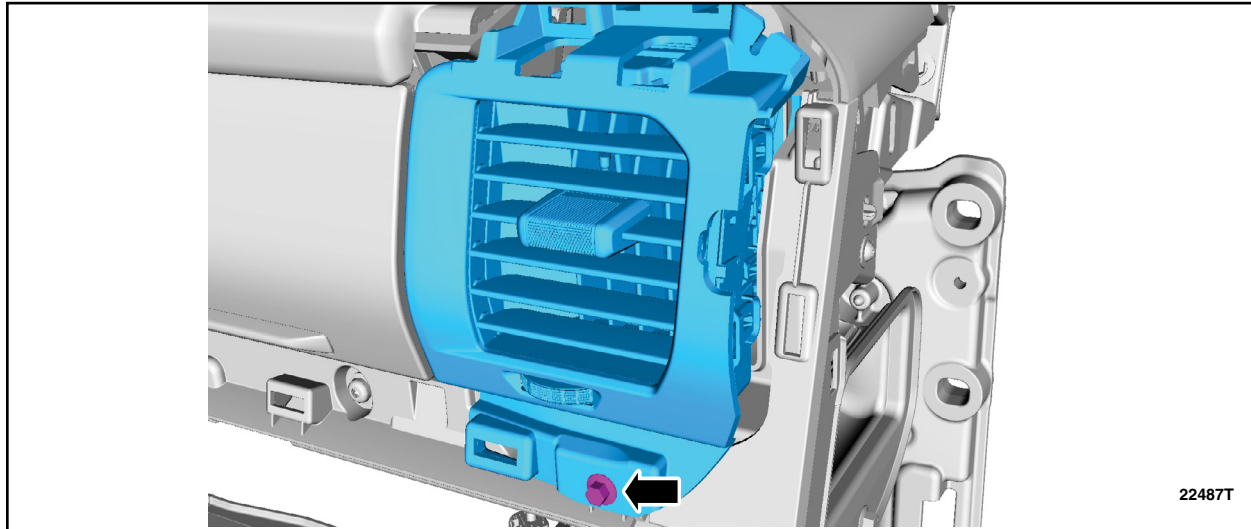
FIGURE 18

19. Remove the bolt and the RH register. See Figure 18.

- Torque 22 lb.in (2.5 Nm).

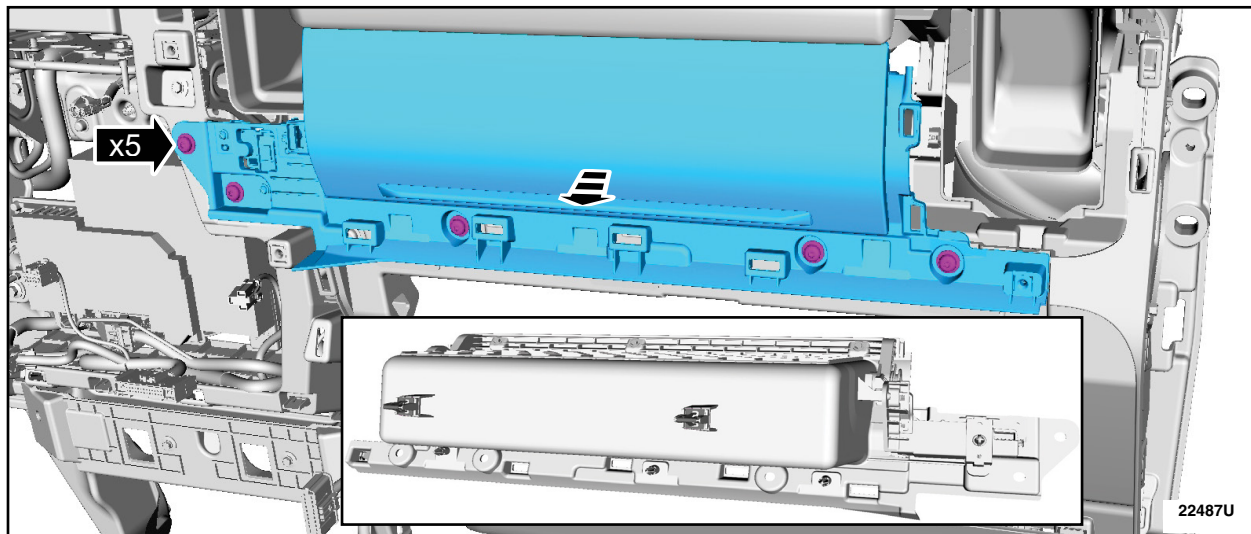
FIGURE 19

20. Remove the bolts and remove the upper storage compartment. See Figure 19.

- Torque 22 lb.in (2.5 Nm).

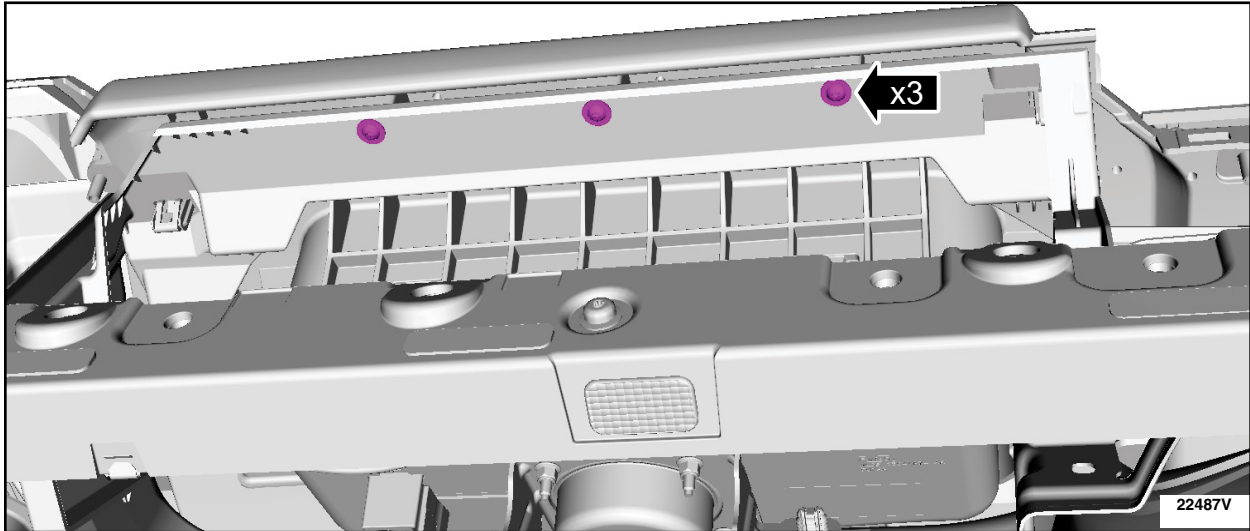
FIGURE 20

21. Remove the screws through the upper stowage bin opening. See Figure 20.

- Torque 11.5 lb.in (1.3 Nm).

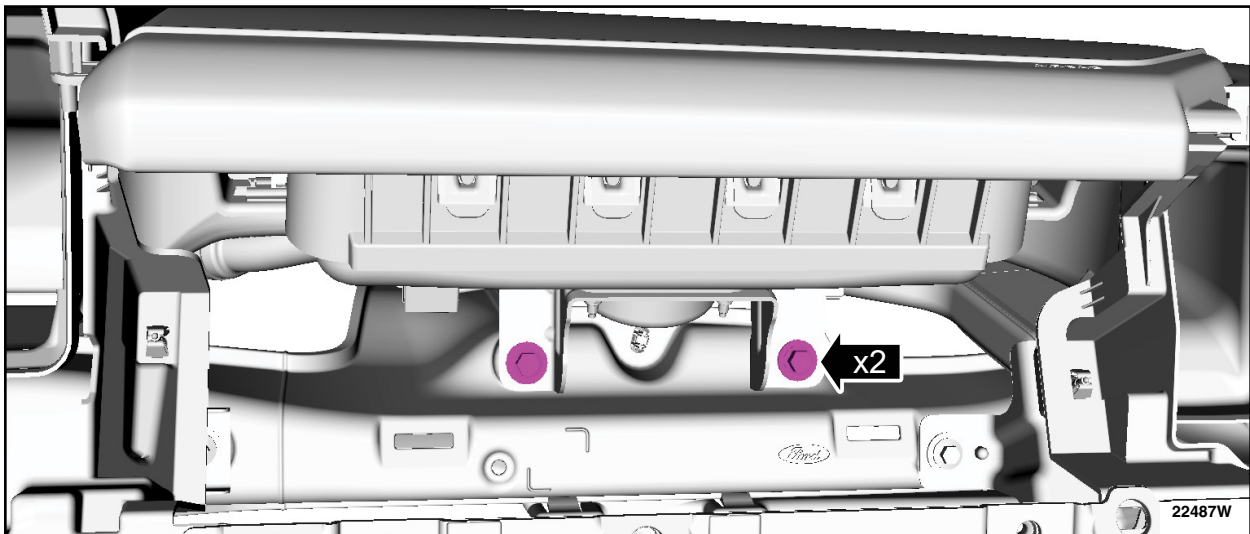
FIGURE 21

22. Remove the bolts. See Figure 21.

- Torque 93 lb.in (10.5 Nm).

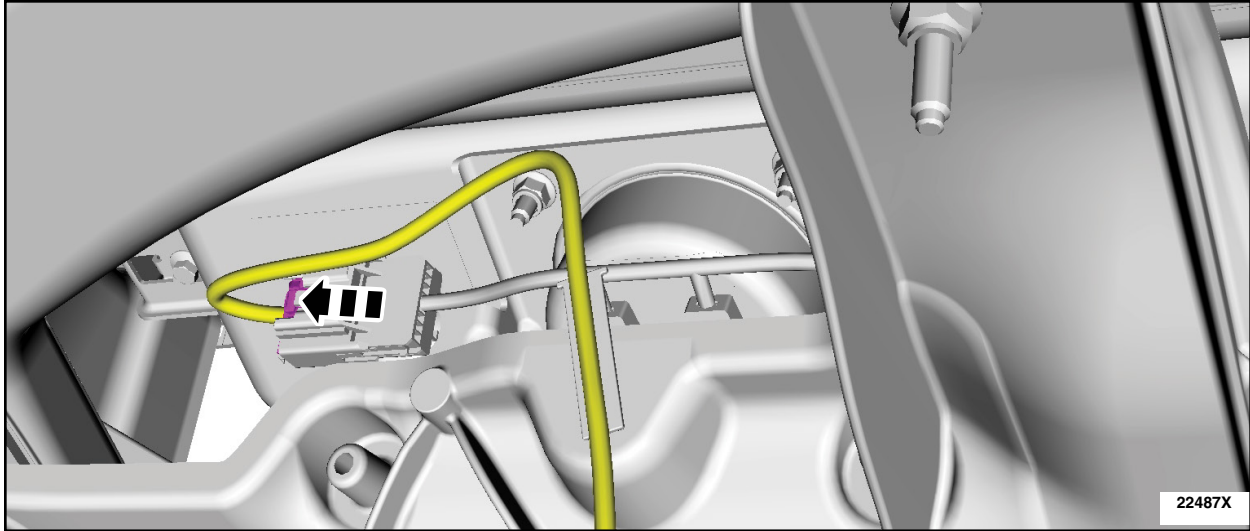
FIGURE 22

23. Disconnect the passenger airbag electrical connector. See Figure 22.

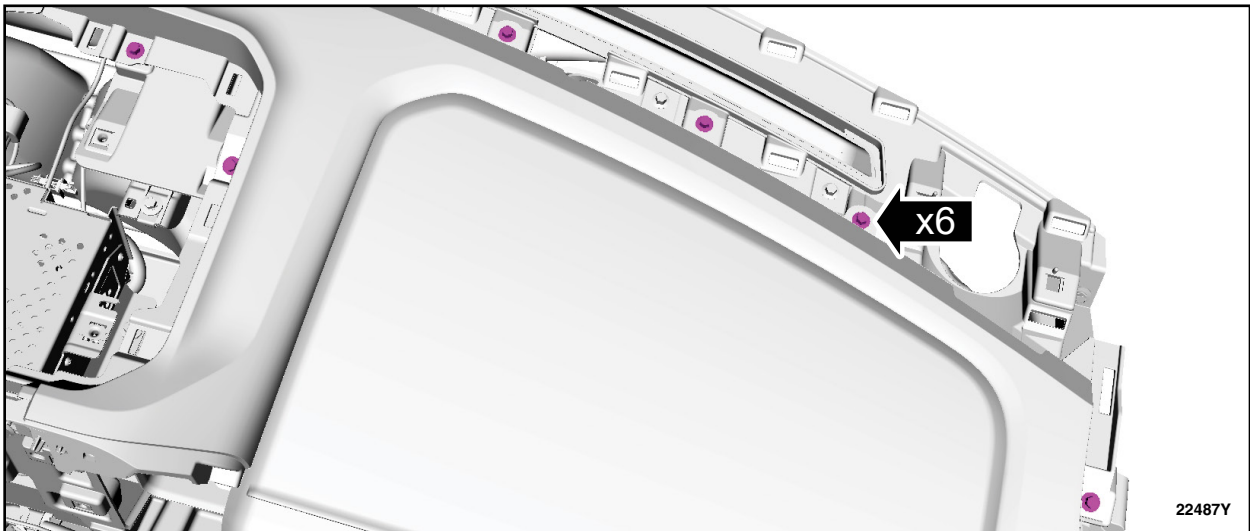
FIGURE 23

24. Remove the RH instrument panel upper section bolts. See Figure 23.

- Torque 22 lb.in (2.5 Nm).

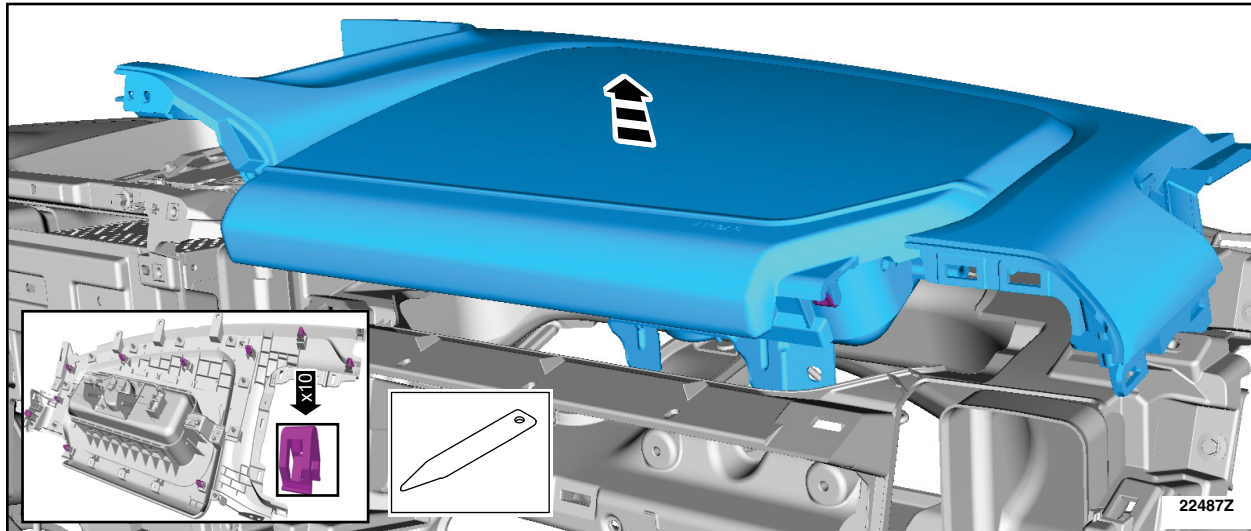
FIGURE 24

25. Remove the RH instrument panel upper section by lifting upwards to release the clips. See Figure 24.
