October 2023  
FL966A-F  
NHTSA #23V-073  
Transport Canada #2023-051

**Subject: Brake Modulator Valves**

**Models Affected: Specific model years 2017-2022 Freightliner 114SD, and Cascadia; and Western Star 47X, and 49X vehicles manufactured June 28, 2016, through April 8, 2022.**

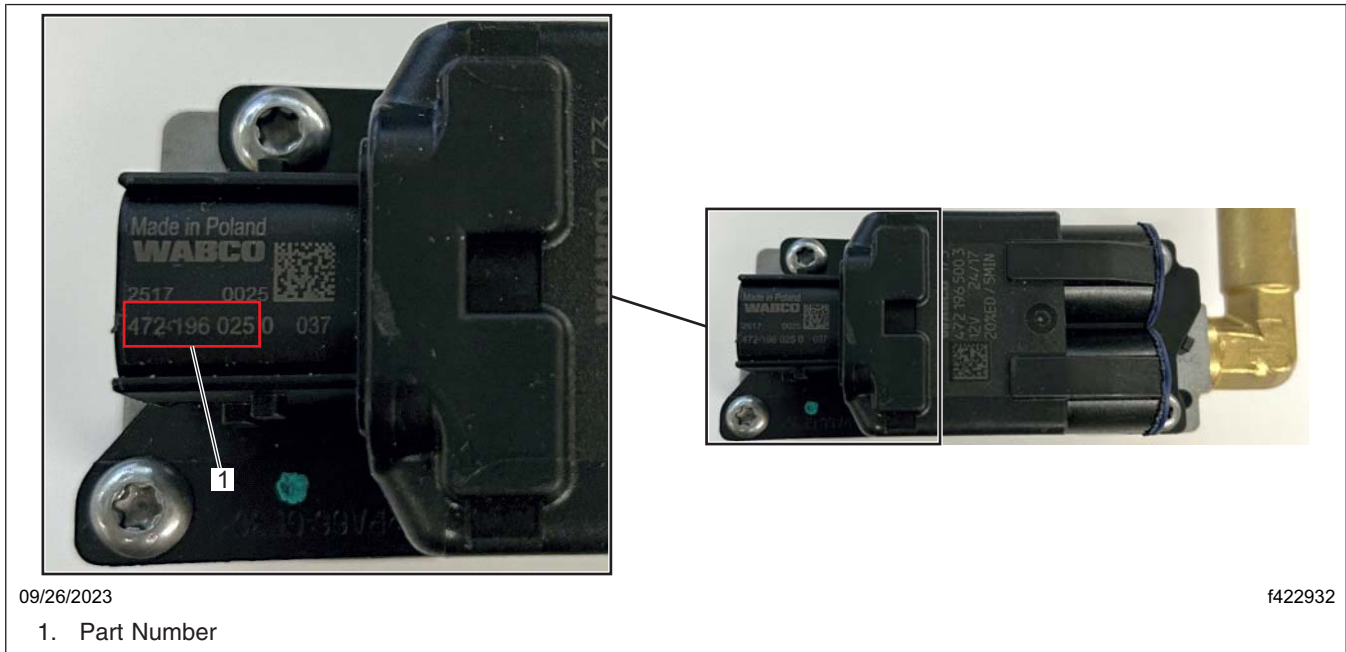
Fig. 1, Modulator Valve

4. Remove the connector from the valve, and inspect the part number underneath the connector. See [Fig. 1](#).

Good part numbers → **472 196 046 0** and **472 196 051 0**

Bad part numbers → **472 196 025 0** and **472 196 037 0**

- If the part numbers are good, install the connector. Clean a spot on the base label (Form WAR259), and attach a campaign completion sticker for FL966 (Form WAR260), indicating this work has been completed.
- If at least one of the part numbers is bad, go to the replacement procedure for the specified group, and replace both the modulator valves.
